AIRPROX REPORT No 2018079

Date: 10 May 2018 Time: 1455Z Position: 5148N 00106W Location: NE Oxford

PART A: SUMMARY OF INFORMATION REPORTED TO UKAB

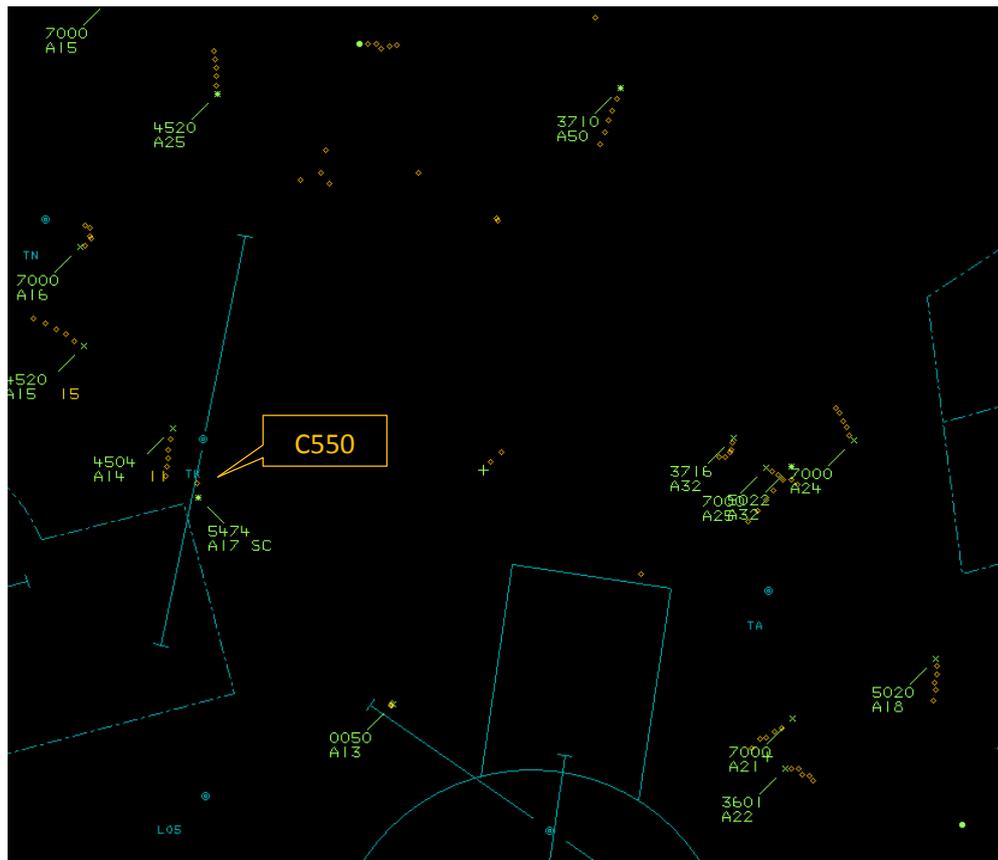
Figure 1 – 1454:16

The C550 departed Oxford on an IFR flight plan, routing to the WCO (Wescott) VOR, in the climb to 5000ft. At 1454:16 the pilot contacted Oxford Radar, was identified by the controller, a Traffic Service was agreed, and the pilot was requested to expedite their climb to 5000ft (Figure 1).

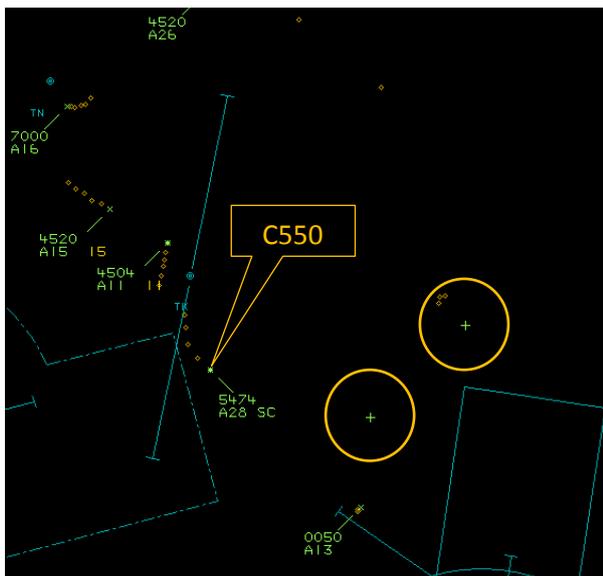
Figure 2 – 1454:35

At 1454:35, the Oxford controller advised the C550 pilot of 4 contacts in the Wescott area between 2200ft and 3500ft. The controller also cautioned the pilot that a lot of gliding activity had been reported in the area, which was acknowledged by the pilot. At the same time, the area radar replay showed two primary-only contacts, (ringed in Figure 2), to the east and northeast of the C550, but they both disappeared on the next sweep of the radar.

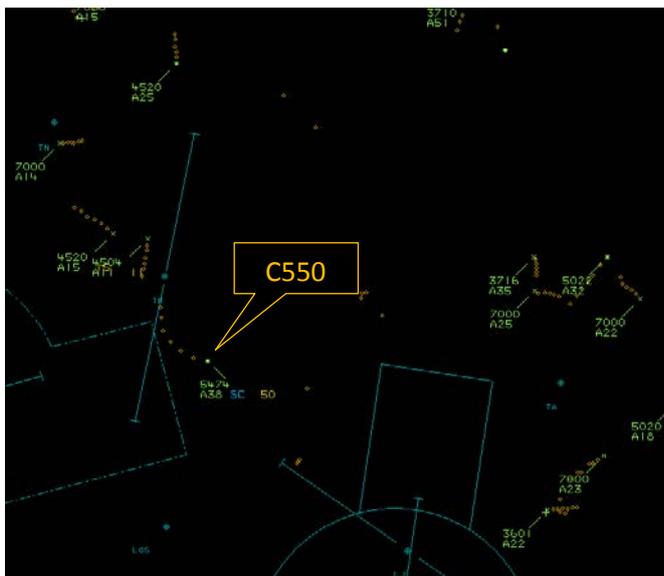
Figure 3 – 1454:50

At 1454:50, the Oxford controller instructed the pilot to remain clear of controlled airspace, and advised them that they would transfer them to London Control early, in order to facilitate further climb into controlled airspace (Figure 3).

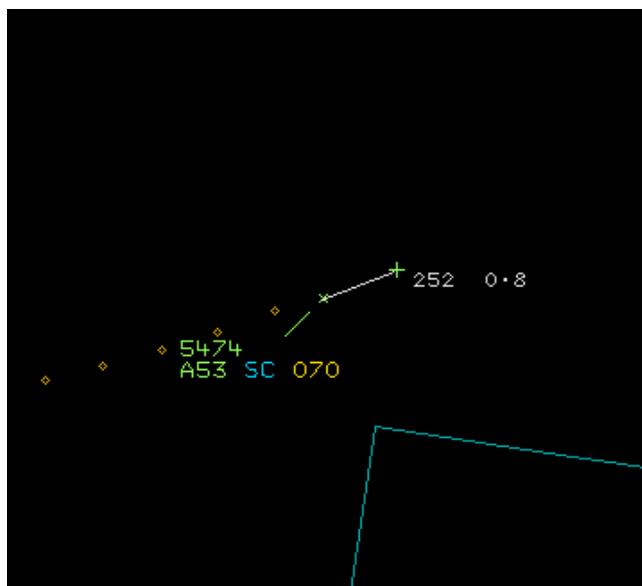
Figure 4 – 1456:10

According to the NATS unit investigation, the C550 pilot contacted the London controller at 1455:18, and reported maintaining 5000ft. The controller issued a climb instruction to 7000ft as part of a joining clearance for the London TMA and, at 1455:32, the aircraft was seen to “squawk ident”. At 1456:10, a primary-only contact reappeared 0.8nm ahead of the C550 (Figure 4). The contact faded at 1456:18 (Figure 5).

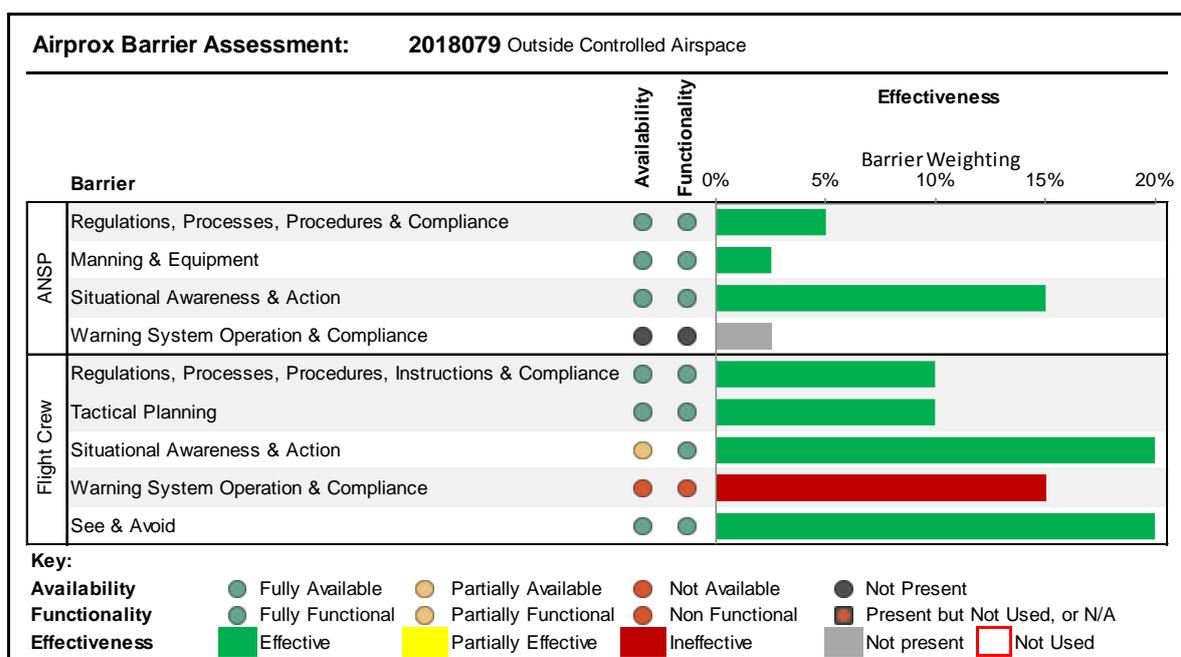
Situational Awareness and Action were assessed as **effective**, although the availability was only partially present because the C550 pilot only had generic traffic information on the glider.

Warning System Operation and Compliance were assessed as **ineffective** because the CWS on each aircraft was incompatible with the other.
