AIRPROX REPORT No 2018091

Date: 19 May 2018 Time: ~1330Z Position: 5435N 00307W Location: 0.5nm SE Keswick

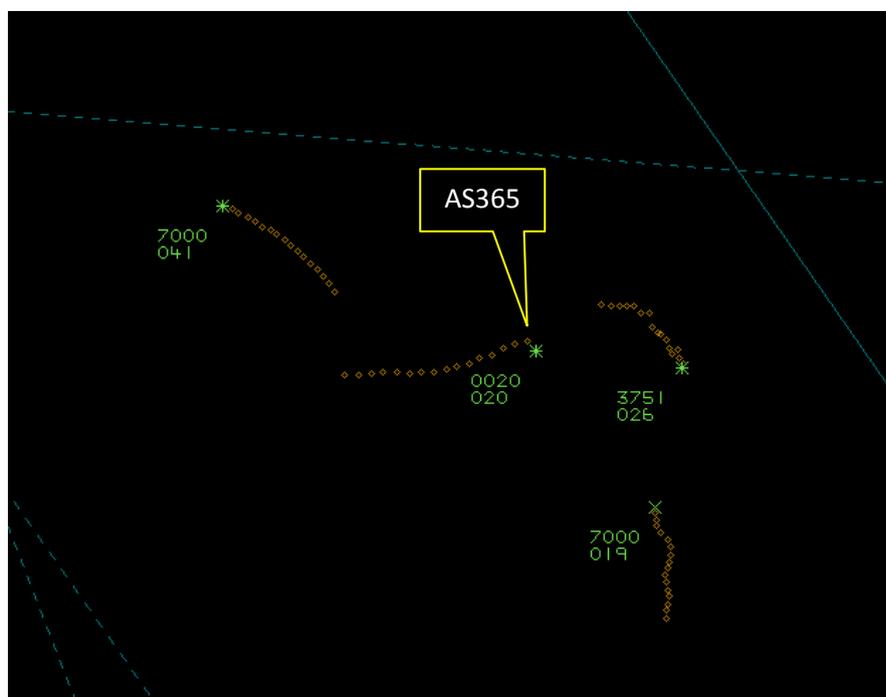
Figure 1: AS365 (Code 0020)

The radar replay shows the AS365 making a turn to the right (Figure 1) and, shortly after, a left turn back onto track. Due to the severity of the right turn, followed by a gentle return onto a north-easterly track, this is the likely location of CPA. There is an intermitted contact that briefly appears on the radar but this cannot be positively identified as the Microlight which the AS365 pilot reports. The other reported microlights in the vicinity also do not appear on the radar replay.
