**AIRPROX REPORT No 2018105**

Date: 02 Jun 2018 Time: 1020Z Position: 5146N 00031E Location: Boreham airfield

**PART A: SUMMARY OF INFORMATION REPORTED TO UKAB**

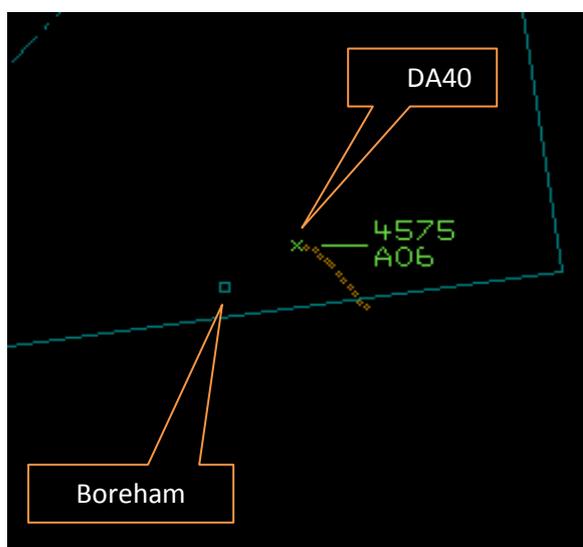
Figure 1-1019:30

The following radar replay snapshots are included to illustrate the developing situation. CPA could not be determined due to the EC135 not appearing on the radar replay until 1019:43, when the aircraft had already passed each other and the EC135 had climbed through the level of the DA40. At the point where the EC135 appeared on the radar the aircraft were separated by 0.4nm laterally, and 100ft vertically.

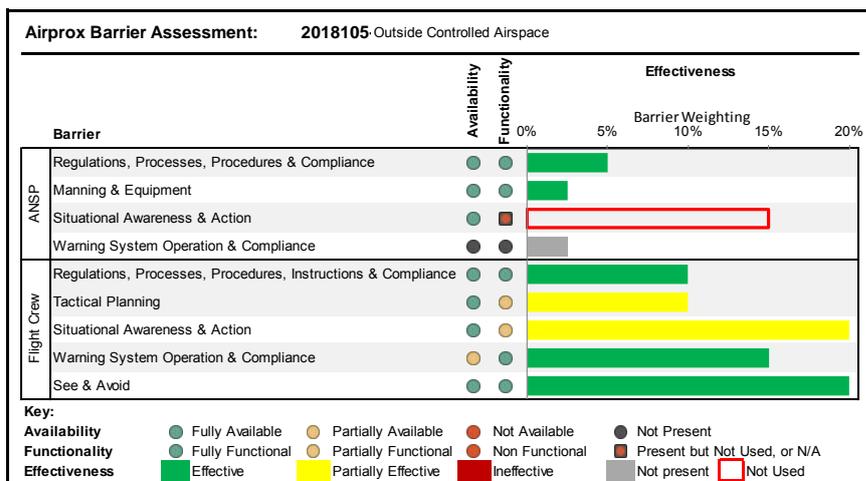
In assessing the effectiveness of the safety barriers associated with this incident, the Board concluded that the key factors had been that:

**Tactical Planning** was assessed as **partially effective** because the DA40 pilot chose to conduct his PFLs close to and active Police Helicopter base.

**Situational Awareness and Action** were assessed as **partially effective** because it was only once airborne that the EC135 pilot assimilated the TCAS information on the DA40.
