AIRPROX REPORT No 2018124

Date: 03 Jun 2018 Time: 0912Z Position: 5155N 00102W Location: 3nm S Buckingham

PART A: SUMMARY OF INFORMATION REPORTED TO UKAB

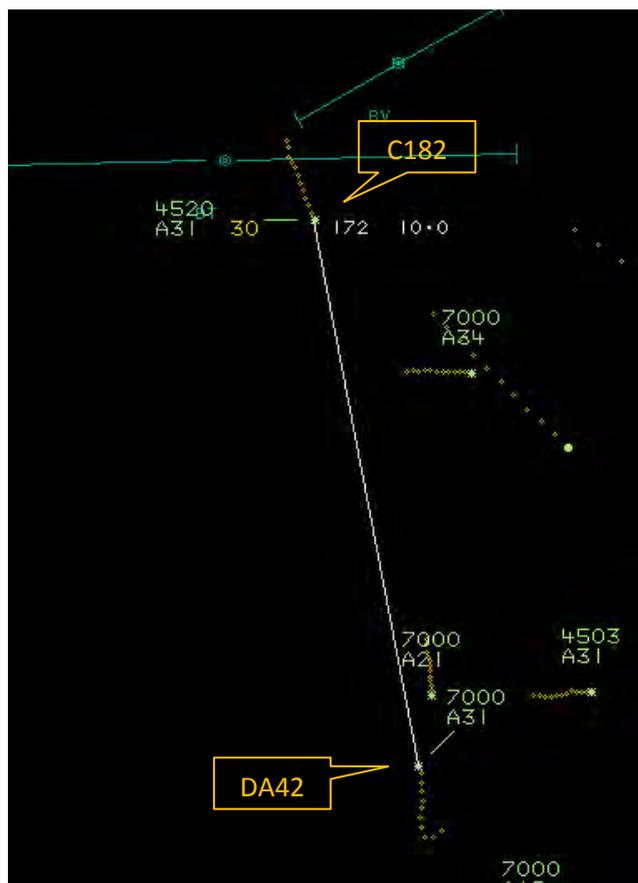
Figure 1 – 0909:50

At 0909:50 (Figure 1) the C182 was tracking south at 3000ft and the DA42 was manoeuvring at 3000ft. CPA occurred at 0912:38 (Figure 2) when the aircraft were separated by less than 0.1nm and 100ft vertically.

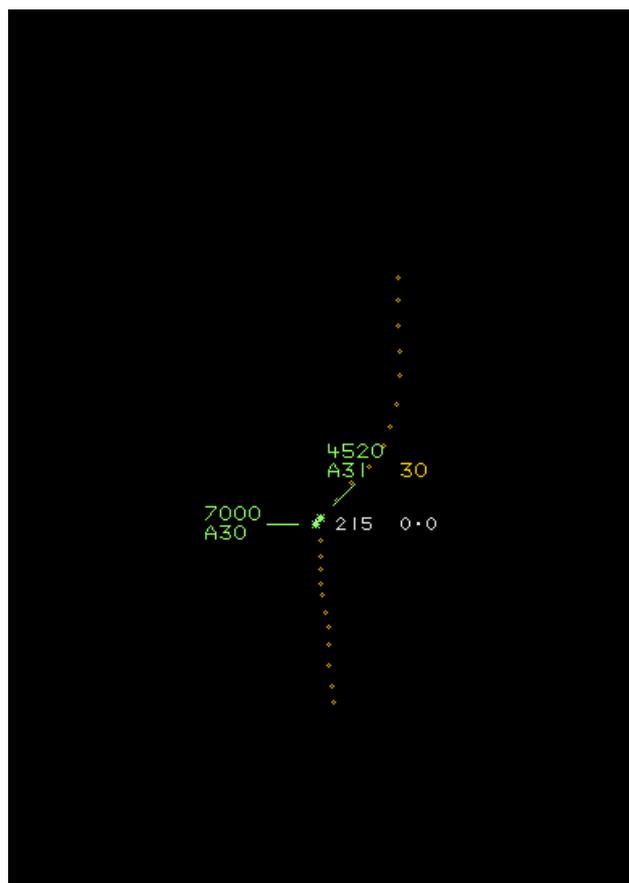
Figure 2 – CPA - 0912:38

The Board quickly agreed that the cause of the Airprox was a late sighting by both pilots. In assessing the risk, the Board thought that the late sightings by both pilots and the associated lack of time available for them to take avoiding action (3-4 secs at their closing speed of 235kts at 0.25nm) made this a Category B incident where safety had been much reduced below the norm.

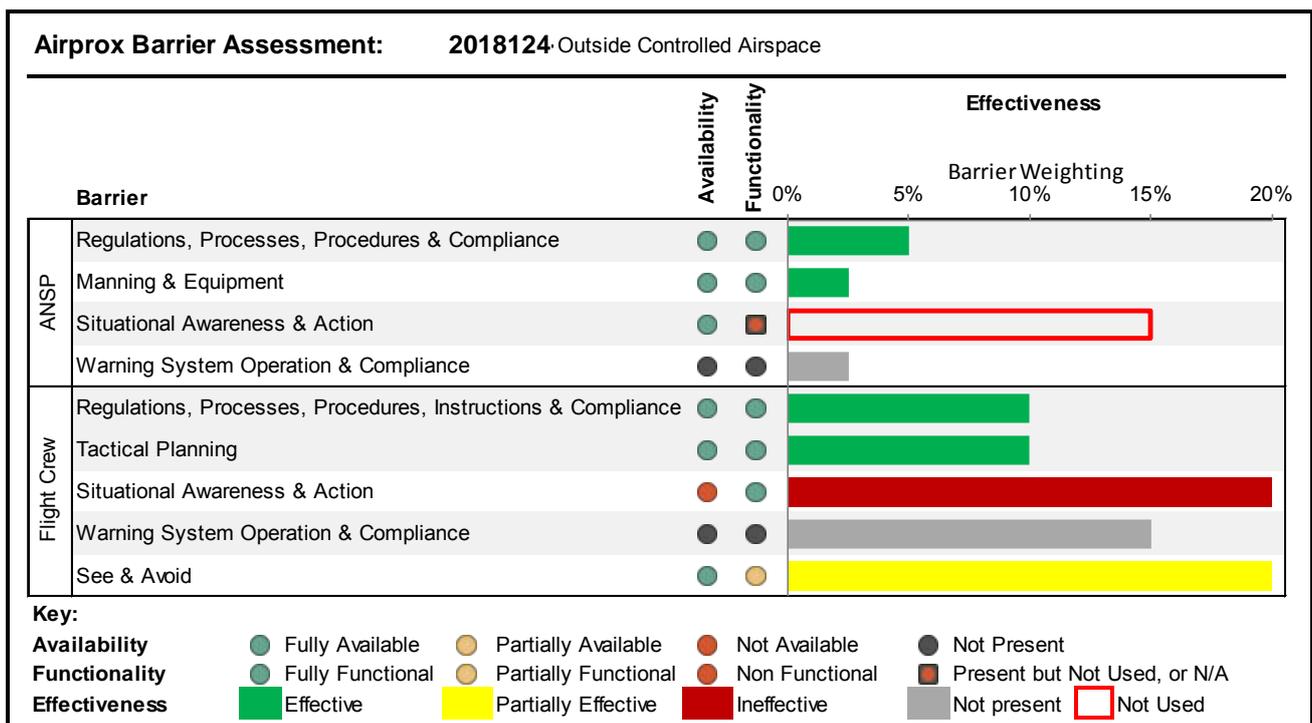
Situational Awareness and Action were assessed as **ineffective** because neither pilot was aware of the other aircraft until just before CPA.

Warning System Operation and Compliance were assessed as **not present** because neither aircraft was fitted with a CWS.

See and Avoid were assessed as **partially effective** because both pilots saw the other aircraft late and took avoiding action later than ideal.
