AIRPROX REPORT No 2018182

Date: 15 Jul 2018 Time: 1319Z Position: 5141N 00147W Location: Fairford

PART A: SUMMARY OF INFORMATION REPORTED TO UKAB

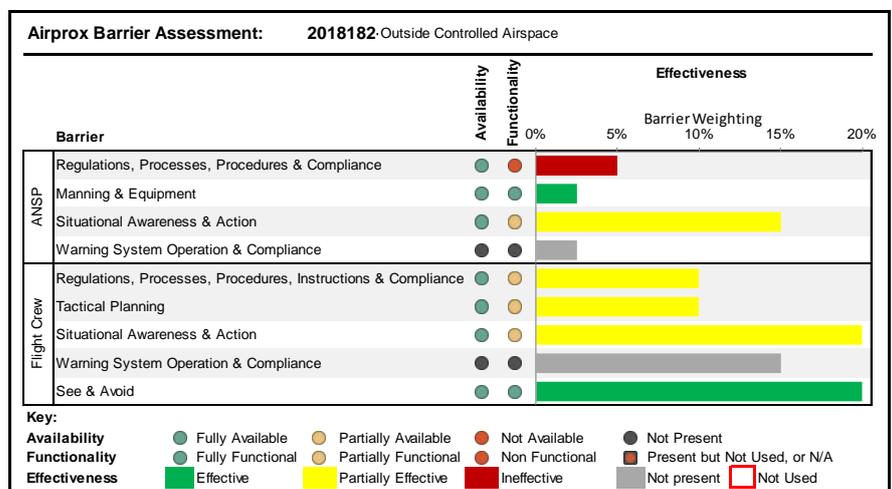
In assessing the effectiveness of the safety barriers associated with this incident, the Board concluded that the key factors had been that:

Regulations, Processes, Procedures and Compliance were assessed as **ineffective** because the FDD and ATC allowed the Typhoons to commence their flypast when the BBMF were still displaying.

Situational Awareness and Action were assessed as **partially effective** because the Fairford Twr Controller did not fully resolve the conflict between the Dakota and the Typhoons.

Regulations, Processes, Procedures, Instructions and Compliance were assessed as **partially effective** because the Dakota pilot did not fully give way to the Typhoons.

Tactical Planning was assessed as **partially effective** because the length of the BBMF display duration was not fully assimilated in the planning stages prior to the display.

Situational Awareness and Action were assessed as **partially effective** because the Dakota pilot was aware that the Typhoons were running in but continued to turn north, albeit querying the instruction.
