**AIRPROX REPORT No 2018183**

Date: 23 Jul 2018 Time: 1040Z Position: 5255N 00038W Location: 6nm NW Holbeach Range

**PART A: SUMMARY OF INFORMATION REPORTED TO UKAB**

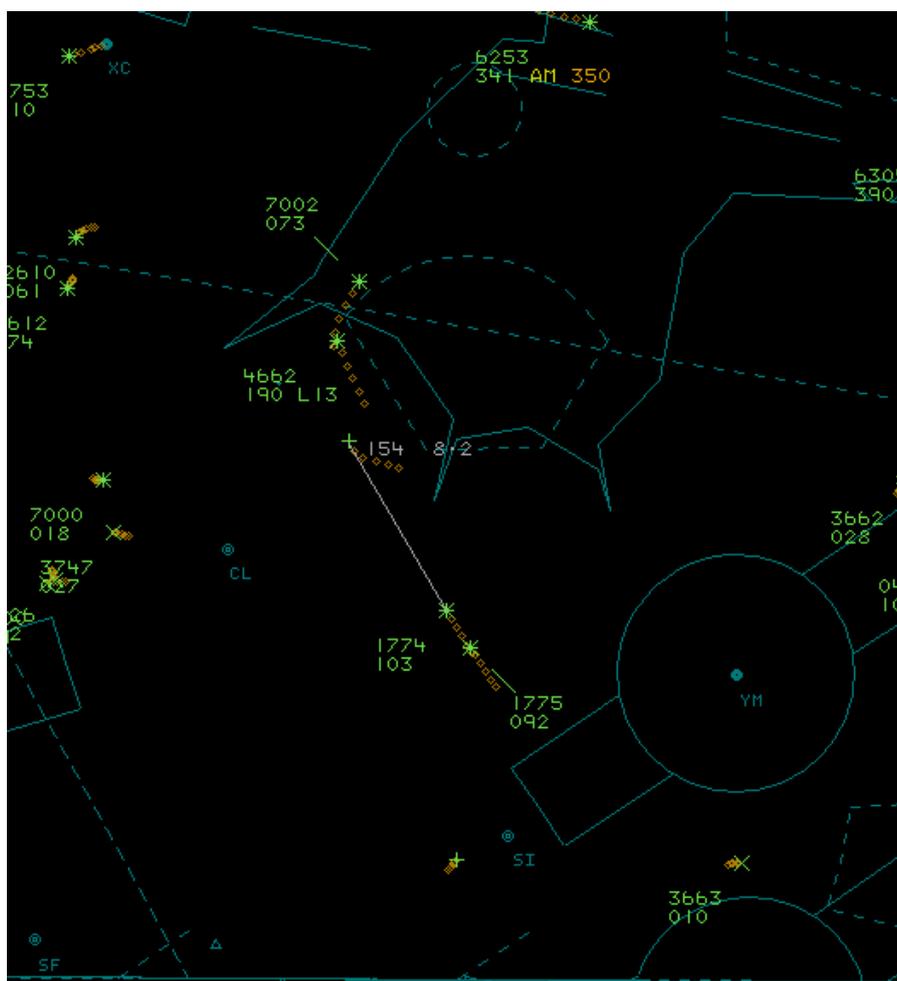
Figure 1

Figure 1, timed at 1038:35, shows the point at which the Tornados were handed over from Marham to Coningsby. The non-squawking return, believed to be the F16, is approx 8nm from the Tornados but no mention of this traffic was made during the handover. The rest of the F16 formation were northwest of Holbeach range squawking 7002.

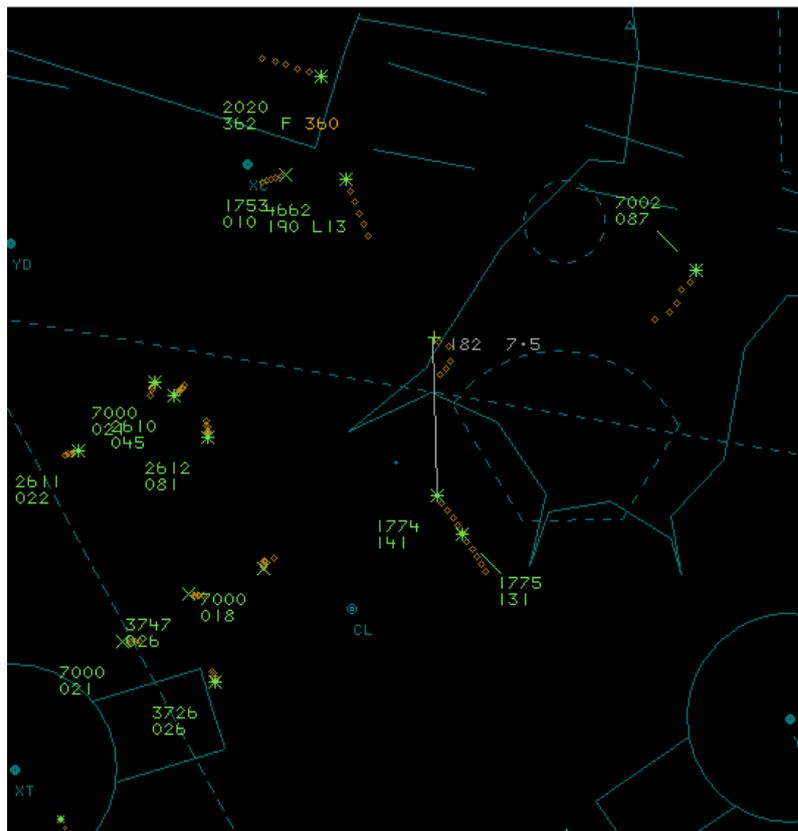
Figure 2

At 1039:07 (Figure 2), the F16 began manoeuvring in a westerly direction whilst the pilot reported being heads down in the cockpit preparing his aircraft systems for a simulated attack on a target within Holbeach Range.

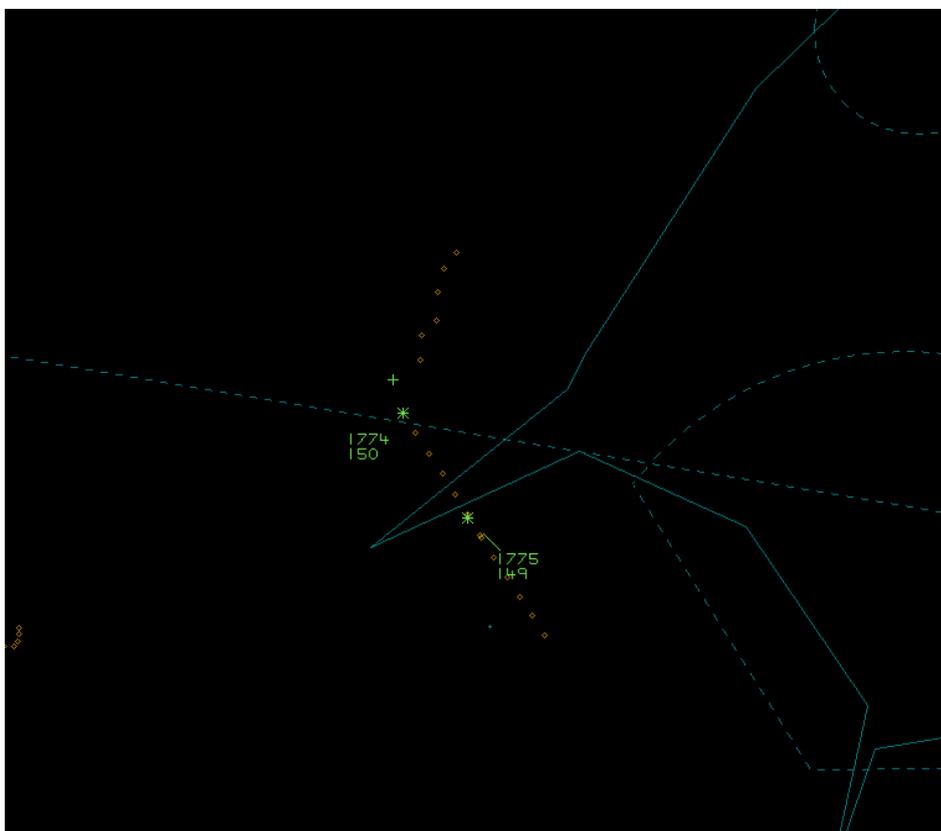
Figure 3. CPA timed at 1040:35

CPA occurred at 1040:35 coincident with the Tornados reporting the presence of the F16 to Coningsby Approach. CPA was measured as 0.2nm, no radar-derived estimate of vertical separation was possible because the F16 was not squawking. The Tornados reported the vertical separation as within 500ft.
