AIRPROX REPORT No 2018190

Date: 25 Jul 2018 Time: 1305Z Position: 5132N 00156W Location: 18nm SW Brize

PART A: SUMMARY OF INFORMATION REPORTED TO UKAB

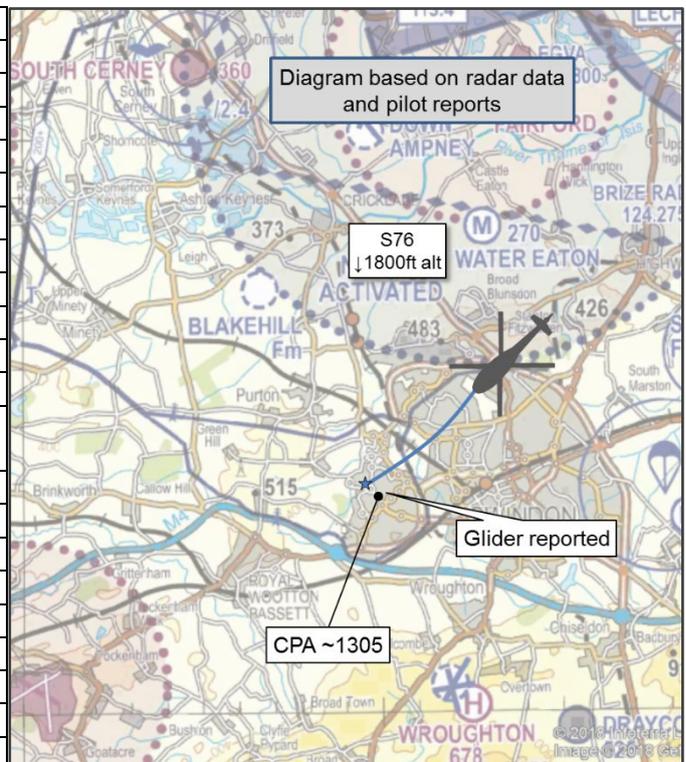
THE S76 PILOT reports that he was VFR and receiving a Traffic Service from Brize Radar. He was descending towards his destination when the handling pilot spotted a glider ‘level and turning towards’, less than 1nm away. He took an avoiding action turn to the right and expedited the descent. He thought they were fortunate to have spotted the glider because they had been flying into sun and in moderate haze. He noted that they had not received Traffic Information from Brize and did not get any TCAS indications (presumably because the glider wasn’t SSR equipped). He wasn’t sure whether the glider pilot saw the S76.

He assessed the risk of collision as ‘Medium’.

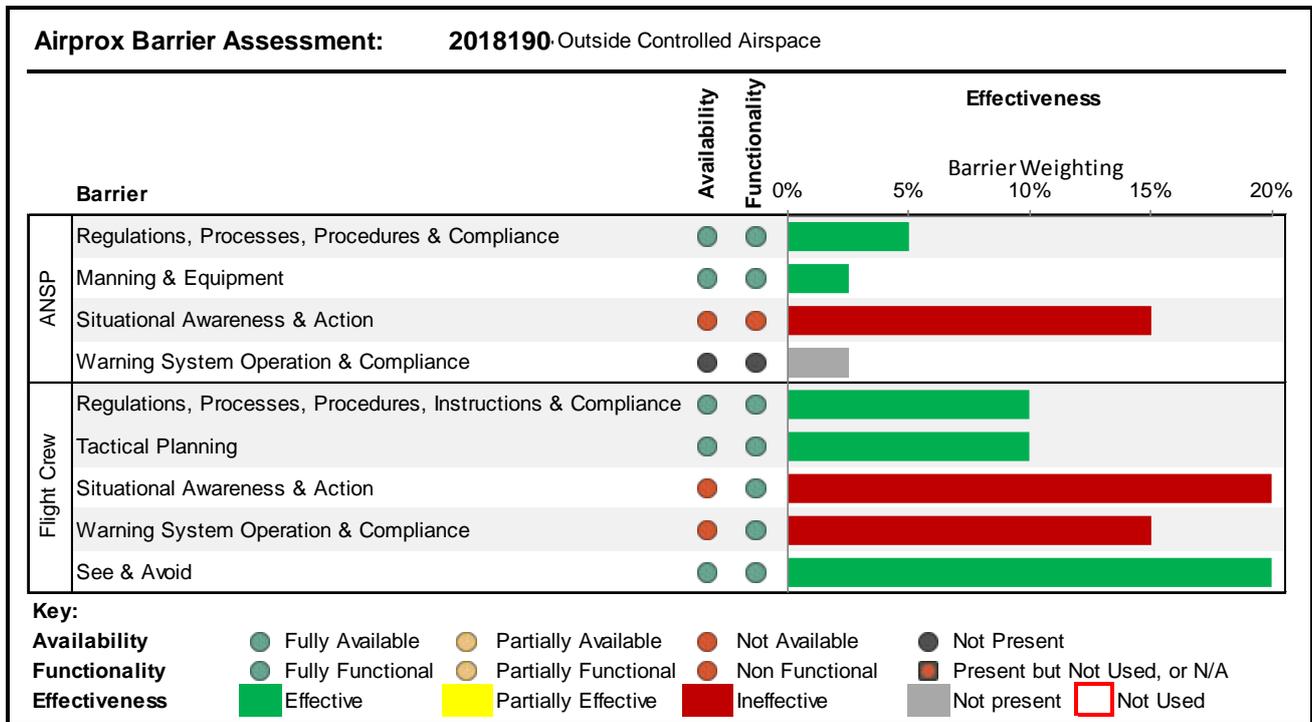
Safety Barrier Assessment⁵

Situational Awareness and Action were assessed as **ineffective** because ATC could not see the glider on the radar and therefore did not have any knowledge of it.

Situational Awareness and Action were assessed as **ineffective** because the S76 pilot did not have any information that the glider was in the vicinity.

Warning System Operation and Compliance were assessed as **ineffective** because the TCAS in the S76 could not detect the glider because it was either not fitted with a transponder or its pilot had not selected the transponder on.
