AIRPROX REPORT No 2018207

Date: 20 Jun 2018 Time: 1420Z Position: 5206N 00023E Location: 10nm E Duxford

PART A: SUMMARY OF INFORMATION REPORTED TO UKAB

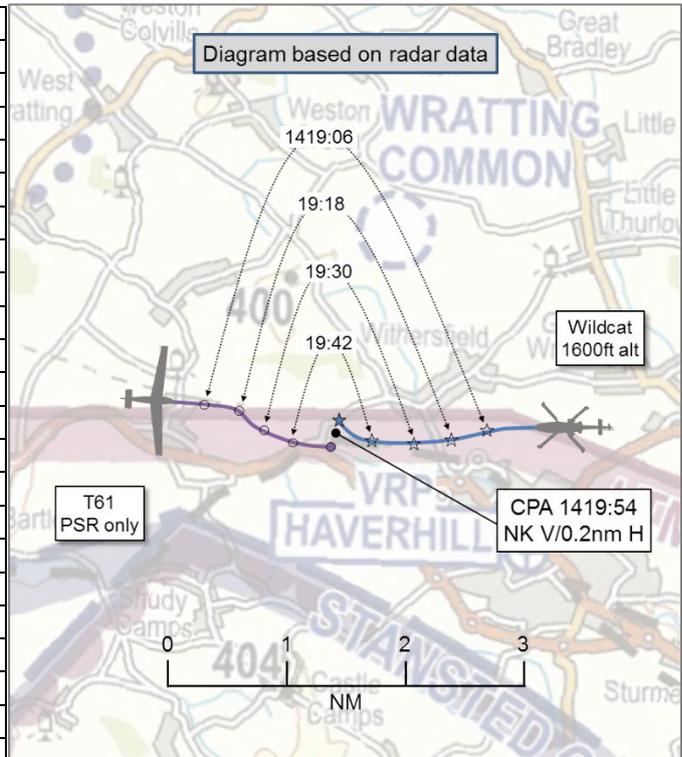
THE WILDCAT PILOT reports being in transit when the handling pilot in the right-hand seat saw a blue and white motor-glider in straight-and-level flight, on the nose, at the same height and on a reciprocal bearing at a range of less than 1nm. He immediately altered course to the right using 30° AOB and the other aircraft, a motor glider, passed the left side by approximately 200 yards. An Airprox was filed immediately with Duxford.

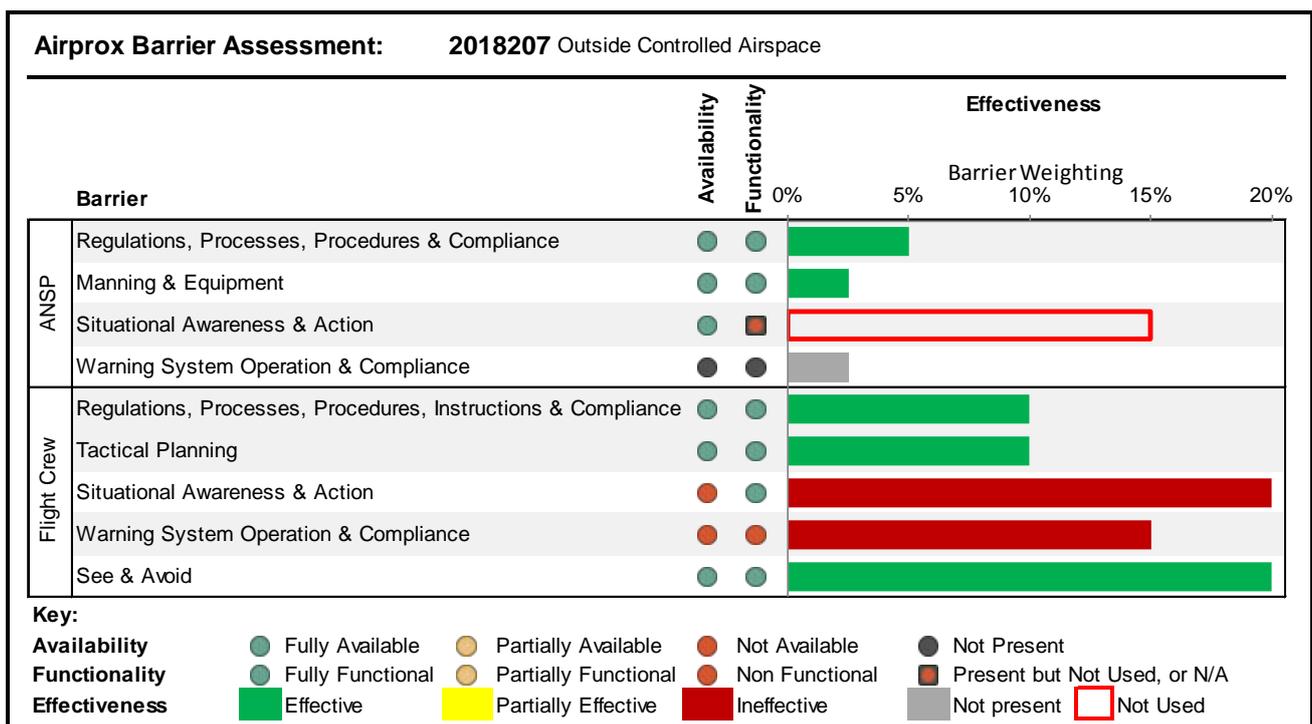
In assessing the effectiveness of the safety barriers associated with this incident, the Board concluded that the key factors had been that:

Situational Awareness and Action were assessed as **ineffective** because neither pilot had any awareness of the other aircraft.

Warning System Operation and Compliance were assessed as **ineffective**, although both aircraft were equipped with collision warning systems they were incompatible, and the Wildcat TAS couldn't detect the non-transponding glider.
