## AIRPROX REPORT No 2018212

Date: 14 Aug 2018 Time: 1443Z Position: 5225N 00040E Location: Lakenheath

### PART A: SUMMARY OF INFORMATION REPORTED TO UKAB

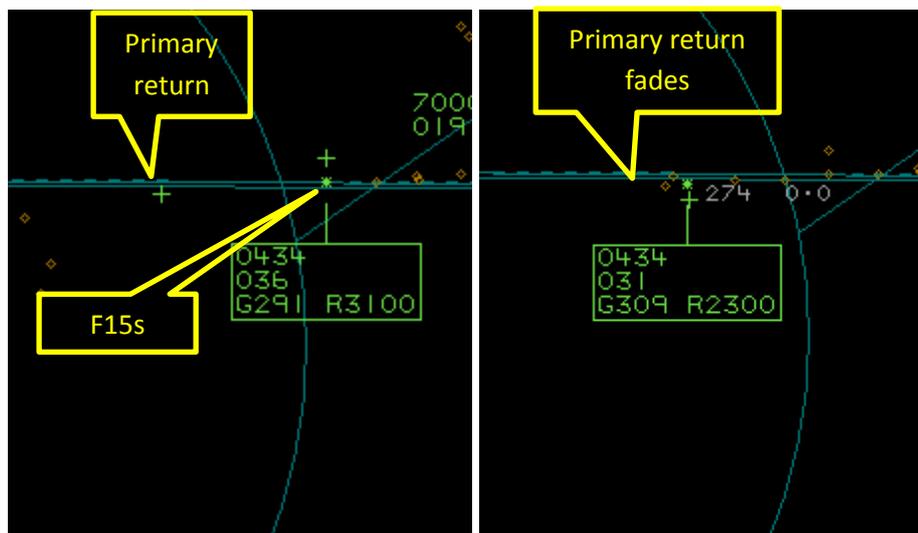
Figure 2: 1443:20

Screenshots taken from the NATS radar (which is not the radar seen by the Lakenheath controllers) show an intermittent primary only contact, thought to be the glider, appear on the radar for two sweeps before fading.

Figure 3 (CPA): 1443:35

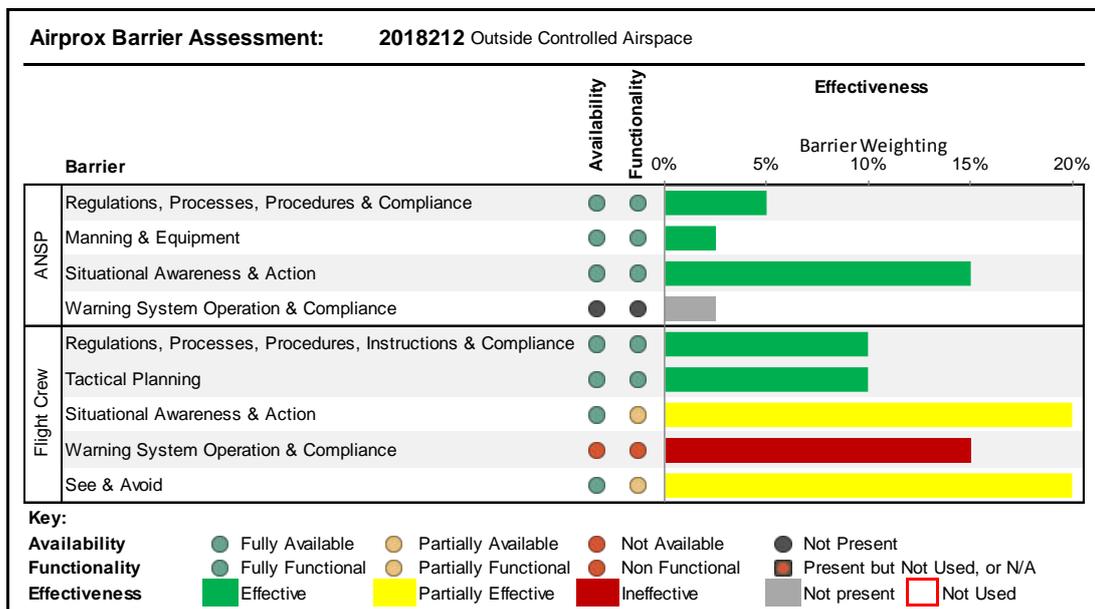
In assessing the effectiveness of the safety barriers associated with this incident, the Board concluded that the key factors had been that:

**Flight Crew:**

**Situational Awareness and Action** were assessed as **partially effective** because although the F15s knew that there were gliders in the area, the information was only generic.

**Warning System Operation and Compliance** were assessed as **ineffective** because the FLARM on the glider could not detect the F15s, and the F15s had no collision warning systems installed.

**See and Avoid** were assessed as **partially effective** because the F15s were able to see the glider, albeit late, and level off.
