**AIRPROX REPORT No 2018249**

Date: 06 Sep 2018 Time: 1215Z Position: 5423N 00135W Location: 1.5nm NE Catterick airfield

**PART A: SUMMARY OF INFORMATION REPORTED TO UKAB**

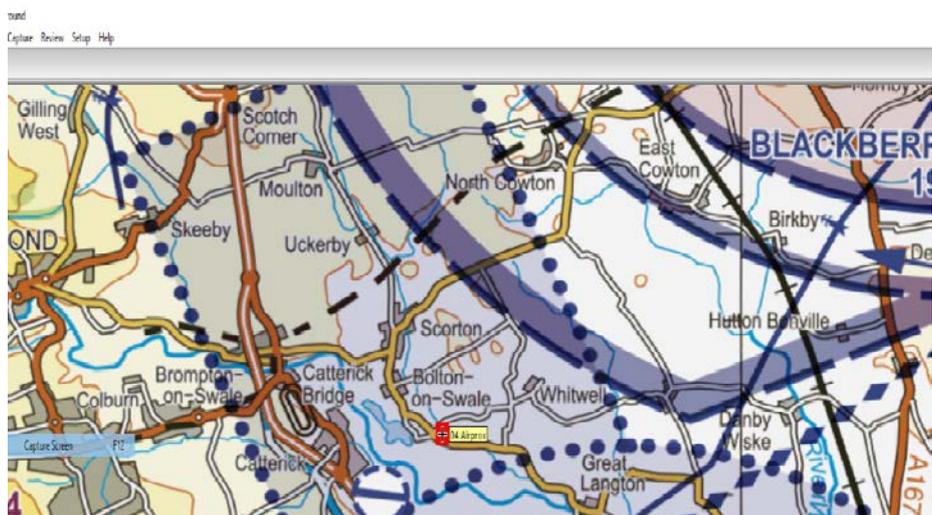
Figure 1. Airprox location.

**THE EUROCOPTER EC135 PILOT** reports that he was on a transit flight from Wakefield to a task in Newcastle. After transiting the Leeming zone he transferred to Durham Tees Valley. During the initial call, he was passed a QNH of 1014hPa and looked in to adjust the altimeter sub-scale; this gave him an altitude 1450ft. As he looked out again he saw a white glider about 300m in front, head-on to him, in a slight climbing attitude and starting a left bank. He shouted a warning to the crew seated in the aircraft cabin and commenced a sharp turn to the left away from the glider, which passed above and to the left at no more than 150ft. The TFO seated in the rear-starboard seat saw the glider during this manoeuvre and added a marker of their current location onto the mission recording system (Figure 1). He then resumed straight and level flight and looked back for the glider, but it could not be seen. Durham ATC and NPAS Ops were informed and the sortie continued.

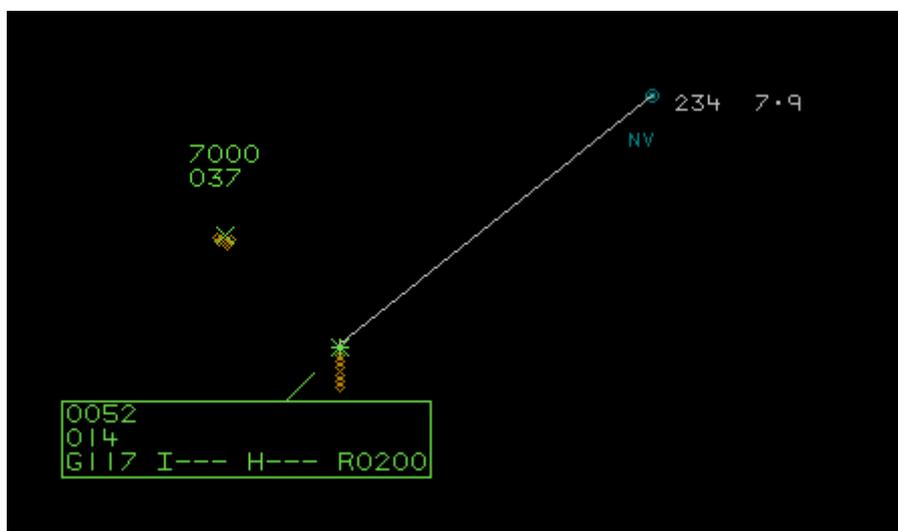
1216:42.

At 1216:42, the EC135 pilot advised the controller that they had just had a 'near miss' with a white G-registered glider. The pilot confirmed that the helicopter was at 1350ft and that the glider appeared to be about 150ft above.

The glider did not display on the area radar replay and the Durham Tees Valley Primary Radar was out of service at the time of the Airprox.

Below is a screenshot of the position of the EC135 when the Airprox was reported, 7.9nm southwest of Durham Tees Valley Airport.

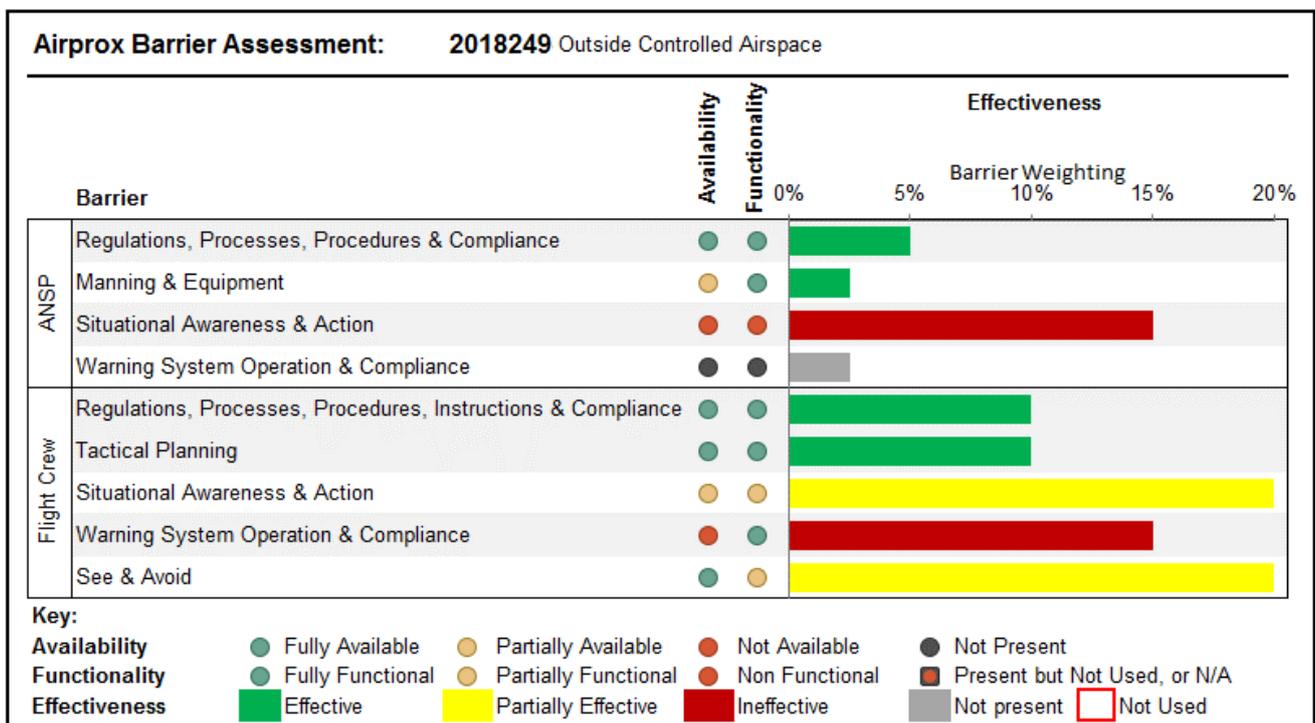
**Manning and Equipment** were assessed as **partially available** because the Durham Primary Radar was not serviceable. That being said, it was not known whether the glider would have shown on the Durham Radar display if it had been serviceable.

**Situational Awareness and Action** were assessed as **ineffective** because the glider was not showing on the Durham radar display. Consequently, Traffic Information could not be passed to the EC135 pilot.

**Situational Awareness and Action** were assessed as **partially effective** because although the glider pilot had overheard the EC135's generic routing when listening in on the Leeming frequency, the EC135 pilot was not aware of the presence of the glider.

**Warning System Operation and Compliance** were assessed **ineffective** because, although both aircraft were equipped with an electronic warning systems, they were not compatible.

**See and Avoid** were assessed as **partially effective** because, although the glider pilot first saw the EC135 at 0.5nm, the pilot of the helicopter did not see the glider until later than ideal.
