AIRPROX REPORT No 2018268

Date: 24 Sep 2018 Time: 1333Z Position: 5154N 00157W Location: 10nm E Gloucester

PART A: SUMMARY OF INFORMATION REPORTED TO UKAB

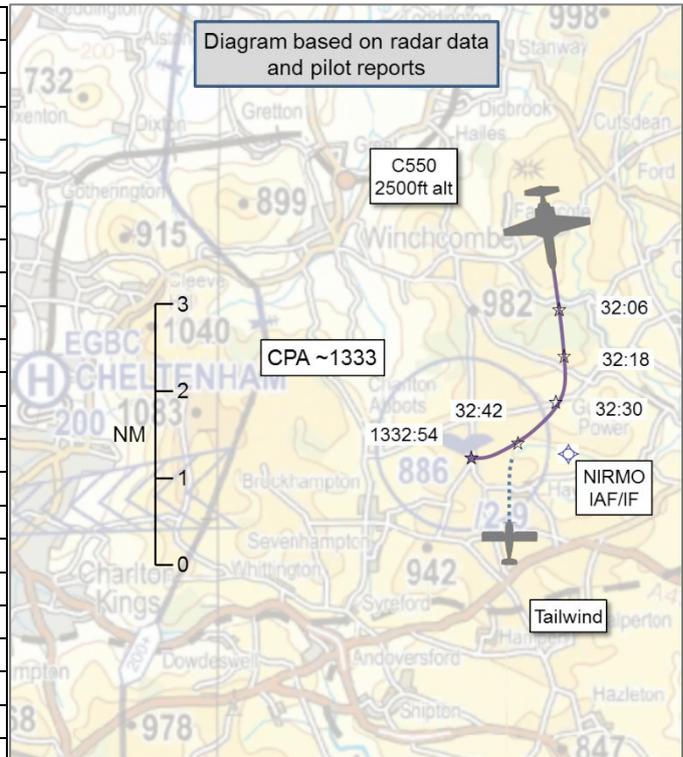
THE TAILWIND PILOT reports being in straight-and-level cruise looking out to his left and below for possible hang gliders from a launching site [Cravens Gorse]. He had just turned 15° right to avoid the area when he saw a Citation business jet at a range of 500m, banked to its right, apparently completing a procedure turn for the approach to Gloucester. The pilot noted that he was well outside the 'feather' marking for the approach but clearly not far enough to avoid the approach area. He also commented that a NOTAM stated that the Gloucester radar was out of service and consequently he was on a listening watch with Brize Radar, although outside the Oxford AIAA.

He assessed the risk of collision as 'Medium'.

THE C550 PILOT reports that he did not see the Wittman Tailwind.

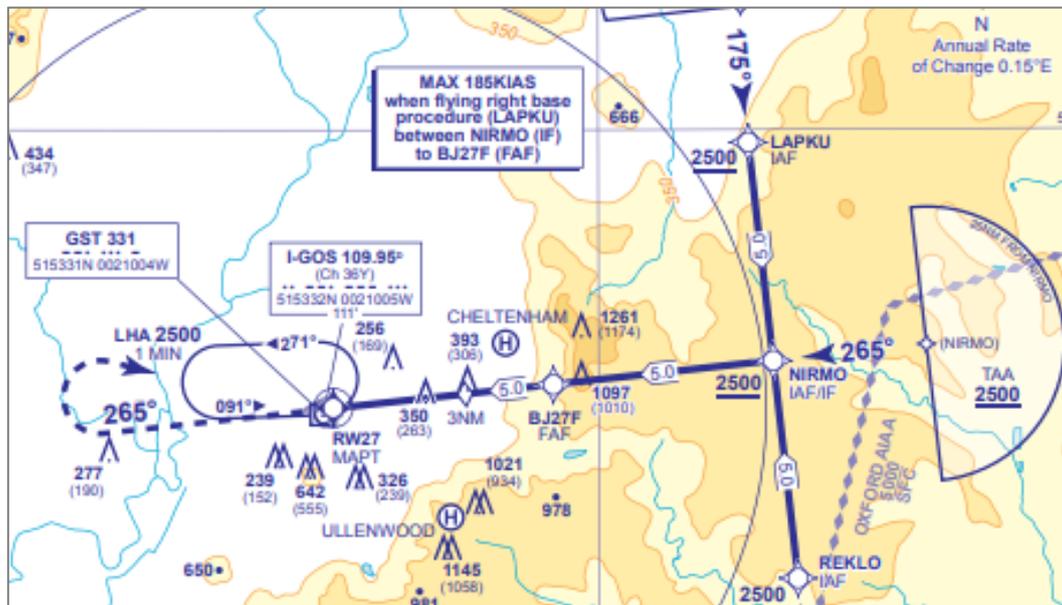
A section of the GNSS approach to Gloucester RW27² is shown below:

Finally, members observed that although the Cravens Gorse hang gliding site was notified as having an upper height limit of 1000ft and an elevation of 886ft (i.e. 1900ft altitude upper limit), it was annotated on the VFR chart as having a top altitude of 2900ft, which was above the RW27 GNSS approach path that bisects the site (2500ft altitude). The Board felt that this may be a charting error but, if this was not the case then it was not a sensible state of affairs; given that this was not germane to the Airprox, the Chair agreed to contact the CAA separately to highlight the issue.

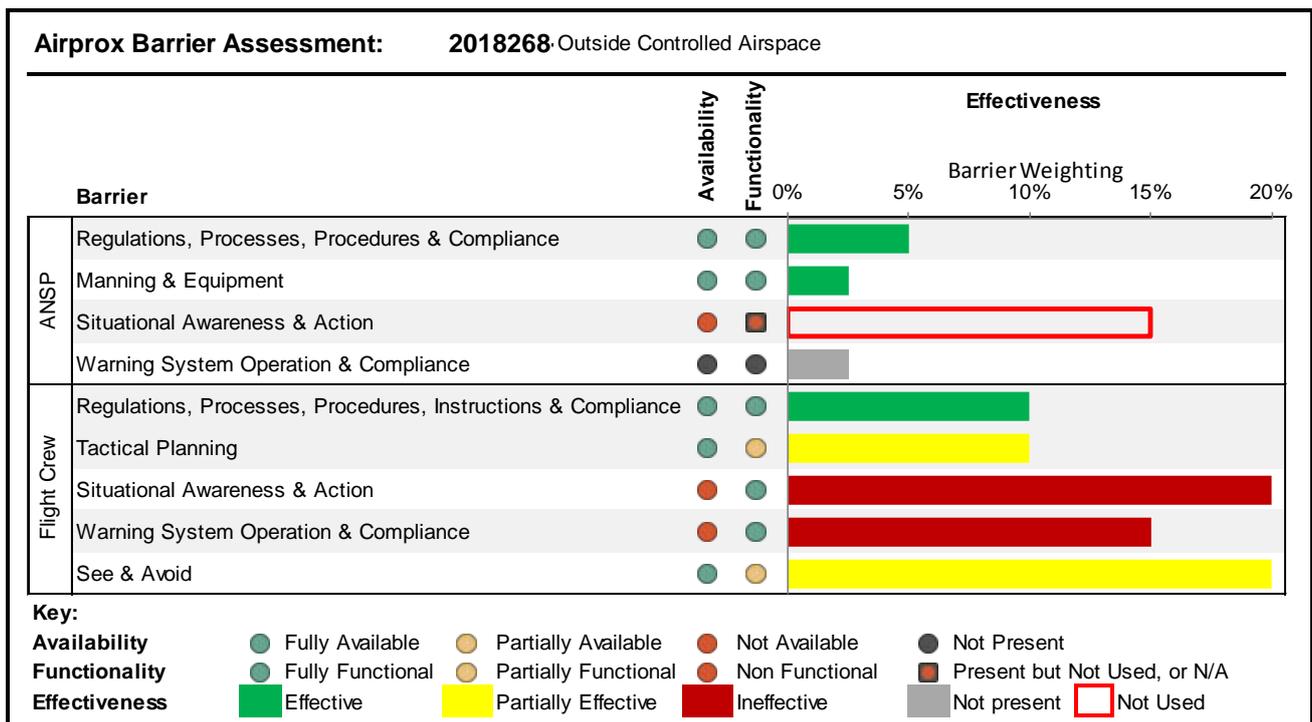
Safety Barrier Assessment⁶

Situational Awareness and Action were assessed as **not used** because the Tailwind pilot was not in communication with an ATSU and the C550 pilot was not in receipt of a service that required situational awareness or action from the controller.

Tactical Planning was assessed as **partially effective** because the Tailwind pilot did not contact Gloucester.

Situational Awareness and Action were assessed as **ineffective** because neither pilot was aware of the other aircraft until the Tailwind pilot saw the C550.

Warning System Operation and Compliance were assessed as **ineffective** because the Tailwind was not electronically conspicuous to the C550 TCAS.

See and Avoid were assessed as **partially effective** because only the Tailwind pilot saw the other aircraft, and at a late stage.
