AIRPROX REPORT No 2018269

Date: 29 Sep 2018 Time: 1356Z Position: 5151N 00141W Location: Little Rissington

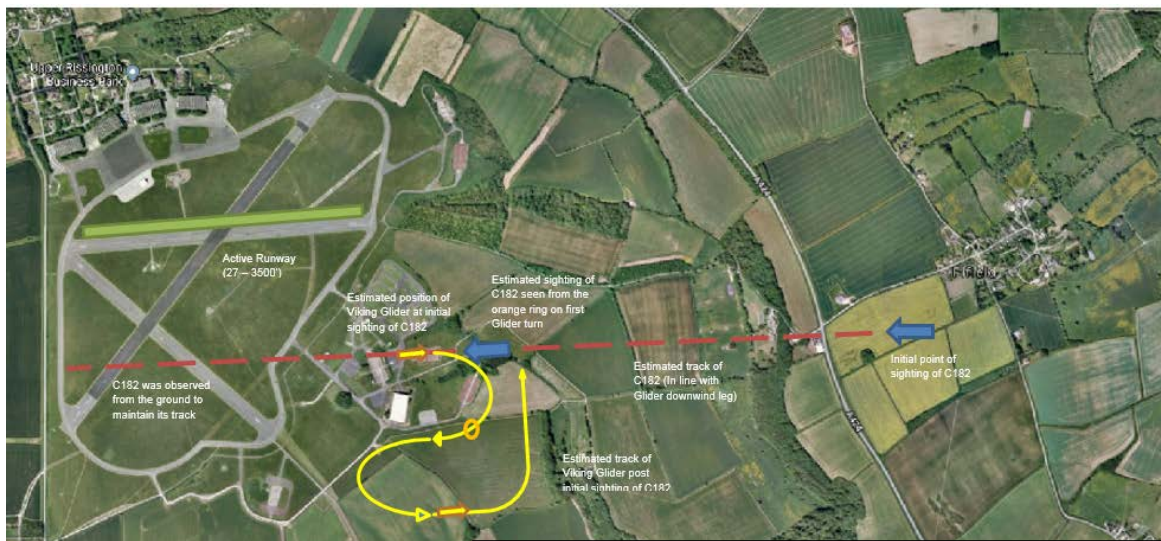
Figure 1 – Glider Pilot’s perception of the encounter

THE VIKING PILOT reports that he was late downwind for RW27 at 850ft. The cadet was in control from the rear seat, practising straight-and-level (although there was slight lift of about 200ft per minute) when a C182 was noticed during a lookout scan by the instructor. It approached from the 12 o'clock and was about 200ft above. The instructor took control to take avoiding action of a 180° turn to the right, followed by a 180° turn to the left to ensure safe separation. They landed without any further issues. The glider pilot produced a diagram of his version of the encounter (Figure 1).

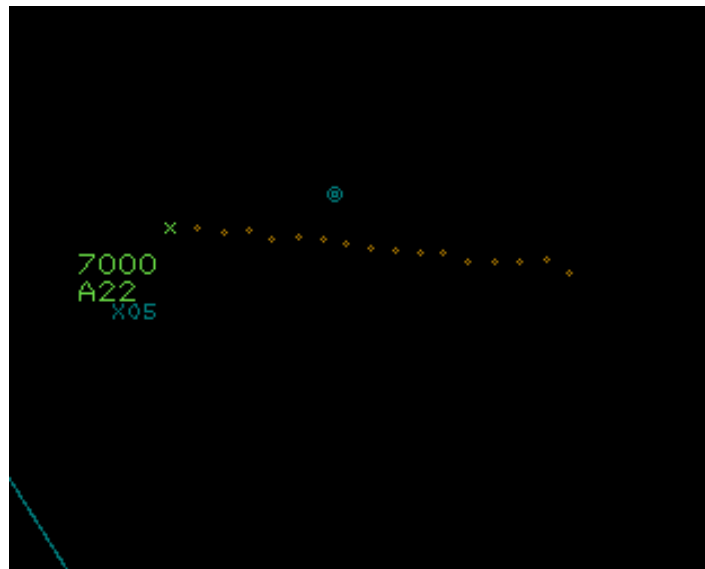
Figure 2: 1356:56

Figure 2 is a screenshot from the NATS radars which shows the C182 indicating 2200ft altitude as it passes Little Rissington at the time of the incident. The glider cannot be seen on the radar.

Notwithstanding, the radar recordings showed that, in the event, the C182 pilot had remained to the south of the glider site and was 700ft above the actual visual circuit and therefore the pattern of traffic. Whilst members thought that he would have been better placed to avoid the glider site by a greater margin, they acknowledged that there was no ATZ as such for gliding sites and, although pilots were strongly advised to avoid flying through the overhead and the winch launch (which he did), there were no avoidance criteria as such for gliding sites other than to '*conform with or avoid the pattern of traffic formed by other aircraft in operation*'. In being 700ft above the pattern of traffic and not overhead the site, it could be argued that the C182 pilot had complied with this requirement.

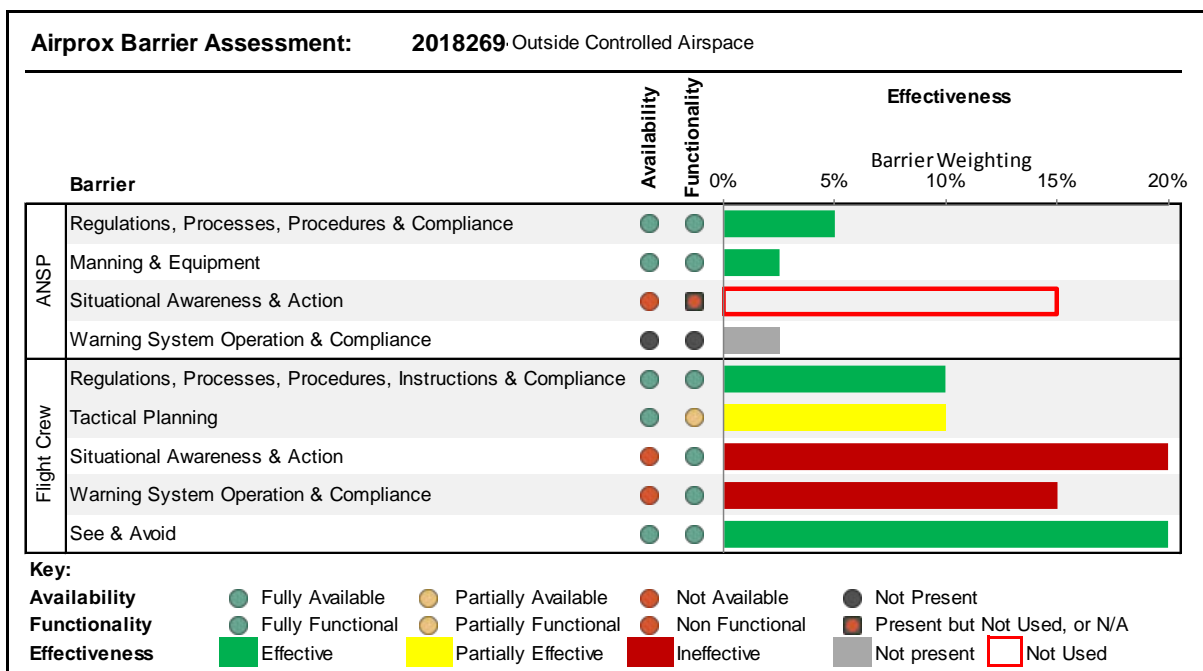
Tactical Planning was assessed as **partially effective** because the C182 pilot would have been better advised to have given the glider site a wider berth.

Situational Awareness and Action were assessed as **ineffective** because neither pilot had any prior situational awareness about the other.

Warning System Operation and Compliance were assessed as **ineffective** because the glider’s FLARM could not detect the C182.
