**AIRPROX REPORT No 2018280**

Date: 11 Oct 2018 Time: 1210Z Position: 5338N 00031W Location: ivo Doncaster

**PART A: SUMMARY OF INFORMATION REPORTED TO UKAB**

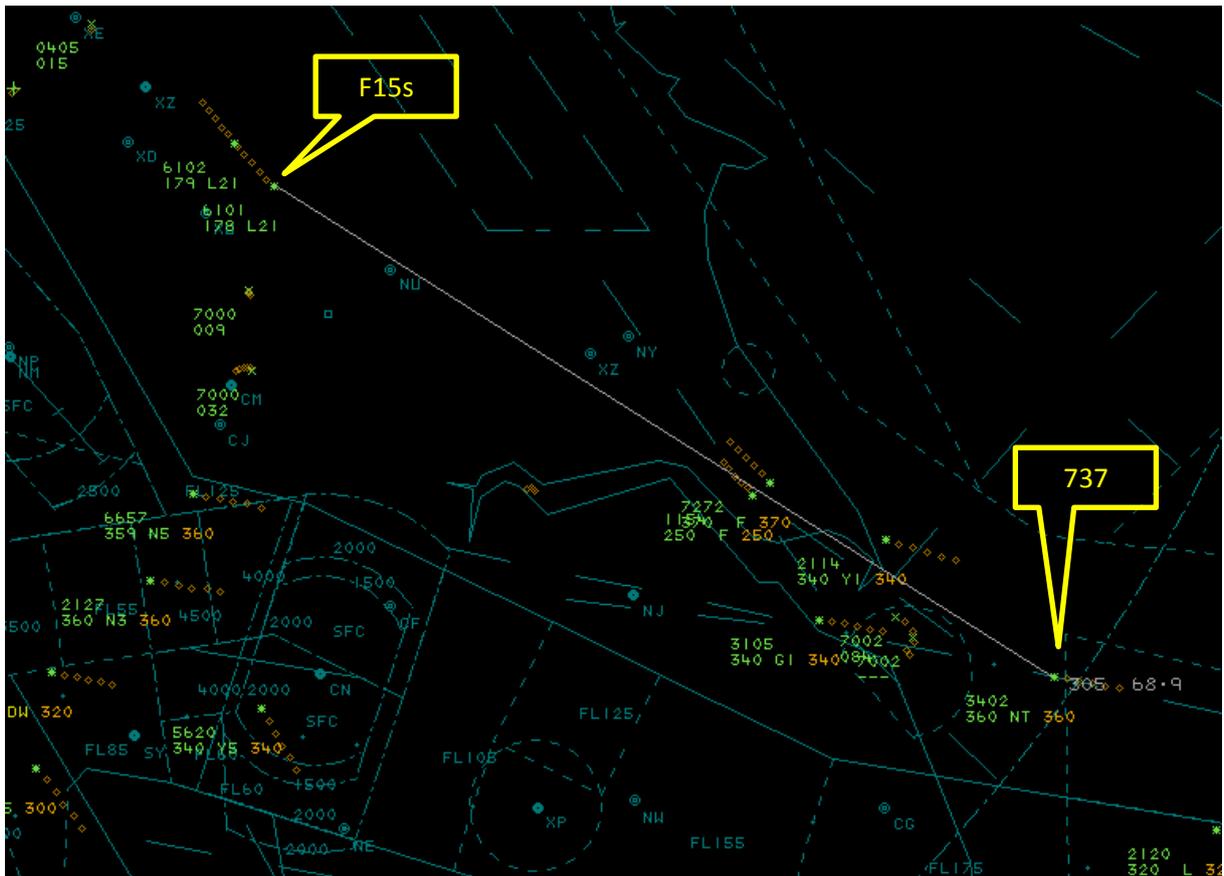
Figure 1.

At 1205:19 (Figure 1), the Swanwick East controller instructed the F15 pilots to climb to FL290. At the time, there was 68nm separation. Having noted that the B737 had been cleared to FL290, at 1206:19 (Figure 2), the controller instructed the lead F15 pilot to "*stop climb Flight Level 240 initially*". The pilot replied "*240 in the climb [F15 C/S]*". At this point, there was still 57nm separation.

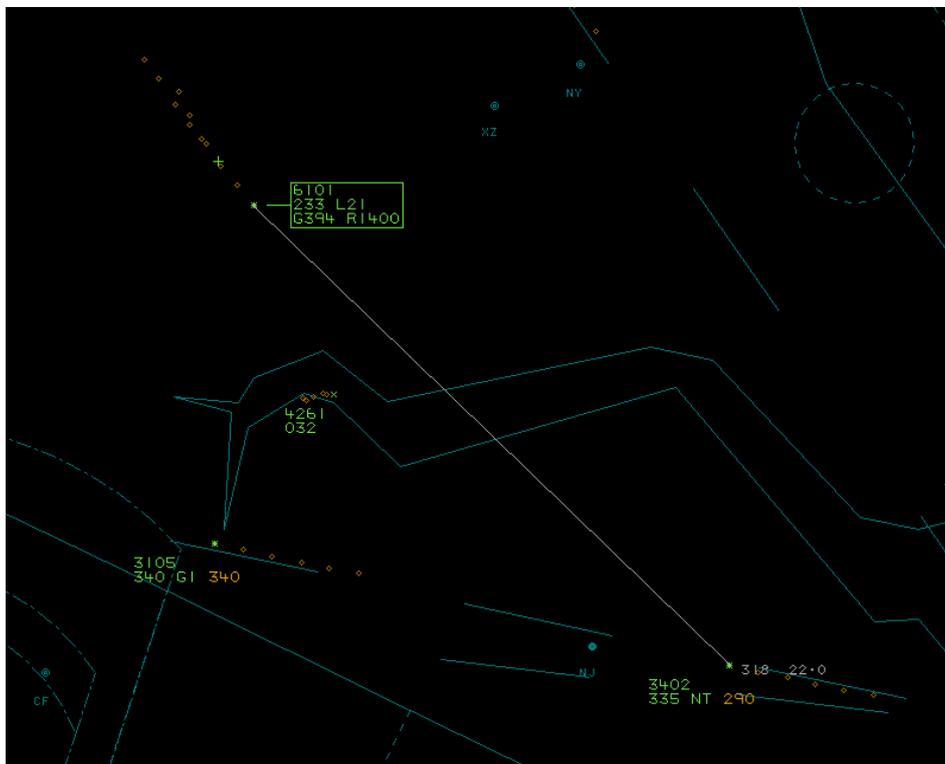
Figure 3.

Some 45sec later, the Swanwick East Controller confirmed the intentions of the F15 pilots and, at 1209:04 (Figure 3), asked “[Lead F15 C/S] will you be able to accept Flight Level 280 for your hold”. The pilot responded “Affirm [F15 C/S] can accept Flight Level 280”. No climb instruction to that level was issued. At this point, the F15s were indicating FL233 with a rate of climb of 1400fpm and the B737 was descending through FL335 for FL290. Lateral separation was 22nm.

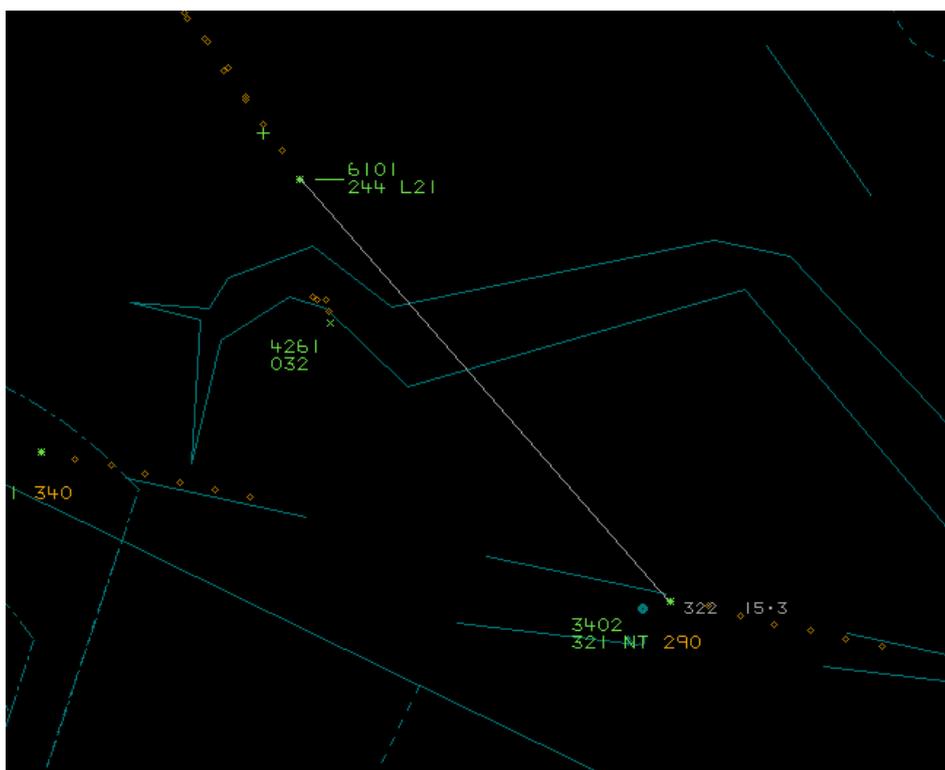
Figure 4.

25sec after this exchange (Figure 4), the F15s climbed above their assigned level. Lateral separation at this point was 15nm.

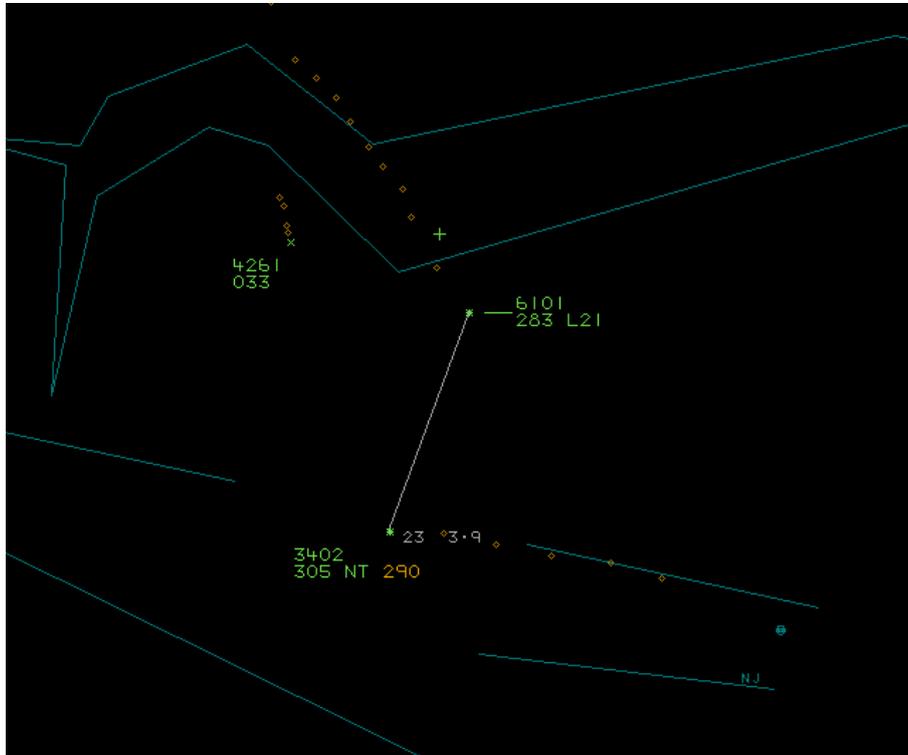
Approximately 50sec later, the Prestwick Planner began to question the Swanwick East Controller about the intentions of the F15s. It was at this point the Swanwick East Controller realised the F15s had climbed above their assigned altitude. During this timeframe, the Prestwick Controller stopped the B737's descent at FL305 and then issued an avoiding action turn to increase separation. CPA occurred during this conversation and was measured at 3.9nm lateral and 2200ft vertical separation (Figure 5).

Figure 5 – CPA.

Cause: The F15 crews climbed above their cleared level.
