## AIRPROX REPORT No 2018287

Date: 23 Oct 2018 Time: 1033Z Position: 5052N 00047W Location: Chichester/Goodwood ATZ

### PART A: SUMMARY OF INFORMATION REPORTED TO UKAB

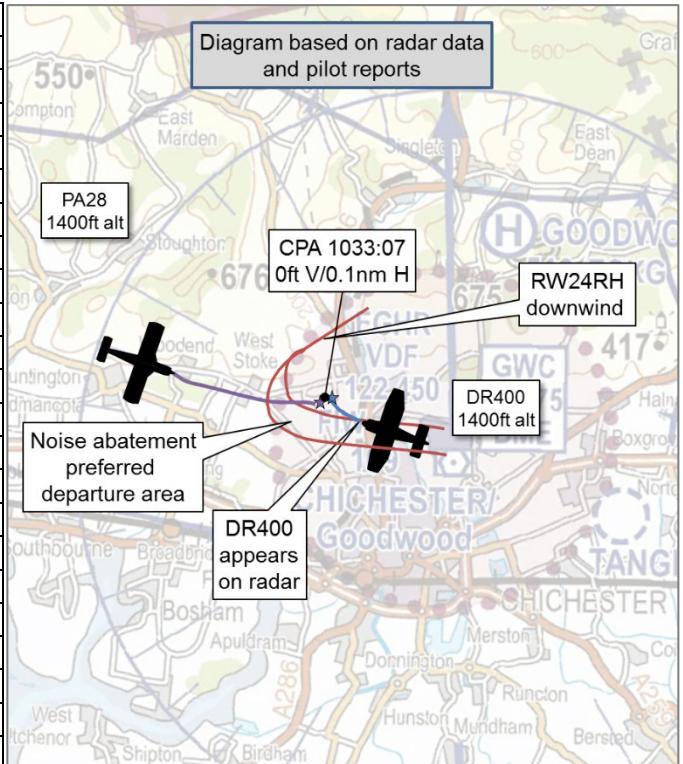
The Board then turned to the actions of the PA28 pilot. The radar replay showed that the PA28 pilot had not joined the circuit in accordance with the noise abatement procedures, with his position being much closer to the runway than that published in the UKAIP (see front page diagram). This was considered to have been contributory to the Airprox because the DR400 pilot could reasonably have expected the PA28 to have been much wider than it was. Although there were no R/T recordings available in this case, members agreed that pilots transmitting "joining downwind" should ideally accompany such a call with further information such as range or a geographical feature to enable other pilots to gain SA and thereby ensure deconfliction. Furthermore, in comparing the Airprox location with the pilots' respective comments, it appears that the PA28 pilot reported downwind early; although this did not have any bearing on the Airprox, it served as a reminder that pilots must make their calls at the specified points if they are to ensure that others are properly aware of their location and intentions.

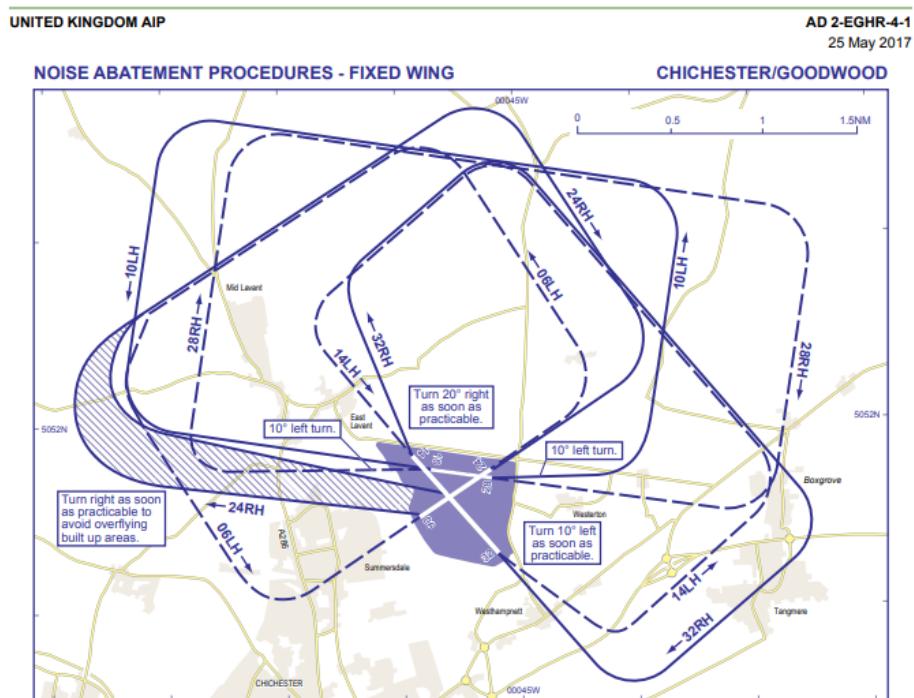
Figure 1: Chichester/Goodwood Noise Abatement Procedure

*Take off: Turn right as soon as practicable to do so and establish a Westerly track. Maintain track until West of built up areas. If remaining in the circuit, ensure that crosswind and downwind track is West/North West of Lavant village. No practice engine failures or low level circuits are permitted on runway 24. Avoid overflight of Lavant village.*

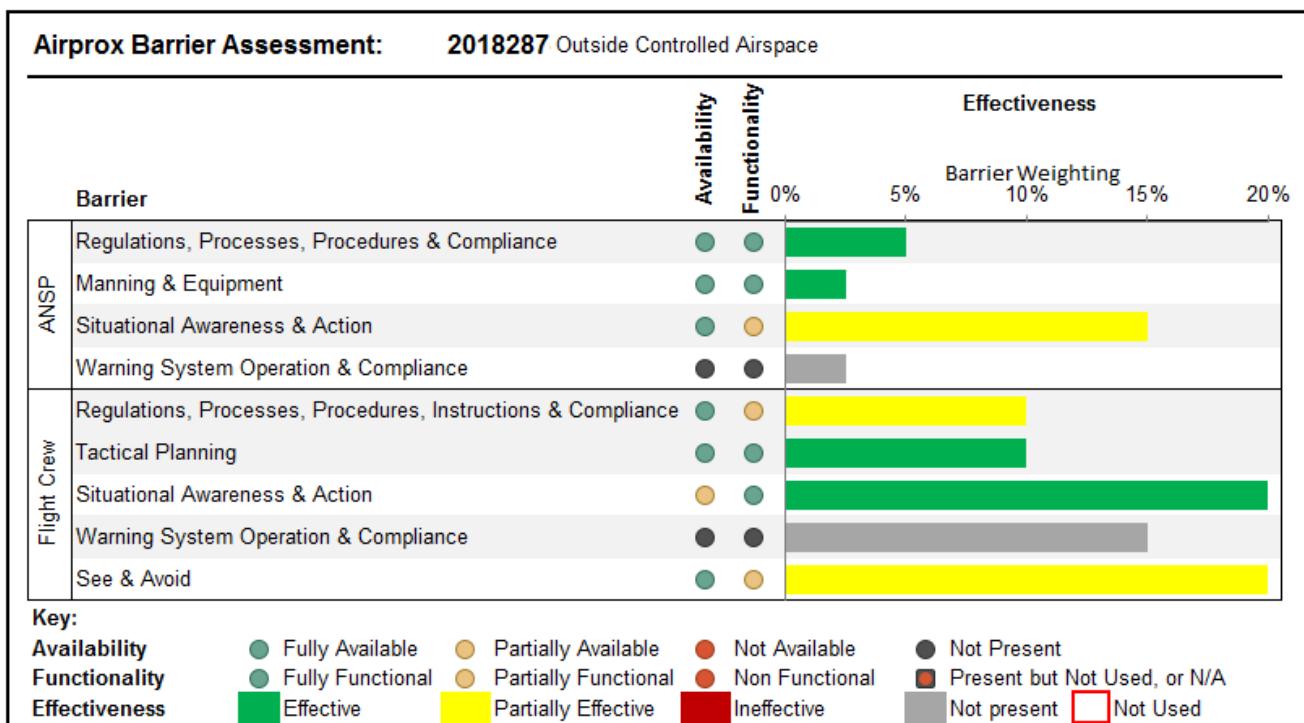
**Situational Awareness and Action** were assessed as **partially effective** because the Goodwood AFISO did not pass Traffic Information to both aircraft on the other aircraft's reported position.

**Regulations, Processes, Procedures, Instructions and Compliance** were assessed as **partially effective** because the PA28 pilot did not appear to have provided sufficient information as to his location when he called ‘joining downwind, and also appeared to have called downwind early.

**See and Avoid** were assessed as **partially effective** because both pilots saw the other aircraft late and had to turn to avoid at a late stage.
