AIRPROX REPORT No 2018289

Date: 24 Sep 2018 Time: 1312Z Position: 5144N 00056W Location: 7nm NE Benson

PART A: SUMMARY OF INFORMATION REPORTED TO UKAB

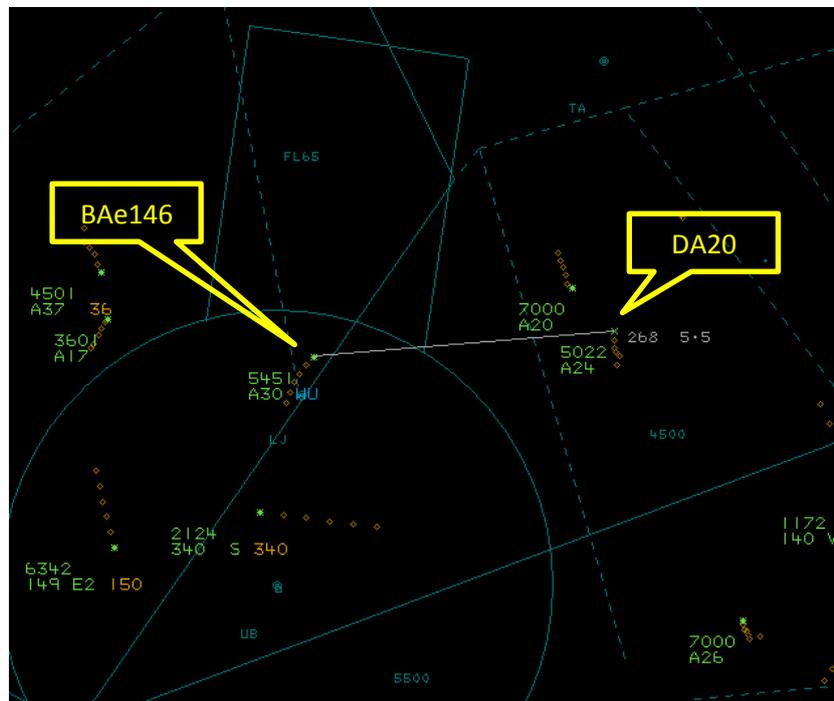
Figure 2.

As the BAe 146 pilot commenced a right turn (Figure 2), Traffic Information was passed on two tracks to the east of Benson, one of which was the DA20 (now Squawking 5022).

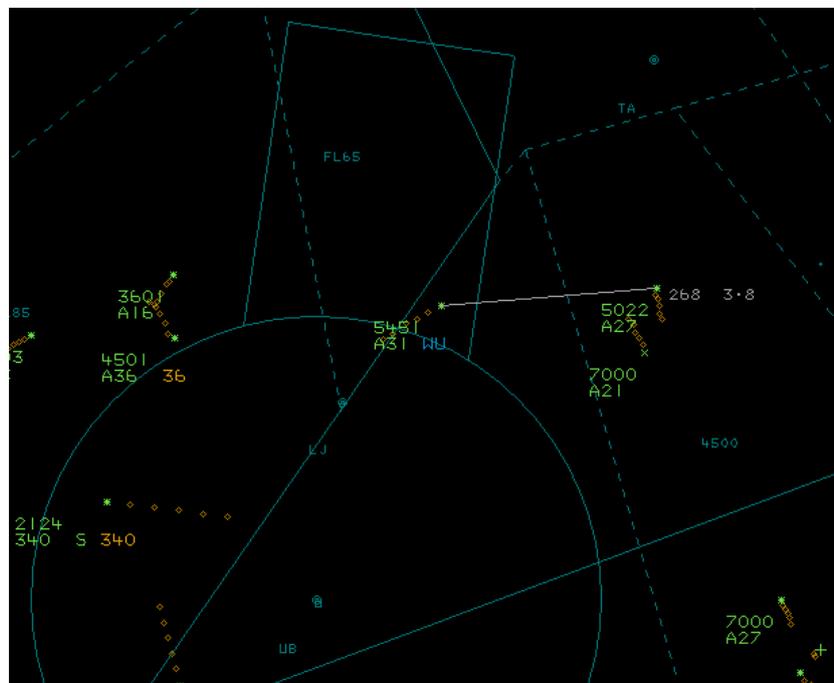
Figure 3.

Approximately 30sec after this initial call (Figure 3), the Traffic Information was updated following a climb by the DA20 pilot.

Traffic Information was passed for third time 25sec later (Figure 3) during which the controller attempted to ascertain if the BAe146 pilot was visual with the DA20. Once confirmed that the BAe146 was not

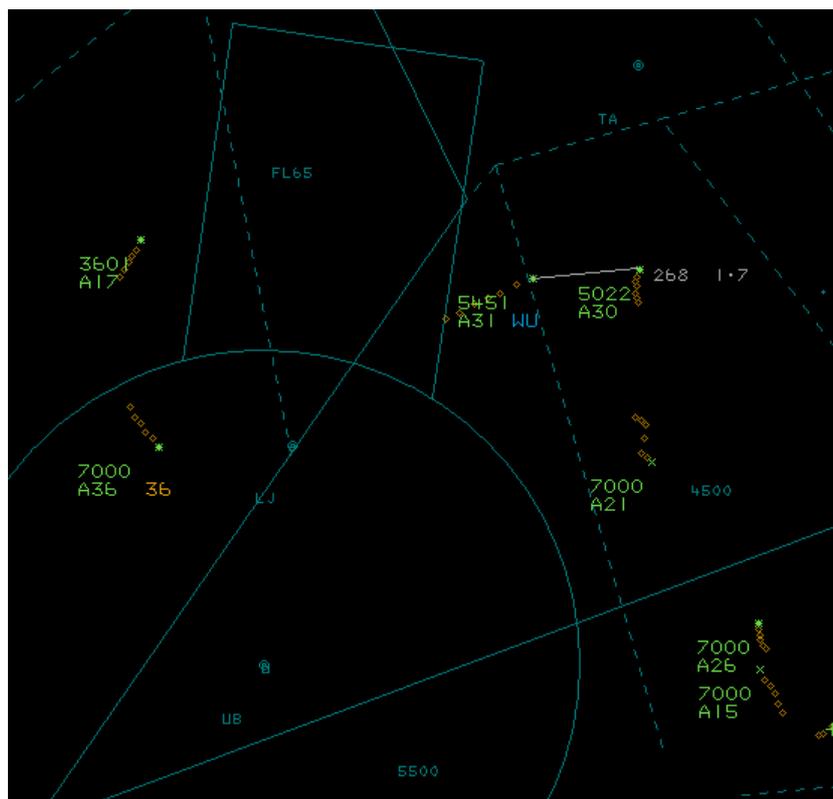
Figure 4.

visual, the controller suggested a turn to the right which would allow the BAe146 to pass behind the DA20. This turn was accepted by the BAe146 pilot (Figure 4).

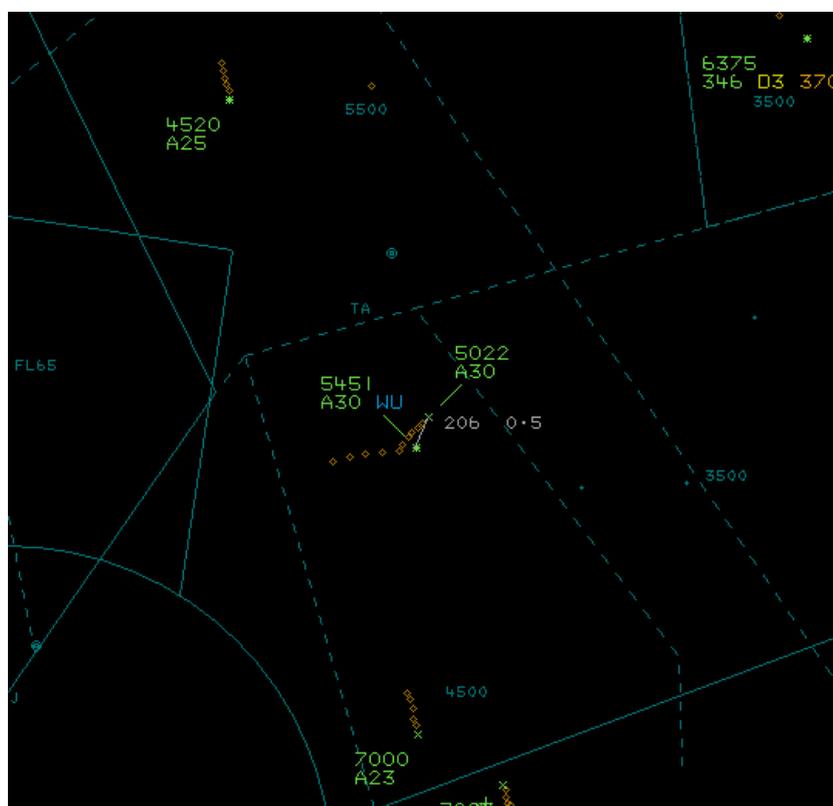
Figure 5 – CPA.

Traffic Information was passed for a final time 15sec after the suggested turn, with CPA occurring some 9sec after this (Figure 5). CPA was measured at 0.5nm with no vertical separation.

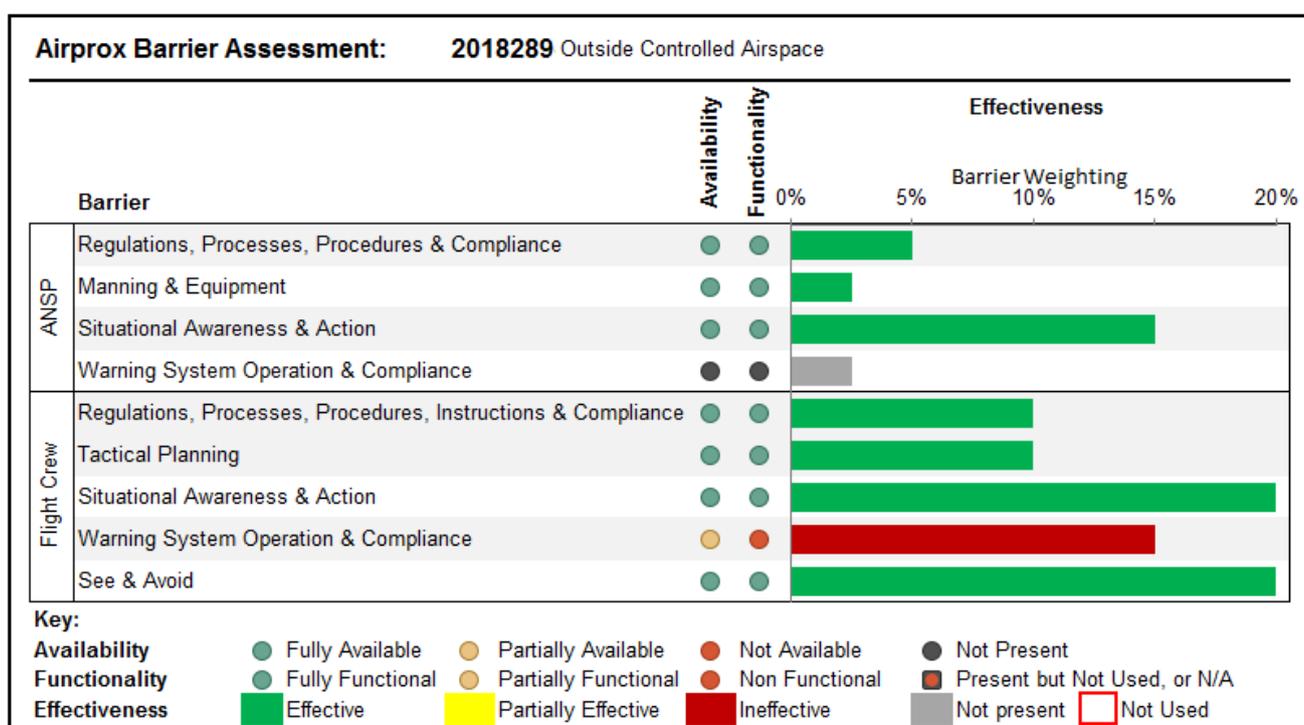
In assessing the effectiveness of the safety barriers associated with this incident, the Board concluded that the key factors had been that:

Warning System Operation and Compliance was assessed as **partially available** because only the BAe146 was equipped with an electronic warning system. The barrier was assessed as **ineffective overall** because the BAe146 pilot decided not to act on his TCAS RA because he had seen non-squawking glider traffic below his aircraft at the time. This was not a reflection on the pilot's decision *per se*, but simply a recognition that, in accordance with SERA.11014, pilots must use their best judgement and full authority in their choice of the best course of action to resolve a traffic conflict or avert a potential collision. As a result, the barrier itself had been ineffective in this Class G environment but the TCAS itself had provided useful situational awareness in support of the fully effective 'Situational Awareness and Action' barrier.
