AIRPROX REPORT No 2018301

Date: 31 Oct 2018 Time: 1417Z Position: 5218N 00046W Location: Sywell

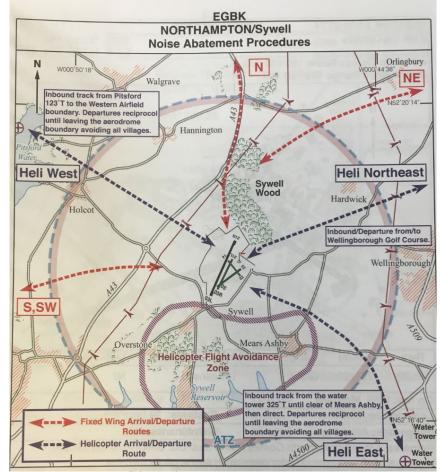
Figure 1: Extract from Pooley's Flight Guide

Pooley's Flight Guide (2019) provides details of the Sywell departure routes below. The northern fixedwing departure route is indicated as commencing from about the end of the downwind leg for RW21, following the A43.
