**AIRPROX REPORT No 2018320**

Date: 19 Dec 2018 Time: 1638Z Position: 5741N 00323W Location: Lossiemouth

**PART A: SUMMARY OF INFORMATION REPORTED TO UKAB**

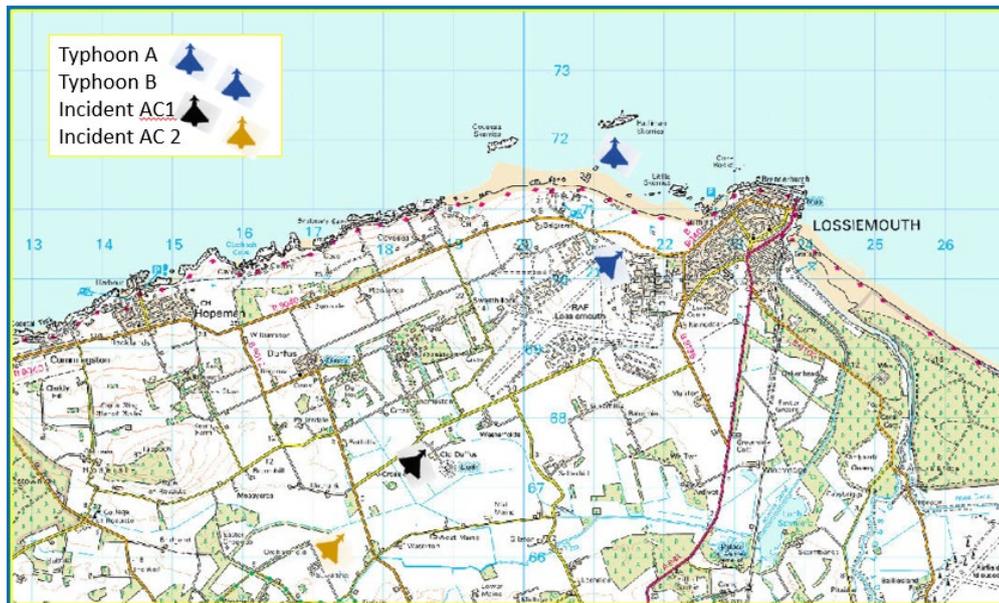
Figure 1

The Typhoons involved in this Airprox [Typhoon(1) and Typhoon(2)] were both part of the same formation and had joined the Lossiemouth visual circuit via the initial position as individual elements in trail. At the time of the incident there were two other Typhoons in the circuit [Typhoon A and Typhoon B] (who had completed a similar join) and two further aircraft in the instrument pattern at 14nm and 20nm from touchdown. Due to the complexity of the situation, the ATC Supervisor was present in the Visual Control Room and the range of the Air Traffic Monitor (slave radar) had been placed at a slightly extended range to aid the integration of the radar traffic. This incident occurred below radar coverage and therefore radar pictures are unavailable. Following this incident an Occurrence Safety Investigation (OSI) was convened and, as part of that process, diagrams of the incident were created using the cockpit video and they are reproduced below. The two aircraft involved in the incident are coloured black and yellow, the other (non-incident) Typhoons are shown in blue. The Typhoons involved in the Airprox joined the visual circuit via initial in one-mile trail. The other two Typhoons in the circuit were just ahead breaking into the circuit.

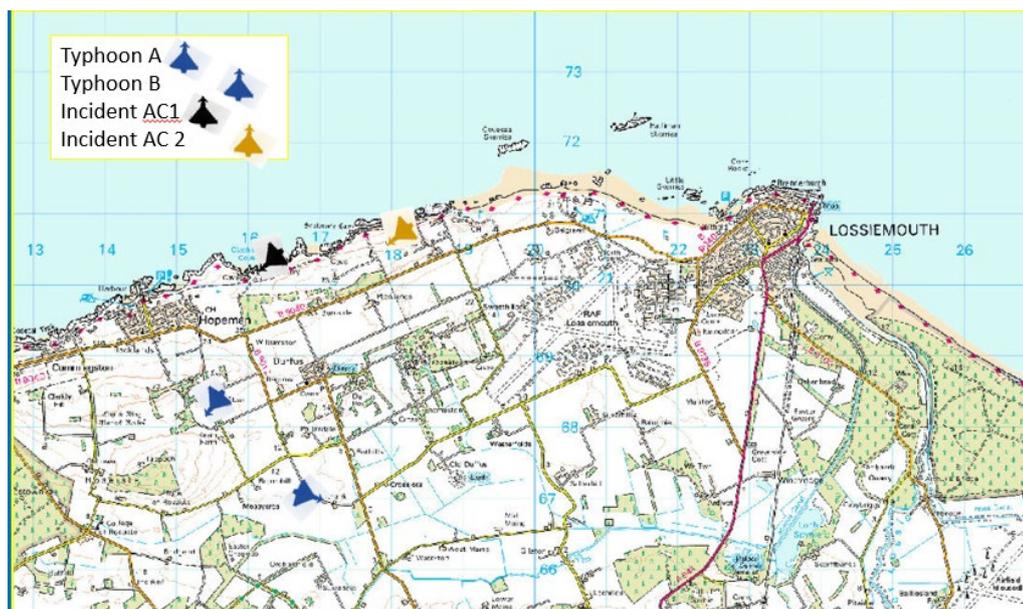
Figure 2

Having established in the visual circuit the pilot of Incident AC1 [Typhoon(1)] reported losing some of the ground cues required to fly the circuit and as such flew a wider than normal downwind leg. The pilot of Incident AC2 [Typhoon(2)] flew a standard pattern and was therefore inside the track of Incident AC1 [Typhoon(1)].

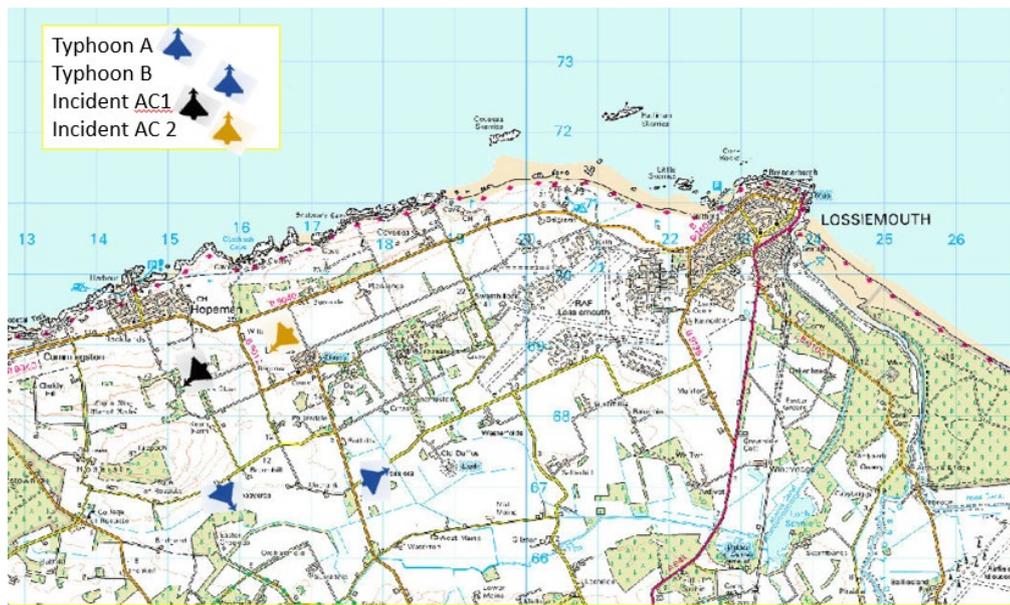
Figure 3

As Incident AC1 [Typhoon(1)] turned final they were given the clearance 'Callsign, cleared to land in turn, one ahead touch and go'. Although this clearance was not CAP413 compliant it was allowed in local orders but was misinterpreted by the pilot of Incident AC1 [Typhoon(1)] who could see two aircraft ahead of him and believed the Tower Controller had misspoken.

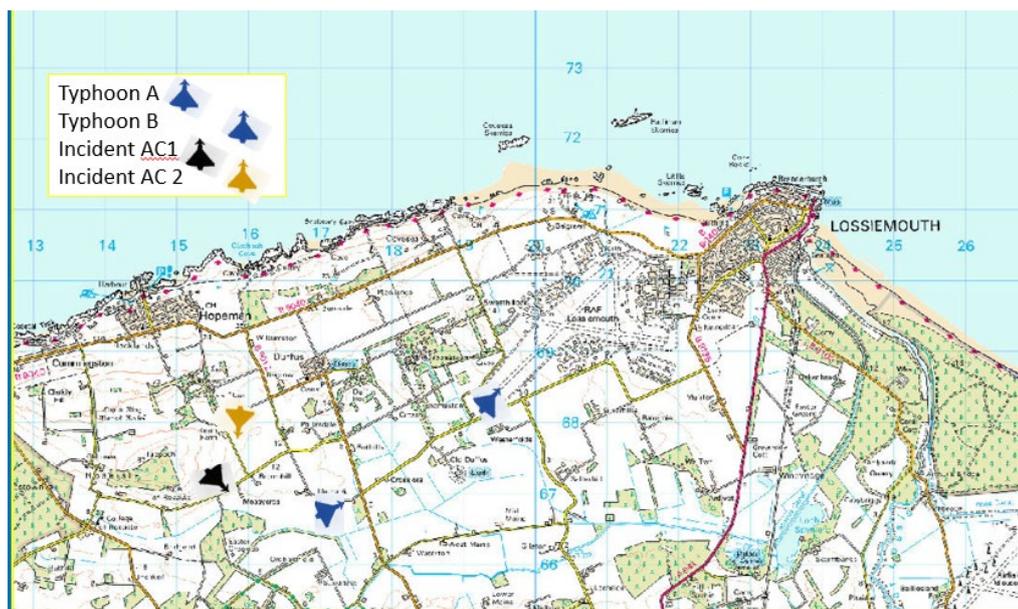
Figure 4

Incident AC2 [Typhoon(2)] called final 19 secs after Incident AC1 [Typhoon(1)] and was cleared to land in turn. Having heard the previous call, Incident AC2 [Typhoon(2)] believed he could see the two aircraft ahead (when in fact there were 3) and was unaware that Incident AC1 [Typhoon(1)] had flown a wider than usual visual circuit.

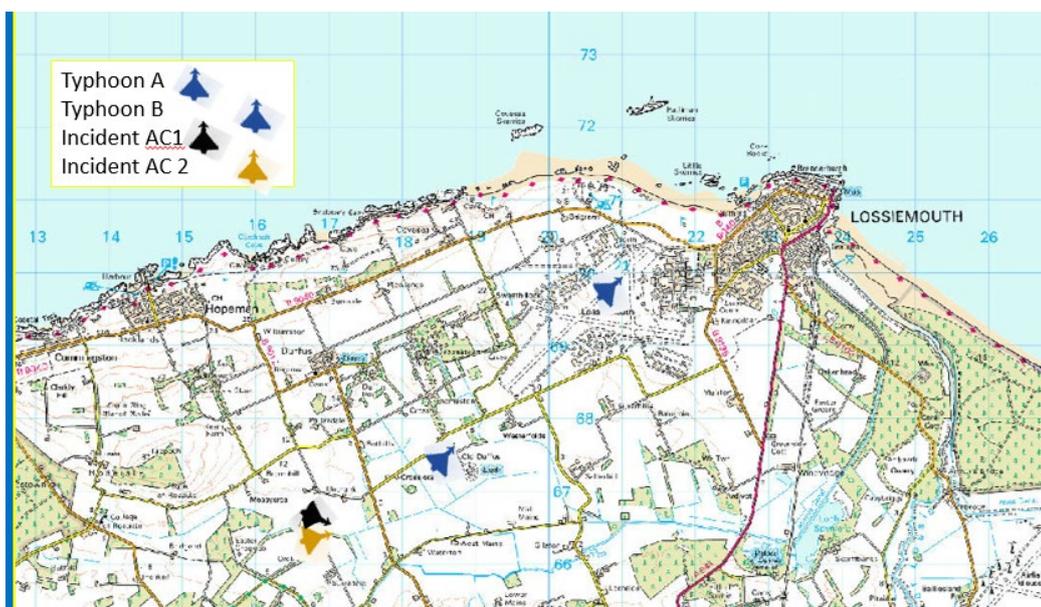
Figure 5 – CPA

CPA occurred 18 secs after the final call from Incident AC2 [Typhoon(2)]. The pilot of Incident AC2 [Typhoon(2)] became aware of the conflict (aided by TACAN) at approx. 0.1nm and initiated a climb to increase separation. The pilot of Incident AC1 [Typhoon(1)] was alerted to the presence of the other Typhoon by the sound of its engines and initiated an immediate descent. The OSI established that, having taken this avoiding action, slant range at CPA was 208ft.
