**AIRPROX REPORT No 2019002**

Date: 12 Jan 2019 Time: 1442Z Position: 5210N 00137W Location: Wellesbourne Mountford

**PART A: SUMMARY OF INFORMATION REPORTED TO UKAB**

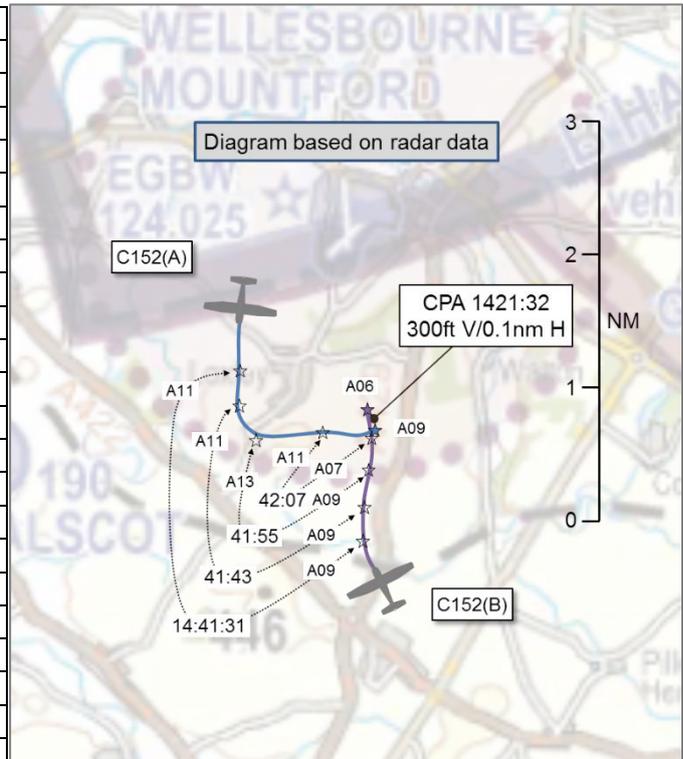
Recorded	Aircraft 1	Aircraft 2
Aircraft	C152(A)	C152(B)
Operator	Civ FW	Civ FW
Airspace	Well'bourne ATZ	Well'bourne ATZ
Class	G	G
Rules	VFR	VFR
Service	AFIS	AFIS
Provider	Wellesbourne	Wellesbourne
Altitude/FL	900ft	600ft
Transponder	A, C, S	A, C, S
<b>Reported</b>		
Colours	White, red, black	White, brown
Lighting	Beacon, landing	Beacon
Conditions	VMC	VMC
Visibility	10km	>10km
Altitude/FL	800ft	<1000ft
Altimeter	QFE (1016hPa)	QFE (1016hPa)
Heading	090°	360°
Speed	65kt	90kt
ACAS/TAS	Not fitted	Not fitted
<b>Separation</b>		
Reported	0ft V/100m H	Not seen at CPA
Recorded	300ft V/0.1nm H
