AIRPROX REPORT No 2019013

Date: 20 Jan 2019 Time: 1209Z Position: 5213N 00137W Location: Wellesbourne - elev 159ft

PART A: SUMMARY OF INFORMATION REPORTED TO UKAB

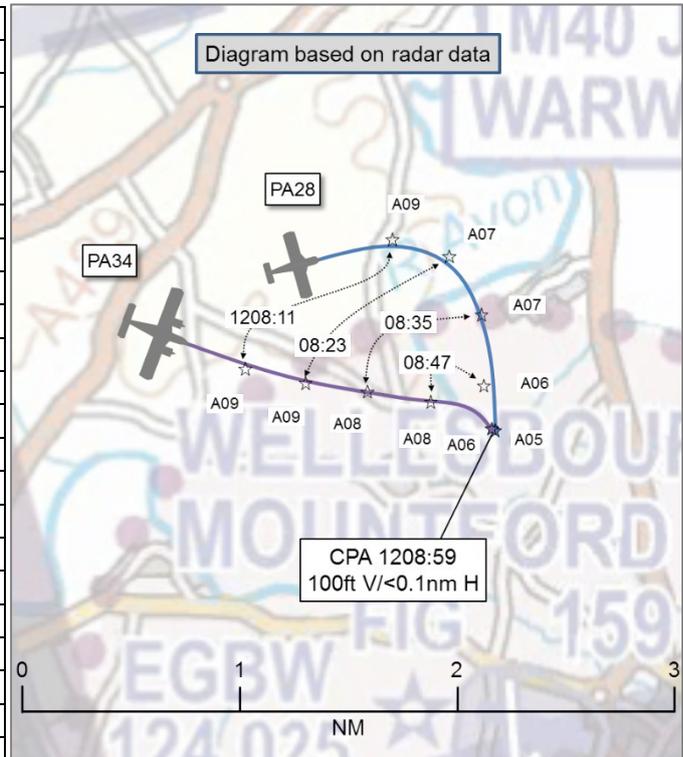
Recorded	Aircraft 1	Aircraft 2
Aircraft	PA28	PA34
Operator	Civ FW	Civ FW
Airspace	Wellesbourne ATZ	Wellesbourne ATZ
Class	G	G
Rules	VFR	VFR
Service	AFIS	AFIS
Provider	Wellesbourne	Wellesbourne
Altitude/FL	500ft	600ft
Transponder	A,C,S	A,C,S
Reported		
Colours	Blue/white	Blue/white
Lighting	Anti-col, landing	Strobes, beacon
Conditions	VMC	VMC
Visibility	3km	>5km
Altitude/FL	600ft	700ft
Altimeter	QFE (1013hPa)	QFE (1013hPa)
Heading	180°	180°
Speed	80ktt	90ktt
ACAS/TAS	Not fitted	Not fitted
Separation		
Reported	0ft V/100m H	Not seen
Recorded	100ft V/<0.1m H

An Airprox was reported when a PA28 and a PA34 flew into proximity in the Wellesbourne Mountford visual circuit at 1209hrs on Sunday 20th January 2019. Both pilots were operating under VFR in VMC and were in receipt of a Flight Information Service from the Wellesbourne AFISO.
