AIRPROX REPORT No 2019014

Date: 22 Jan 2019 Time: 1135Z Position: 5220N 00128W Location: Coventry Aerodrome

PART A: SUMMARY OF INFORMATION REPORTED TO UKAB

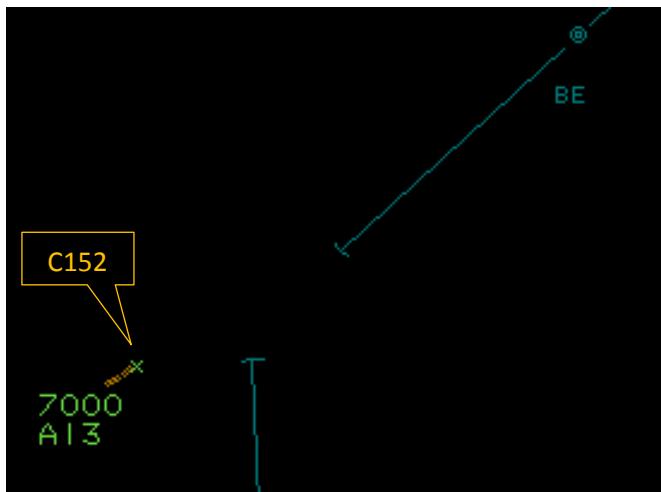
Figure 1 - 1130:20

At 1130:20 (Figure 1), the C152 called the Coventry AFISO advising that they were just about to cross the M40 inbound to land and requested joining instructions. The pilot was advised that RW23 left-hand was in use and the QNH was 1001. A Basic Service was agreed, the pilot was advised to report joining downwind and that there would soon be 4 aircraft in the circuit. The pilot readback all elements of the R/T exchange except for the circuit direction.

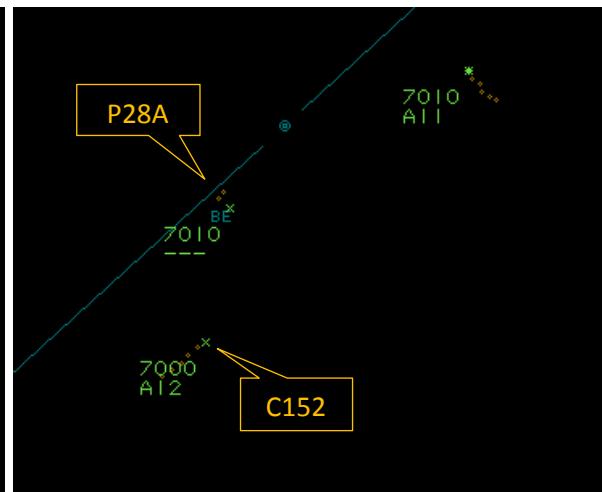
Figure 2 - 1134:50

At 1134:50 (Figure 2), the PA28 pilot reported crosswind. The AFISO responded with “*traffic ahead of you is a 152 joining downwind I believe*”. The pilot responded with “*copied the traffic*”.

The first Traffic Information passed to the PA28 pilot on the joining C152 was when the PA28 pilot reported in the crosswind position and the AFISO advised the pilot that they believed that the C152 was ahead of them. The relevant positions of the PA28 and the C152 at this point would indicate that the PA28 was more likely to be slightly ahead of the C152 (Figure 2). The Traffic Information passed to the pilot of the PA28 was a little late and could have resulted in the pilot being of the belief that the C152 was ahead of them in the circuit.

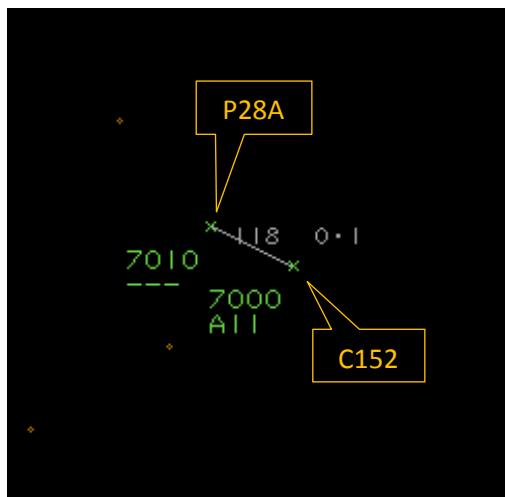
Figure 3 - 1135:27

CPA occurred at 1135:27 (Figure 3), with the aircraft separated by 0.1nm laterally, vertical separation could not be measured.
