AIRPROX REPORT No 2019034

Date: 25 Feb 2019 Time: 1206Z Position: 5152N 00019W Location: Luton CTR

PART A: SUMMARY OF INFORMATION REPORTED TO UKAB

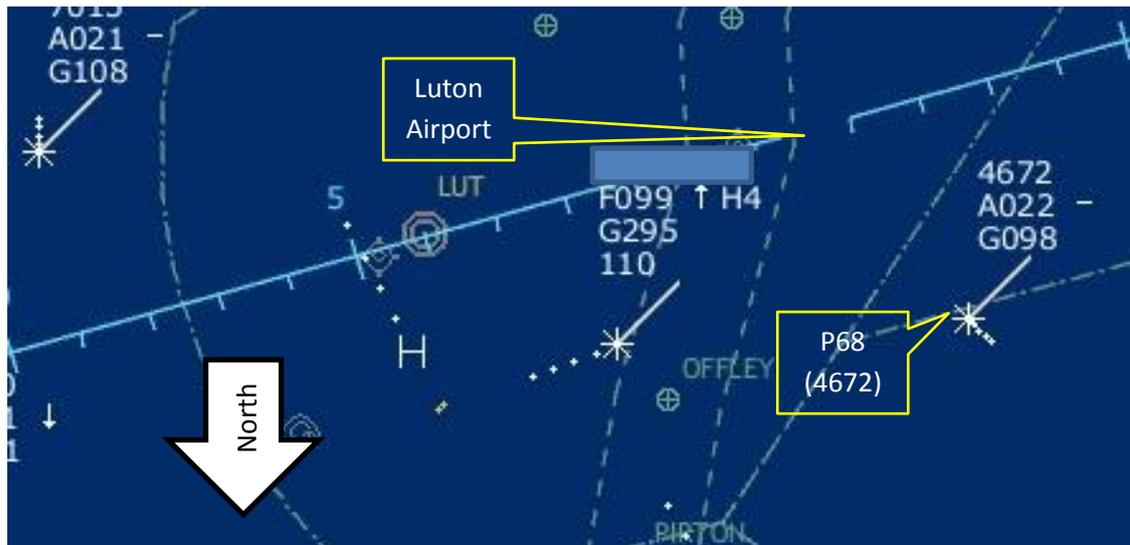
Figure 1:1200:20

An OJTI and Trainee took over on AIR with the handover from the outgoing controller indicating the P68 had been crossing the runway usually at the RW08 threshold, but occasionally further east. At the time of the handover the P68 was tracking SE toward the RW08 Threshold (Figure 1). During the handover the OJTI had asked questions using the override button on the Mentor box. The OJTI indicated that, due to this, he had kept the Mentor box in his hand after the handover was completed which is not usually how he operates. Use of either the headset transmit switch or the Mentor Box transmit switch is not mandated and is left to the OJTI's discretion. In this instance the effect was for the OJTI to be operating in an unfamiliar way.

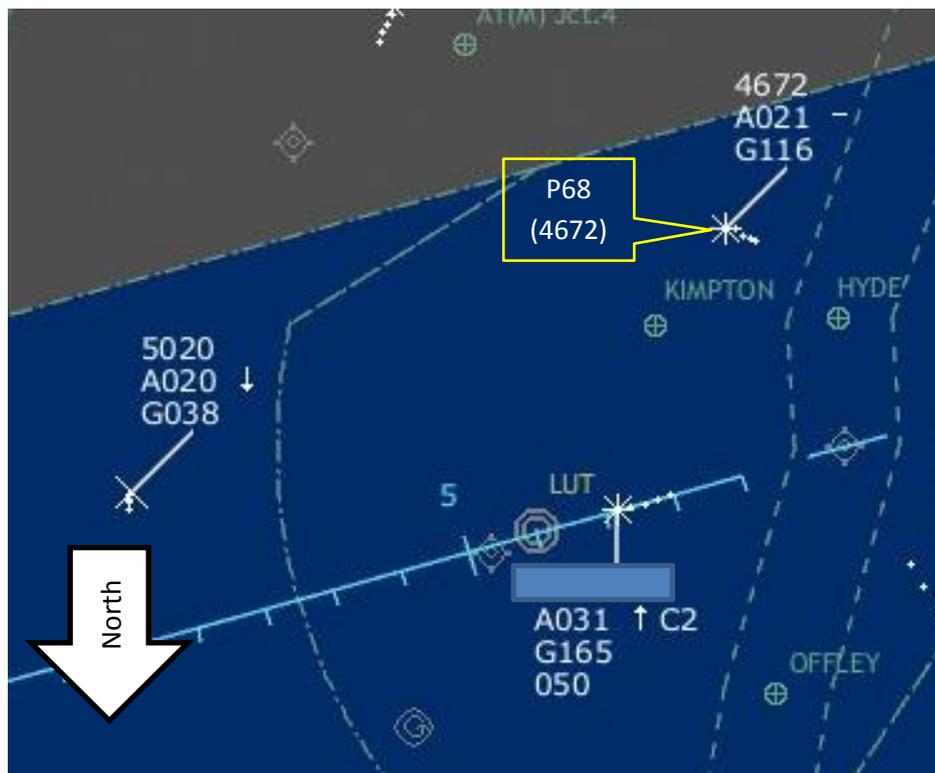
Figure 2: 1204:40

As the A320 lined up, the P68 was south of the airfield and tracking away. When the A320 was cleared for take-off the P68 was 4nm SSE, tracking away from the airfield (Figure 2).

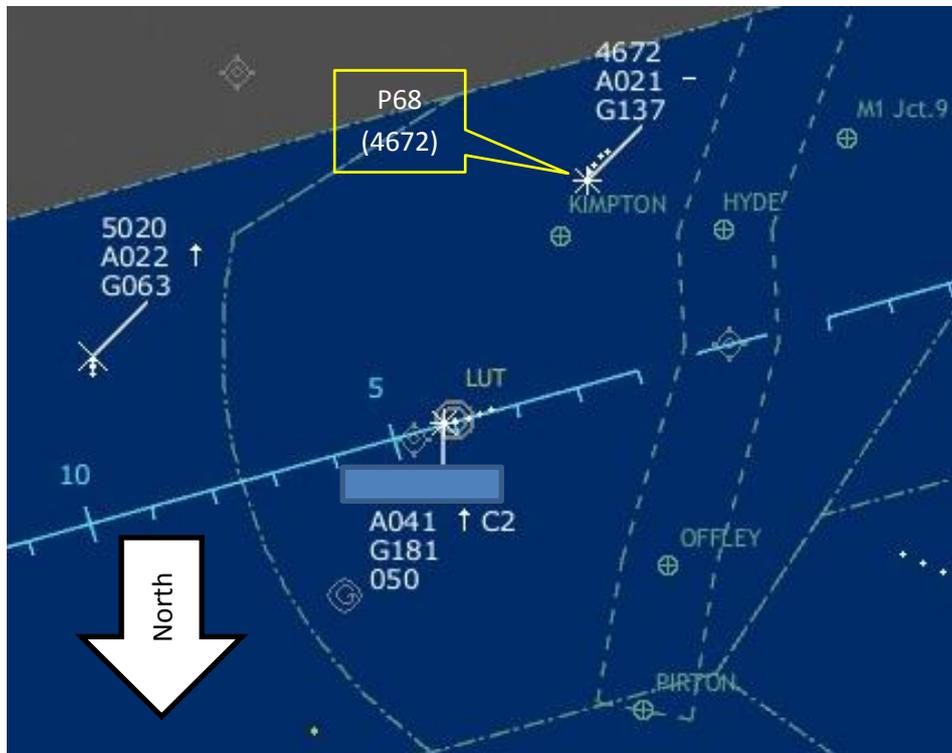
Figure 3: 1205:07

As the A320 pilot began the take-off roll, the P68 transmitted that they were ready to commence the next pass and began the turn back towards the airfield. The previous controller had been giving specific clearance for each run, specifying whether the aircraft would pass at the RW08 threshold or not and passing traffic. Traffic is given by the trainee to the P68 pilot on the departing A320, including the phrase 'track to the south' which was ambiguous, but meant as part of the Traffic Information to the P68 pilot (Figure 3) [UKAB Note: From the interview with the controller, 'track to the south' was intended to be the direction the departure would take on the SID. The student had become confused due to the southerly orientation of the ATM and had meant to say that the departing aircraft would

track north]. There was no clearance to hold, carry out the run or a clearance limit given. The lack of clearance was not questioned by the P68 pilot or the OJTI. The OJTI had assumed the P68 pilot would track to cross at the RW08 threshold and if the P68 had followed this track would not have come into close proximity to the departure.

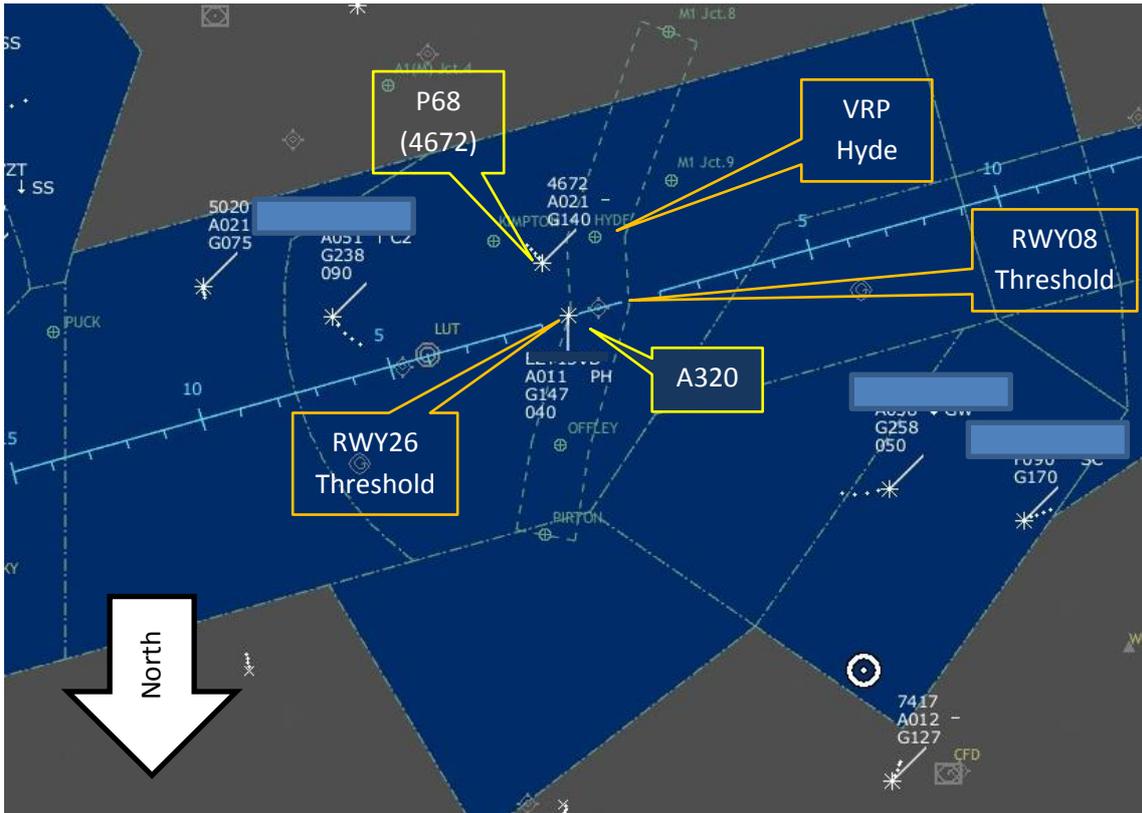
Figure 4: 1205:51

The P68 begins tracking toward the airfield. The OJTI attempted to pass traffic to the A320 pilot via the button on the Mentor Box, but this is not on the RT replay, and it would seem did not get transmitted to the A320 pilot. Engineering investigated the Mentor Box and there were no problems found with the transmit switch on the box. It is possible (and the most likely action) the OJTI pressed the telephone override on the Mentor Box by mistake. Neither controller nor trainee picked up this seems to have happened.

The P68 pilot informs AIR that the run will be via the RW26 threshold, behind the traffic. At this point the OJTI decided this would be a conflict and issued the instruction to hold at the southern Airfield boundary, but this is readback by the P68 pilot to remain south of the runway and not picked up by the AIR controller (Figure 4). The instruction given is also not sufficiently positive to ensure the P68 is deconflicted from the outbound - a direction of turn and instruction to hold at VRP HYDE would have been appropriate to a Fixed Wing aircraft in this location.

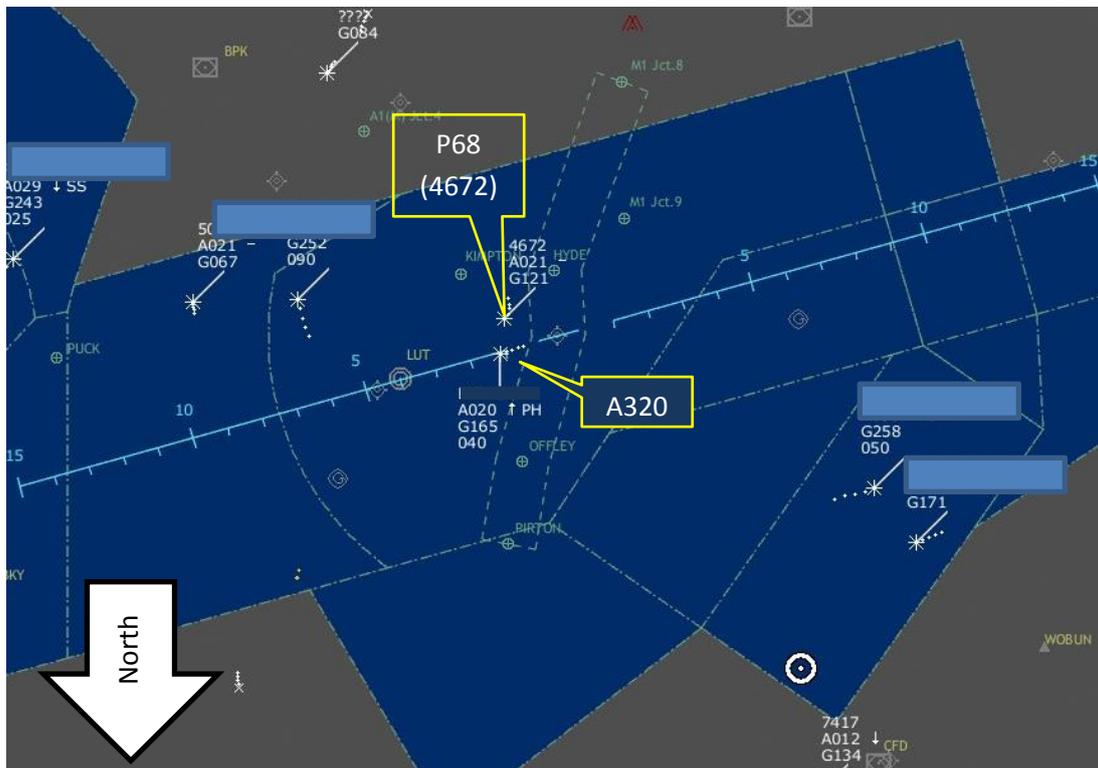
Figure 5: 1206:12

The P68 pilot began a right turn to orbit south east of the airfield, which took it closer to A320 (Figure 5). The OJTI had been expecting the turn to be to the left and therefore keep the P68 further from the departing traffic. The OJTI then amended the P68's clearance to track and hold at HYDE, which was the correct instruction, but passed too late.

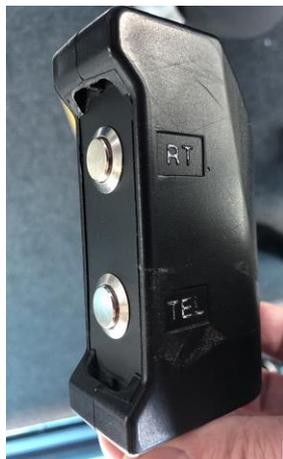
Figure 6

The OJTI cleared up the confusion of what was meant by 'track to the south'- which was intended as TI, not an instruction for the P68 pilot. The OJTI had considered the TI passed to the P68 pilot to be of an okay standard, but also wanted to ensure TI was passed to the A320 pilot so took control of the frequency. When the handover had been carried out, the OJTI had asked questions which had necessitated the use of the Mentor Box telephone override button. Due to this the OJTI still had the Mentor Box in his hand and used this when overriding the RT and pass TI. Normally he would not have hold of the box (only picking it up when phone calls are required) and would use the headset transmit switch to override a trainee's transmissions. The OJTI said it was possible he had pressed the telephone override button instead of the RT override button when passing the TI.

The Mentor Override Box is pictured (Figure 6). It was identified that it would be possible to accidentally press the telephone button instead of the R/T button on the Mentor Override box, which is why it was modified with tape and OJTIs made aware of the possibility of this happening. Since the Airprox the Mentor Override Box has been modified to prevent a recurrence of the incident (Figure 7).
