**AIRPROX REPORT No 2019035**

Date: 23 Feb 2019 Time: 1426Z Position: 5328N 00222W Location: Manchester Barton

**PART A: SUMMARY OF INFORMATION REPORTED TO UKAB**

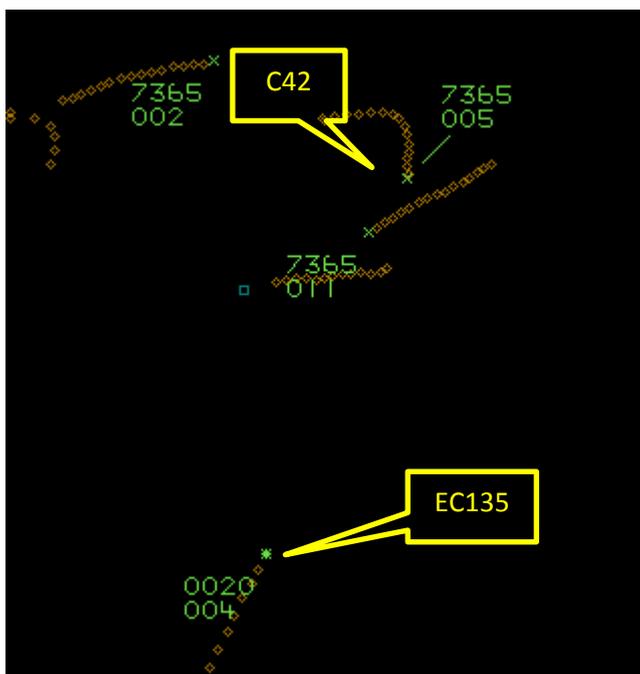
Figure 1: 1424:50

Figures 1-3 are screenshots taken from the NATS radar, which is not available to the Barton AFISO. Figure 1 shows the EC135 as it approaches the airfield from the south; the C42 is on right base. Figure 2 shows the EC135 as it turns onto left base and CPA is at 1426:08, Figure 3.
