AIRPROX REPORT No 2019056

Date: 25 Mar 2019 Time: 1444Z Position: 5143N 00046W Location: 1.5nm E Princes Risborough

PART A: SUMMARY OF INFORMATION REPORTED TO UKAB

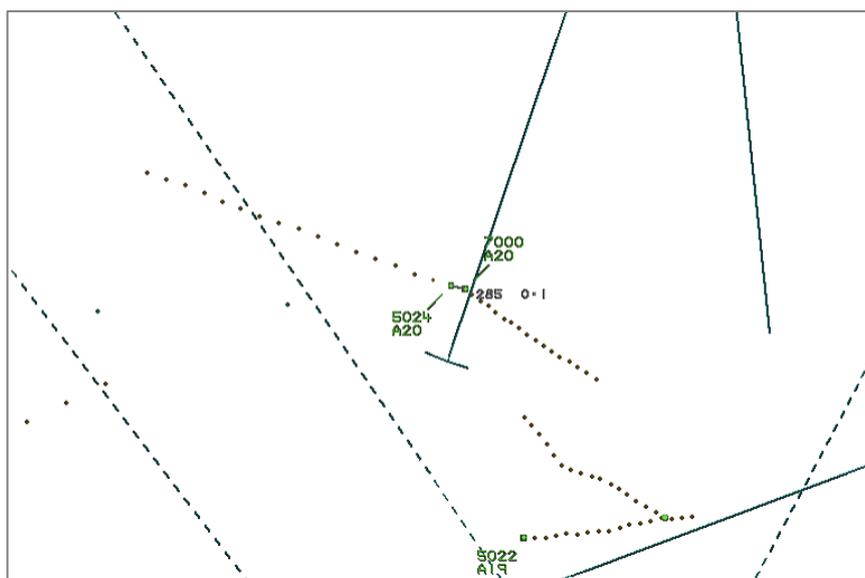
Figure 1: 1444:14 C152 (code 7000) and AW109 (code 5024)

An Airprox was reported when an AW109 and a C152 flew into proximity about 1.5nm east of Princes Risborough at 1444hrs on Monday the 25th of March 2019. Both pilots were operating under VFR in VMC, the AW109 pilot in receipt of a Traffic Service from Farnborough and the C152 pilot reports receiving a Basic Service from Benson or Brize he thought [UKAB note: neither agency was working the C152 immediately preceding or at the time of the Airprox].

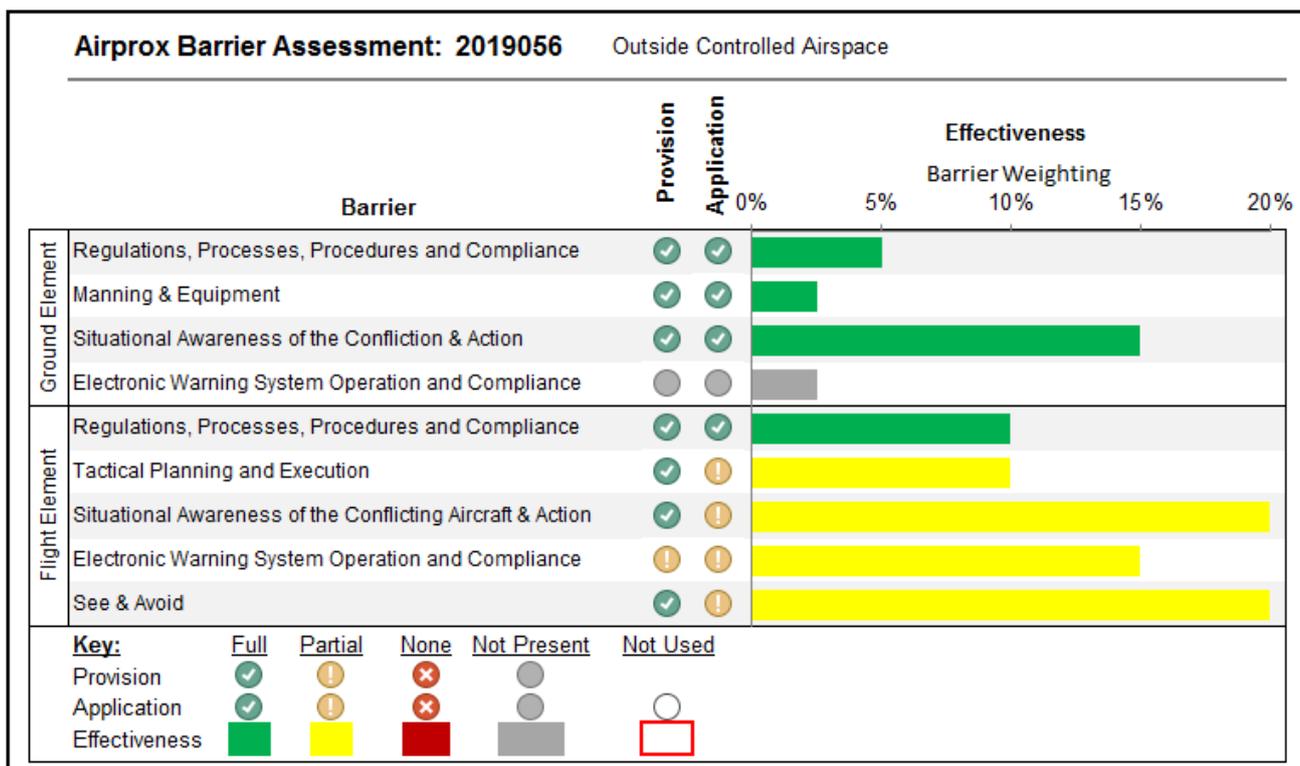
Tactical Planning and Execution was assessed as **partially effective** because the C152 may not have been under a service. In that area it would have been better if he had requested a service from Farnborough LARS.

Situational Awareness of the Conflicting Aircraft and Action were assessed as **partially effective** because the AW109 pilot should have acted on his TAS information sooner than he did.

Electronic Warning System Operation and Compliance were assessed as **partially effective** because although the AW109 pilot increased his lookout he did not act to resolve the conflict.

See and Avoid were assessed as **partially effective** because the C152 pilot saw the AW109 early but did not alter course until the 2 aircraft were closer and the AW109 pilot saw the C152 late; both pilots had to carry out emergency avoiding action.
