AIRPROX REPORT No 2019066

Date: 23 Feb 2019 Time: 1305Z Position: 5053N 00044W Location: Goodwood

PART A: SUMMARY OF INFORMATION REPORTED TO UKAB

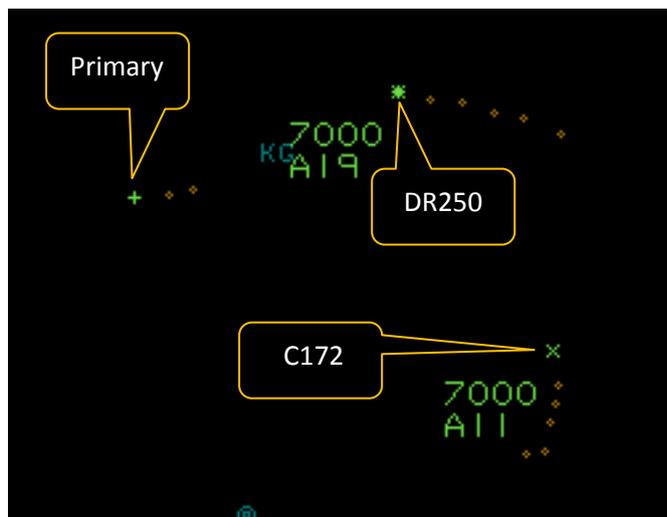
Figure 1 - 1304:00

At 1304:00 (Figure 1), a primary contact appeared on the radar replay just ahead of the DR250.

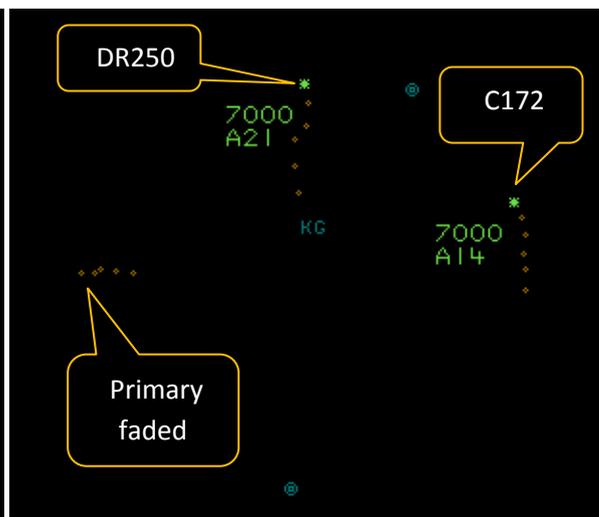
Figure 2 - 1304:40

At 1304:40 (Figure 2), the Bulldog pilot advised the FISO that they were departing to the east and the FISO acknowledged. On the radar the primary target faded in a position consistent with the late downwind call from the Cub pilot

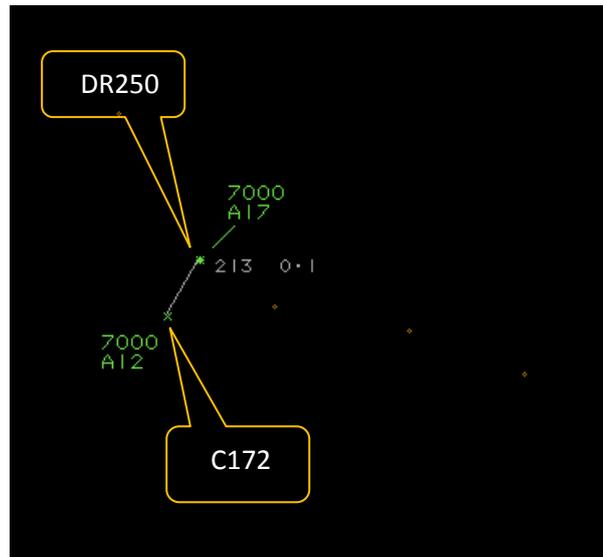
Figure 3 - 1305:03 CPA between the C172 and the DR250.

CPA between the C172 and the DR250 was at 1305:03 with a separation of 0.1nm laterally and 500ft vertically (Figure 3). The Bulldog did not display on the radar recording and so CPA between the Bulldog and the C172 could not be determined.

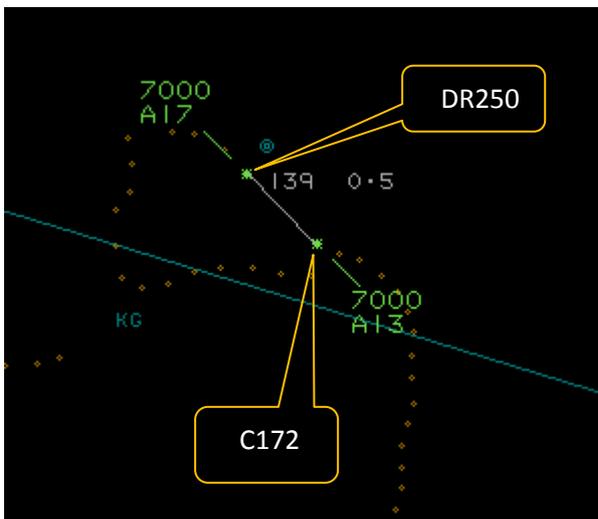
Figure 5 1304:55

Although the DR250 and the C172 had 500ft separation at CPA, the screenshots at Figures 5 and 6 (taken from the NATS radar) show that, just prior to CPA, the DR250 had descended to 1500ft and was only 200ft above the C172, 0.2nm separated, before climbing back to 1700ft at CPA.
