AIRPROX REPORT No 2019075

Date: 18 Apr 2019 Time: 1302Z Position: 5233N 00024W Location: Sibson – elev 130ft

PART A: SUMMARY OF INFORMATION REPORTED TO UKAB

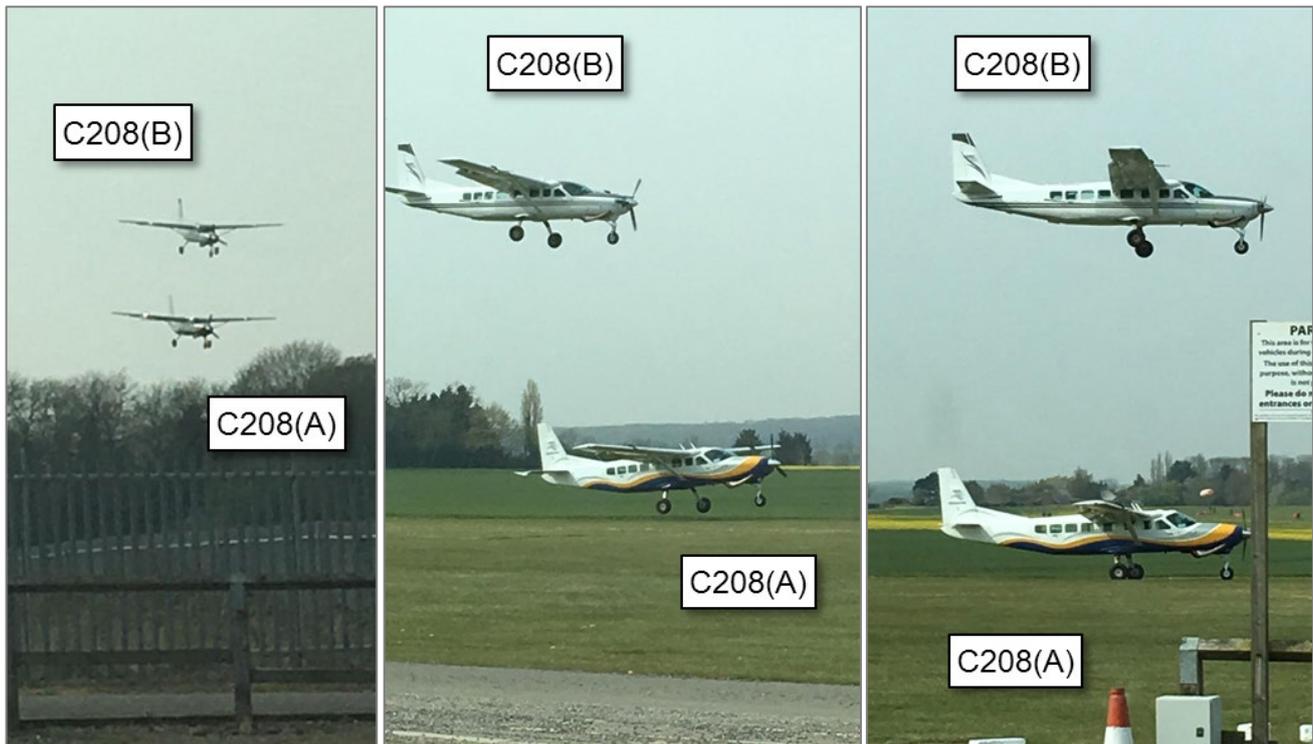
Both C208 pilots shared an equal responsibility for collision avoidance and not to operate in such proximity to other aircraft as to create a collision hazard¹. An aircraft operated on or in the vicinity of an aerodrome shall conform with or avoid the pattern of traffic formed by other aircraft in operation². When two or more heavier-than-air aircraft are approaching an aerodrome or an operating site for the purpose of landing, aircraft at the higher level shall give way to aircraft at the lower level³. Photographs of the aircraft on short final and during the landing/overshoot were made available as follows:
