AIRPROX REPORT No 2019101

Date: 12 May 2019 Time: 1024Z Position: 5611N 00320W Location: Portmoak G/S – elev 360ft

PART A: SUMMARY OF INFORMATION REPORTED TO UKAB

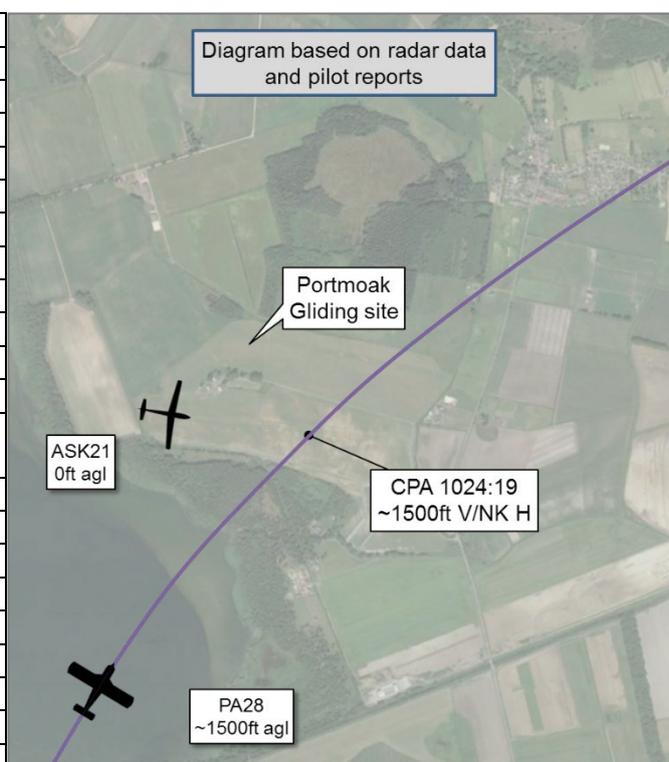
THE ASK21 INSTRUCTOR reports that during a series of short training flights the student pilot was in control during the winch launch. At the moment the cable went taut a nearby pilot standing behind the glider called "stop the launch" so he and the student released the cable almost simultaneously. He made a "winch stop stop stop" call to the winch driver by radio. A few seconds later he saw an aircraft appear over the trees to the south which passed directly overhead the airfield and departed to the north.

Members first commended the glider launch team and ASK21 crew for their actions in halting the winch launch; the Board agreed that the PA28 pilot's flight path overhead Portmoak gliding site was such that had the glider been launched, there would have been a very high risk of collision with either the glider or the winch cable. Even just a few seconds later, the glider would have been airborne in a steep winch-launch climb and its pilots would have been unlikely to have seen the PA28 in time to avoid.

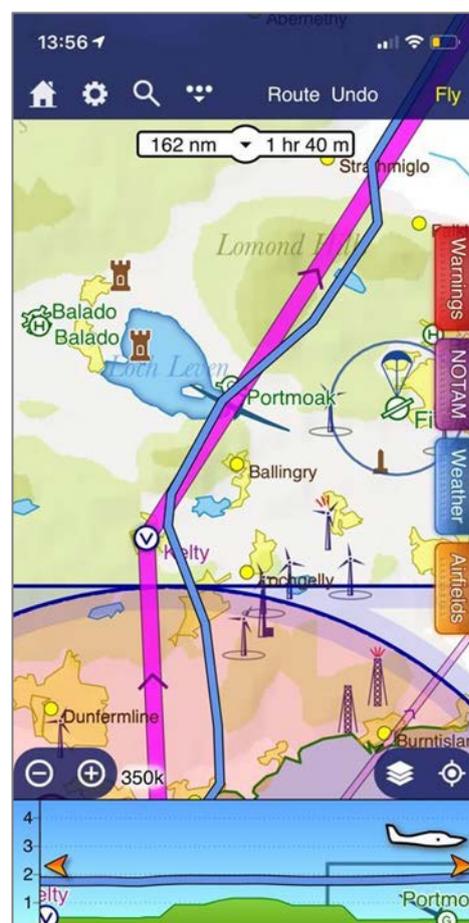
Figure 1 – SkyDemon re-routed track. Planned track magenta, actual track blue.

4. During the flight, SkyDemon was being used as the primary source of navigation data. When the planned track changed from routing via the Kirkcaldy VRP to via the Keltly VRP, he updated the intended track on the planning chart placing a waypoint on the Keltly VRP (see Figure 1). This had the effect of placing the magenta track line directly over Portmoak and obscuring it to some extent. The presence of the airfield was not as conspicuous on the chart as it would normally have been, nor was the air ground frequency of Portmoak. The fact that Portmoak was obscured on the chart was only noticed in retrospect after notification of the Airprox.

Recommendation: SkyDemon review the selection and depiction of sites used for aerial sporting and recreational activities.

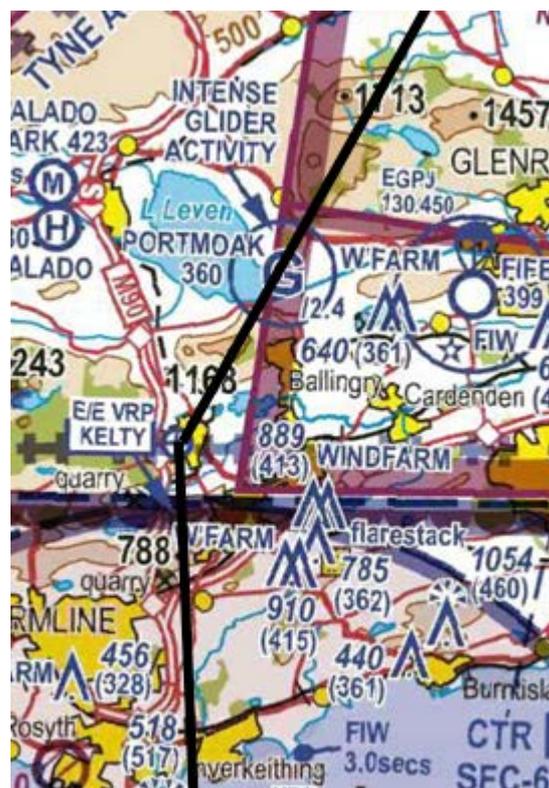
Figure 2 – VFR chart: PA28 pilot’s re-routed track in black

The PA28 pilot had transited the Edinburgh CTR and had planned to exit at a VRP to the northeast of the CTR (Kirkaldy) and thence towards Leuchars, thereby avoiding the Portmoak, Fife and Balado sites. However, he was re-routed by ATC and this resulted in him leaving the CTR to the north, at the Kelty VRP. He had updated his route on SkyDemon but had not assimilated the presence of the Portmoak gliding site on his updated route (**CF4**). It was noted that a reroute with a physical chart involves the pilot drawing the new track on the chart and thereby assimilating factors such as gliding sites which may affect the reroute. In contrast, a tablet-based application merely involves the insertion of a waypoint with the rest of the new route line often being automatically redrawn 'off screen'. Without the pilot panning across the new route line, assimilation of factor airspace and aviation sites was at risk of not readily being achieved (**CF3**). Members then discussed the depiction of gliding sites and areas of intense gliding activity on the SkyDemon display and were shown the various options within SkyDemon for the selective display of aviation information. It was agreed that the current SkyDemon depiction of gliding sites was sub-optimal in that their presence could easily be overlooked compared to the more obvious depiction on the VFR chart (**CF3**). It was also agreed that the facility to selectively turn off the

Members agreed that whilst the SkyDemon application could display gliding sites, it was a question of degree. It was noted that some other aviation mapping applications included an option for the display of a CAA VFR chart, which highlighted gliding sites by adding a larger blue circle around the site. As shown in Figure 2, which is the PA28 track as depicted on a VFR chart, the presence of Portmoak and its intense gliding activity warning are much more evident than in Figure 1, the SkyDemon version. After further discussion, the Board resolved to recommend that ‘SkyDemon review the selection and depiction of sites used for aerial sporting and recreational activities’.

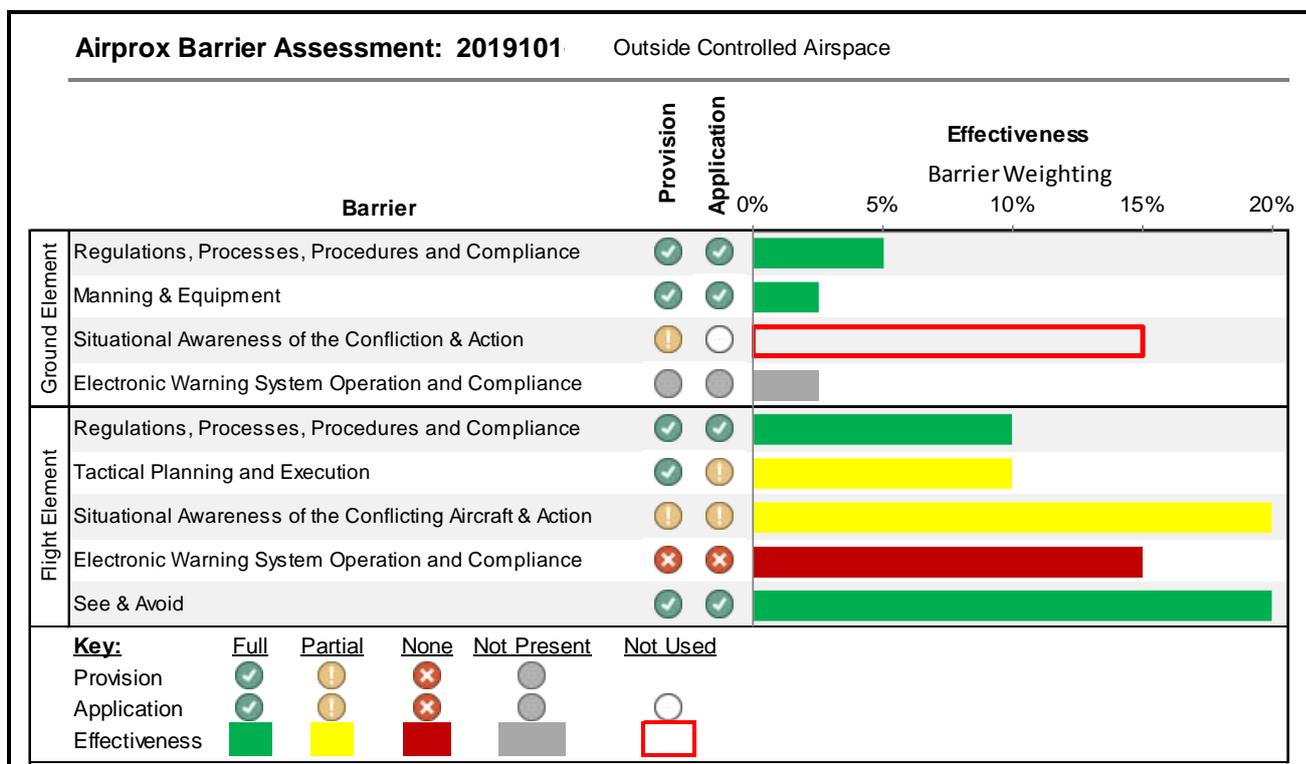
Situational Awareness of the Confliction and Action were assessed as **not used** because under the requested Basic Service, the Edinburgh controller was not required to monitor the PA28 in order to give specific situational awareness, albeit he did give a generic warning about likely activity in the area.

Tactical Planning and Execution was assessed as **partially effective** because after being re-routed, the PA28 pilot warned his passengers to assist in lookout but still flew through the overhead of a promulgated and active gliding site and below the maximum winching altitude whilst winching operations were in progress.

Situational Awareness of the Conflicting Aircraft and Action were assessed as **partially effective** because the PA28 pilot did not fully act on the information he had been given when he was informed of likely gliding in the area despite being generically aware that Portmoak gliding site was nearby.

Electronic Warning System Operation and Compliance were assessed as **ineffective** because the PA28 was not fitted with a TAS and the glider FLARM was incompatible with the PA28 transponder.
