AIRPROX REPORT No 2019106

Date: 14 May 2019 Time: 1555Z Position: 5050N 00015W Location: Brighton City Airport

PART A: SUMMARY OF INFORMATION REPORTED TO UKAB

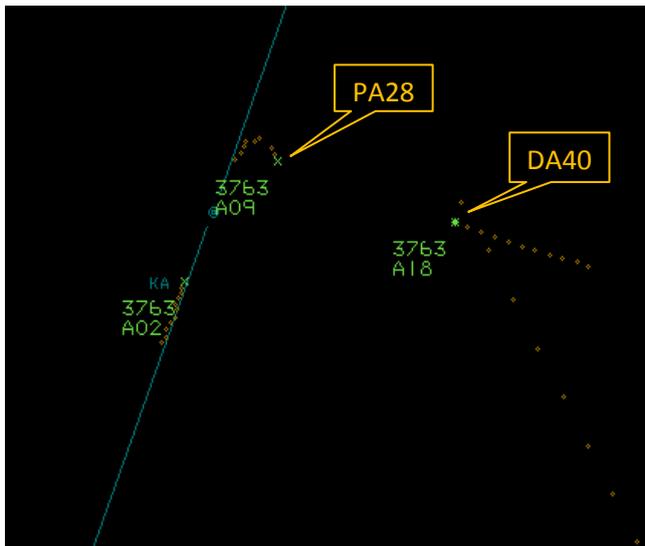
Figure 1 – 1555:00

At 1553:30, the PA28 pilot had reported ready for departure, was cleared for take-off RW02 and given a right turnout. Between 1554:40 and 1555:00 (Figure 1), the following continuous exchange took place. The DA40 pilot reported north abeam the power station and the controller asked the pilot which runway they would prefer for landing. After an exchange about the wind conditions the pilot responded that they were happy to join crosswind RW02. The controller instructed the pilot to join crosswind RW02, to report downwind and advised the pilot that the circuit was active with traffic on short final. The joining instructions were readback accurately. This was followed immediately

with further Traffic Information on the PA28, described as a recently departed Cherokee, becoming opposite direction, routing east, VFR. The DA40 pilot responded that they had not yet sighted the traffic.

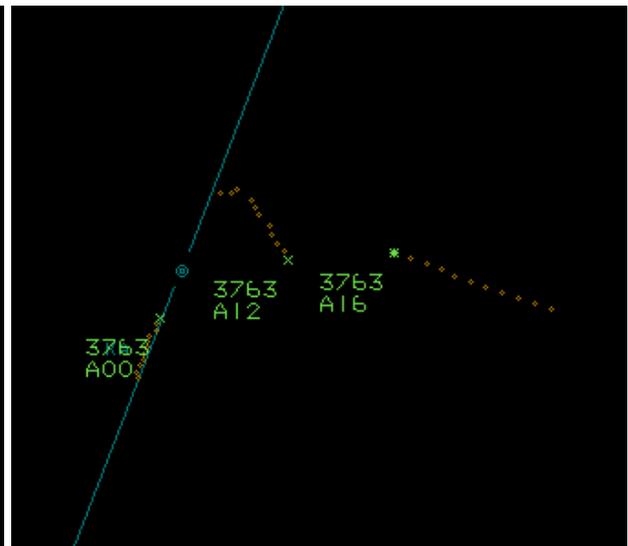
Figure 2 – 1555:20

At 1555:20 the PA28 pilot was advised to look out for traffic just north of the power station joining crosswind, he responded that they were looking (Figure 2).

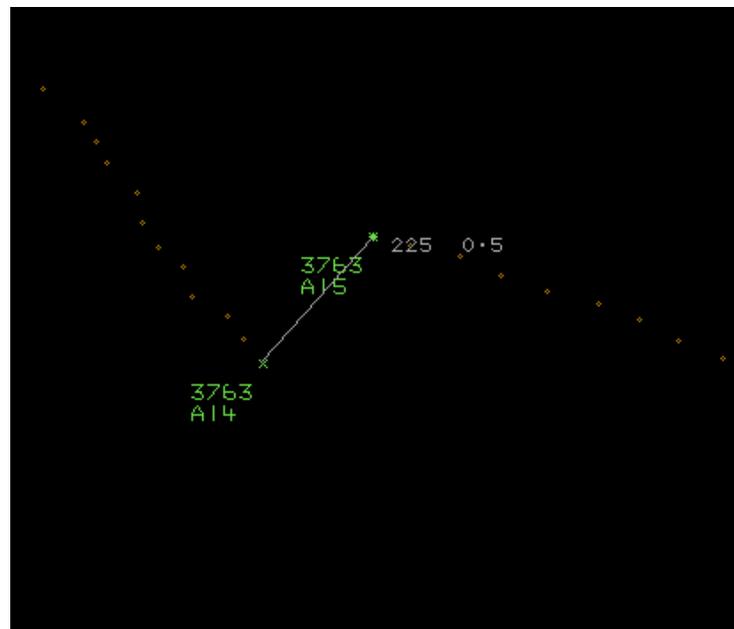
Figure 3 – 1555:30 CPA

At 1555:30 the DA40 pilot was advised that the PA28 traffic should pass down their left-hand side and the pilot reported that they were visual. This transmission was coincident with CPA, with the aircraft separated by 0.5nm laterally and 100ft vertically (Figure 3).
