**AIRPROX REPORT No 2019117**

Date: 22 May 2019 Time: 1637Z Position: 5612N 00321W Location: Loch Leven

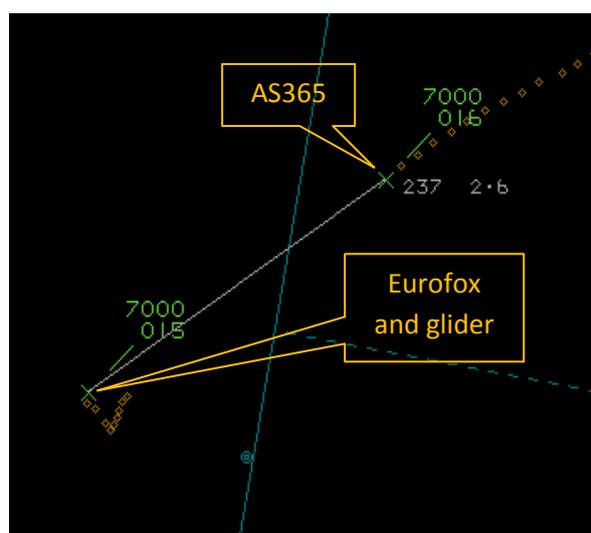
Figure 1: 1636:26

Neither pilot was receiving an ATS. The Airprox can be seen on the NATS area radars as shown on the following screenshots. At 1636:26 (Figure 1), the Eurofox and glider can be seen to the west of Portmoak and the AS365 is to the NE. The two aircraft continue to close (Figure 2) until CPA at 1637:12 (Figure 3).
