AIRPROX REPORT No 2019137

Date: 04 Jun 2019 Time: 1707Z Position: 5200N 00124W Location: 10nm N Oxford Airport

PART A: SUMMARY OF INFORMATION REPORTED TO UKAB

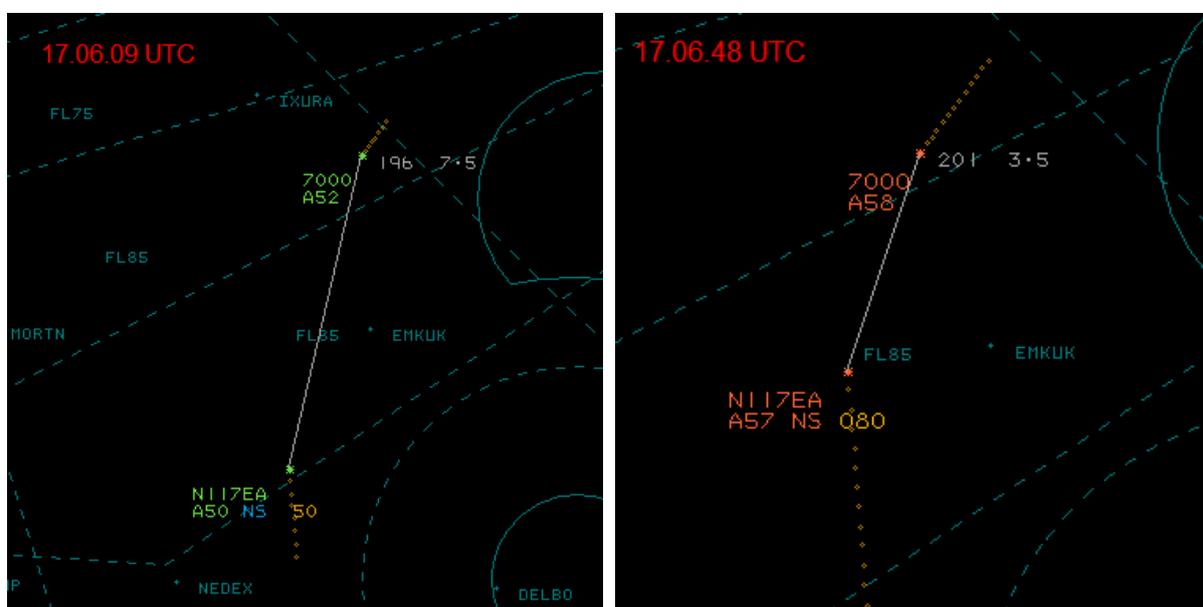
Figure 1

At 17:06:09 (Figure 1), the controller instructed the pilot of [EA500C/S] to join Controlled Airspace on track IXURA in the climb to FL80. This was correctly read back by the pilot. The controller then passed traffic information “in your 1 o'clock, range 5 miles, opposite direction, 5500 feet unverified.” The pilot of [EA500C/S] reported that they had the aircraft on TCAS.

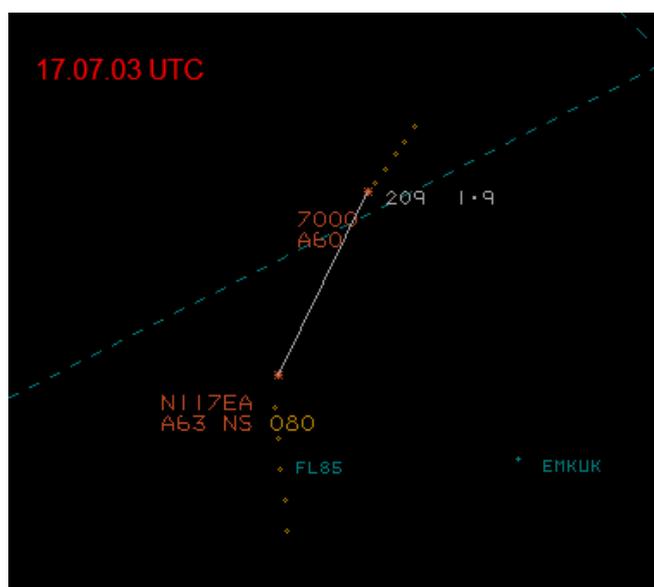
Figure 3

CPA occurred at 17:07:03² (Figure 3), almost coincident with the London FISO (at 17:07:04 on a different frequency) issuing the pilot of [BE36 C/S] with a Basic Service and instructing him to remain outside Controlled Airspace. This was correctly read back.

² UKAB analysis indicated that CPA occurred at 17:07:18 with a vertical separation of 600ft and lateral separation of 0.4NM.

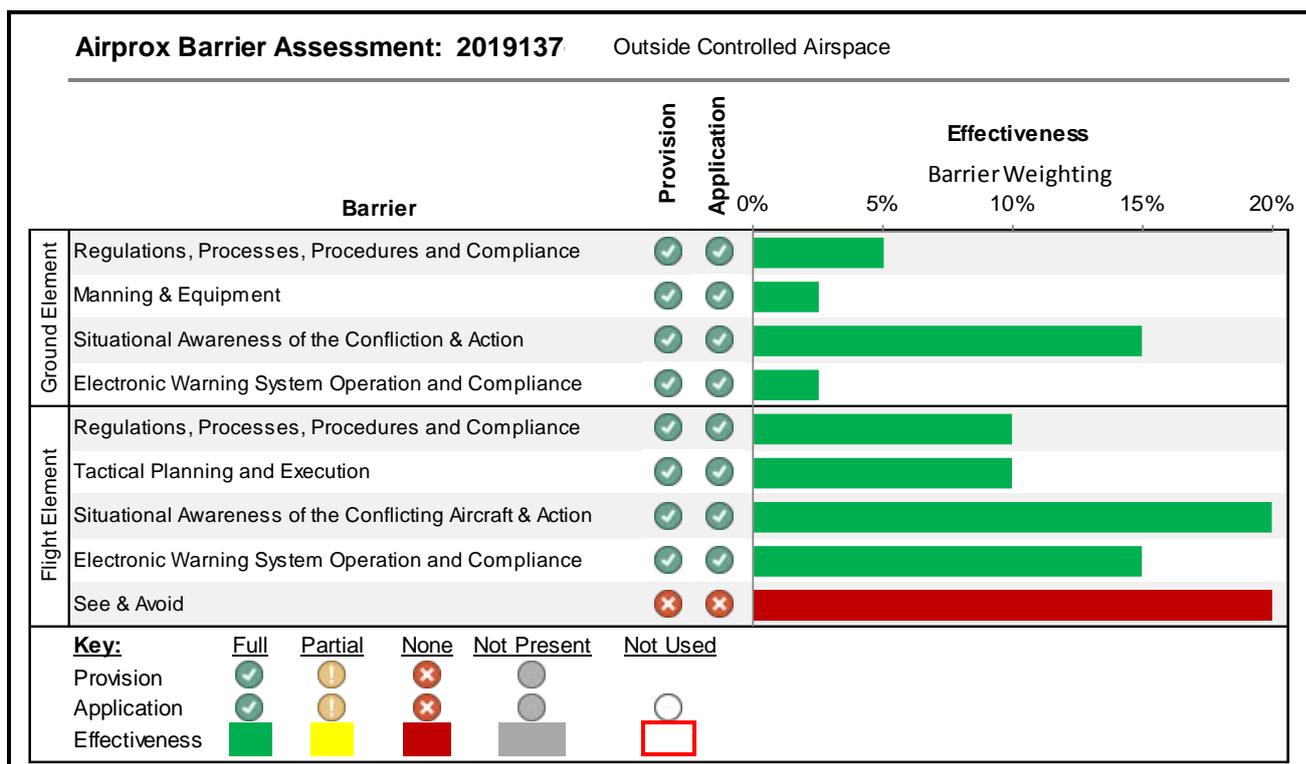
See and Avoid were assessed as **ineffective** because neither pilot saw the other aircraft.
