AIRPROX REPORT No 2019139

Date: 09 Jun 2019 Time: 1033Z Position: 5213N 00002W Location: Overhead Bourn Airfield

PART A: SUMMARY OF INFORMATION REPORTED TO UKAB

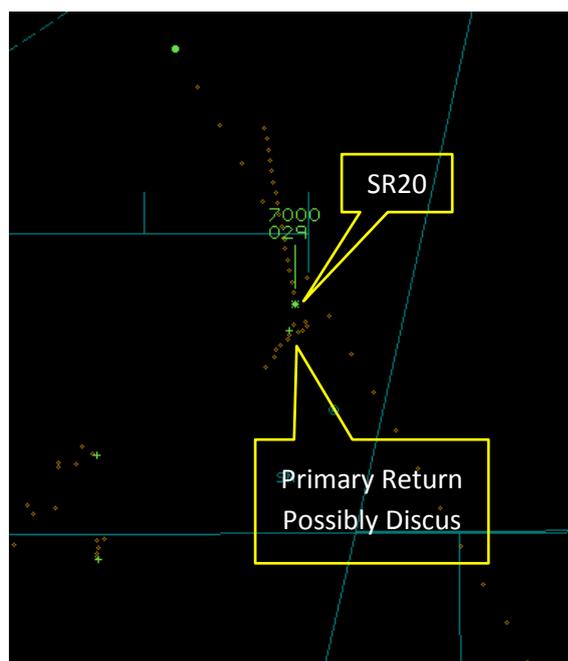
Figure 1

The radar replay displays a primary-only contact operating as per the description of the Discus pilot and corresponds with his igc file, although this cannot be fully verified. The SR20 pilot's planned route would have taken him between Bourn and Cambridge but his actual route took him over Bourn airfield. Shortly after passing close to the primary-only contact the SR20 pilot turns left briefly before turning right, which is as described by the SR20 pilot on sighting a glider but this is after CPA with the primary return/igc file and so this indicates that the glider he turned to avoid was not the Airprox Discus (Figure 2).

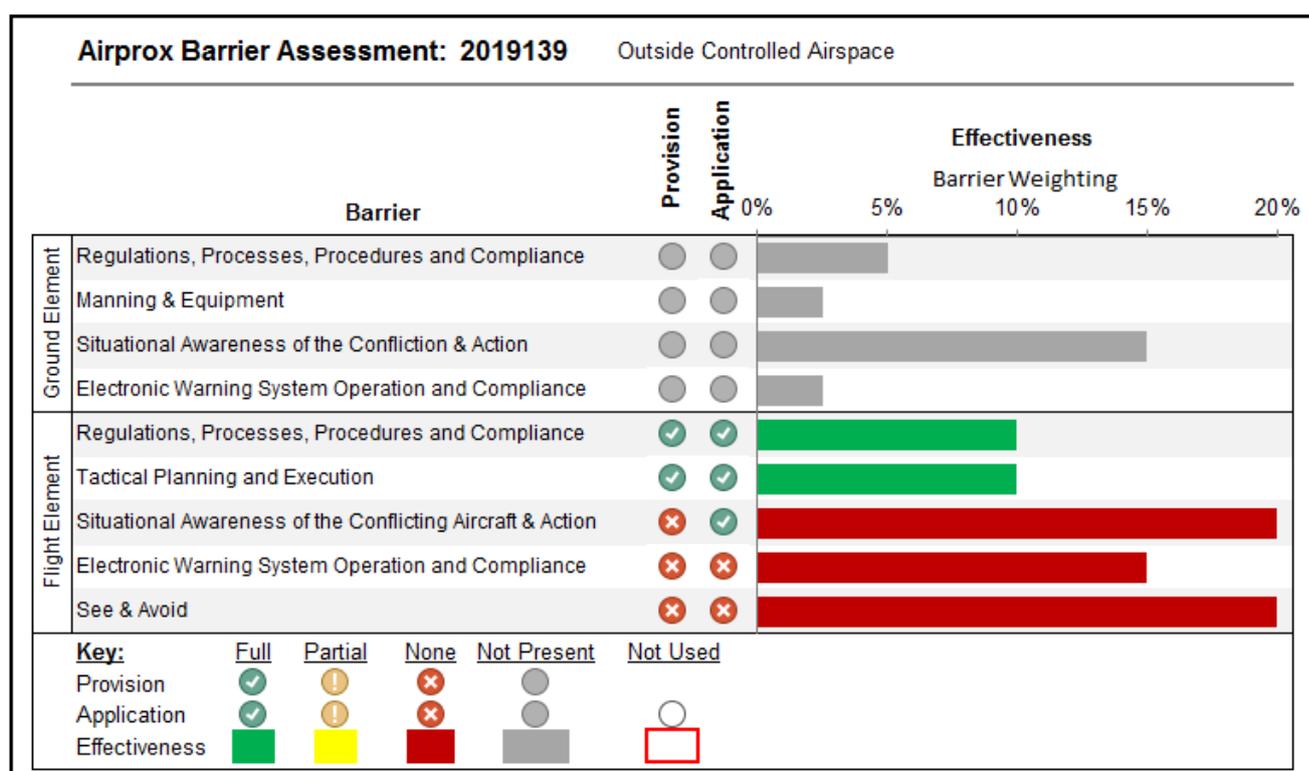
Situational Awareness of the Conflicting Aircraft and Action were assessed as **ineffective** because neither pilot had any SA on the other aircraft.

Electronic Warning System Operation and Compliance were assessed as **ineffective** because the aircrafts' systems were incompatible with each other.

See and Avoid were assessed as **ineffective** because the SR20 pilot didn't see the Discus Glider and the Discus pilot only saw the SR20 as it passed by, too late to carry out any action that would materially increase the separation.
