AIRPROX REPORT No 2019144

Date: 08 Jun 2019 Time: 1247Z Position: 5059N 00018E Location: 1-2nm NE TIMBA

PART A: SUMMARY OF INFORMATION REPORTED TO UKAB

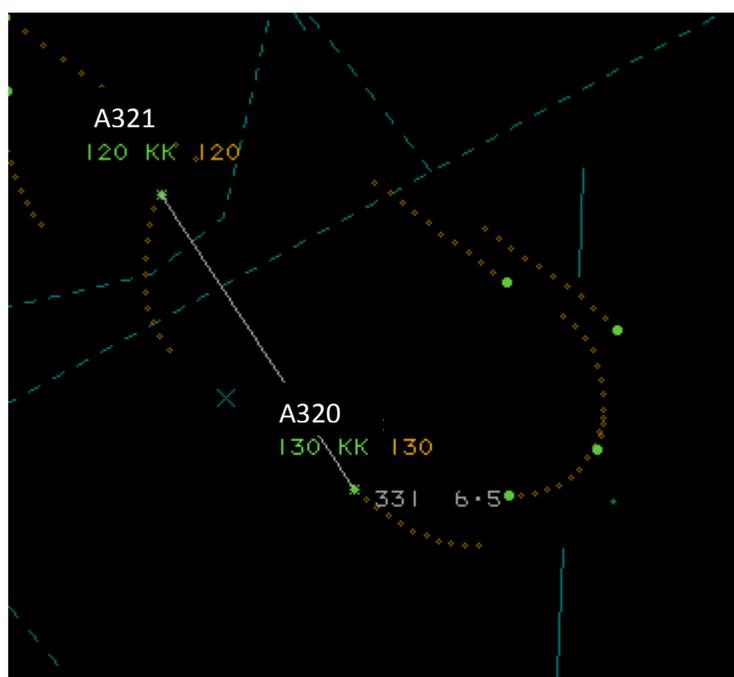
Figure 1 1246:47.

At 1246:47 (all times UTC), the two aircraft were positioned as illustrated in Figure 1.

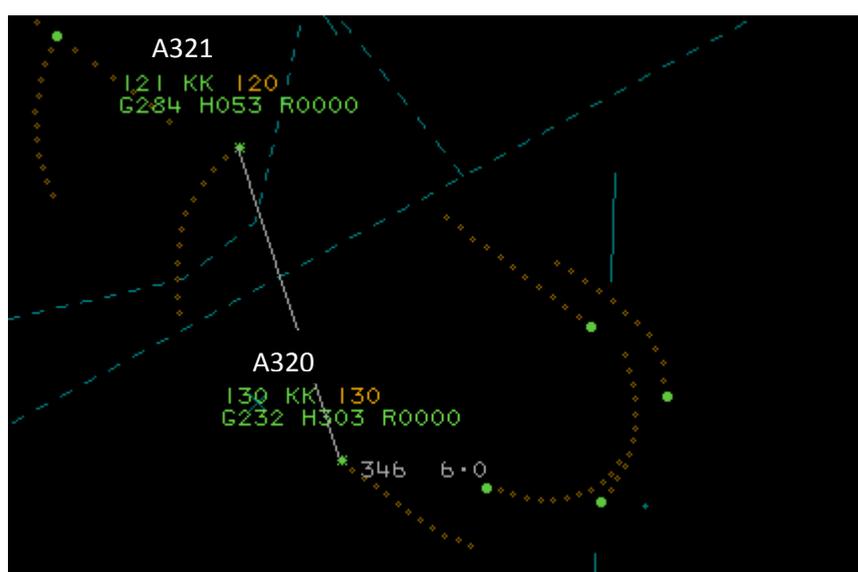
Figure 2: Point of loss of separation at 1247:02.

At 1247:02 (Figure 2), the Mode C of the A321 increased to FL121, at which point separation was lost with the A320 that was maintaining FL130.

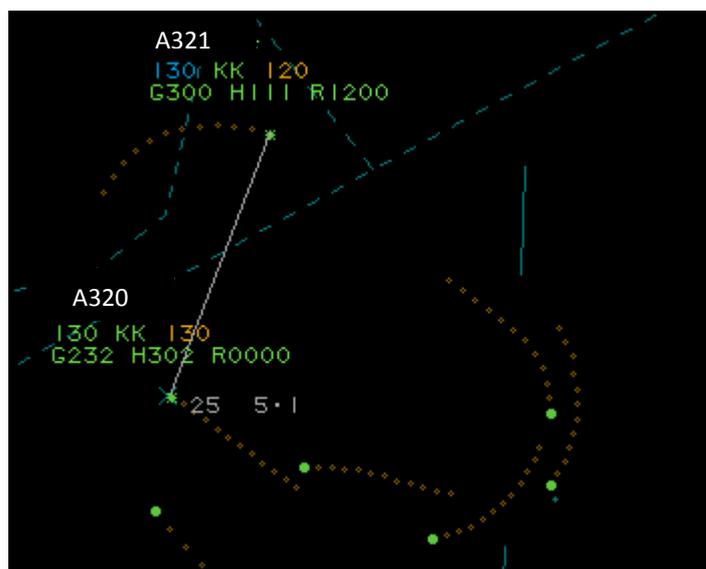
Figure 3: Minimum separation 1247:30.

Minimum separation also occurred at 1247:30 (Figure 3), and was recorded on the LTCC Multi-Track Radar as 0ft and 5.1nm in the TIMBA hold.

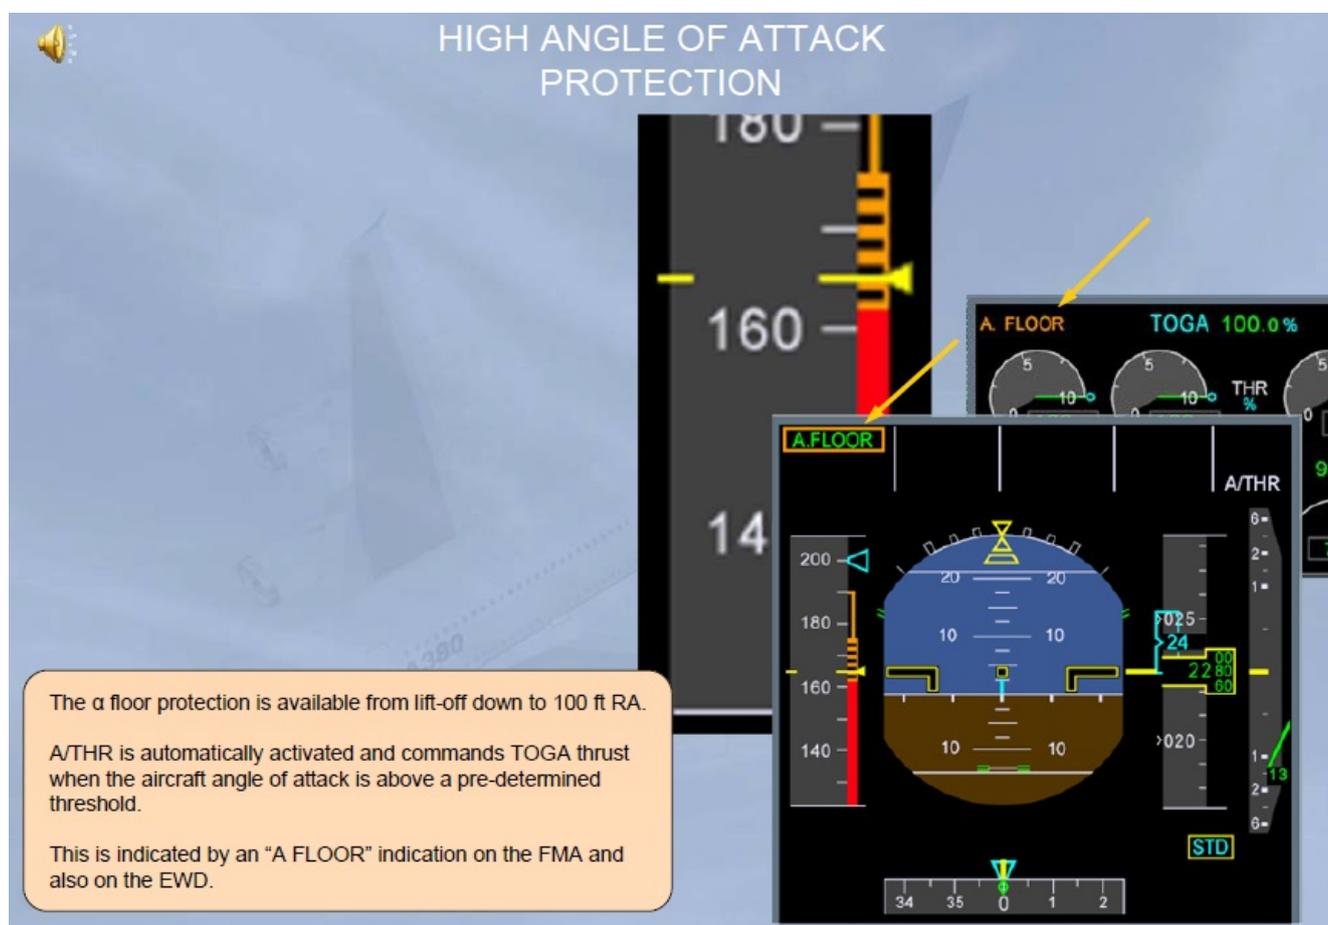
Figure 4.

One of the pilots mentioned holding near 'green dot' speed. This was effectively the minimum drag speed indicated on the airspeed indicator below which drag increases the slower you go until the low speed protection takes effect. He believed that the system went straight into the full low-speed regime (illustrated in Figure 4) due to the sudden turbulence which could cause large and sudden changes in airspeed and increase in load factor (increase in positive 'g') through tightening the turn and turbulence.

Increasing load factor causes the system to operate at a higher indicated airspeed than at 1 'g'. At a few kts above stalling speed, full power is automatically applied (A.FLOOR) and the system sets the pitch attitude to maintain the speed. This is where he believed the A321 crew found themselves but, once the speed had increased above the top of the yellow barbers pole, everything returns to normal except that full power (A.FLOOR) is still being applied and the autopilot remains dis-engaged (which probably occurred as they emerged from the cloud with wings level). The 'A.FLOOR' mode needs to be disconnected promptly for 'normal' auto thrust to be re engaged, otherwise it could lead to the significant height excursion as seen in this event.
