AIRPROX REPORT No 2019157

Date: 22 Jun 2019 Time: ~0952Z Position: 5143N 00205W Location: ~2nm NE Aston Down

PART A: SUMMARY OF INFORMATION REPORTED TO UKAB

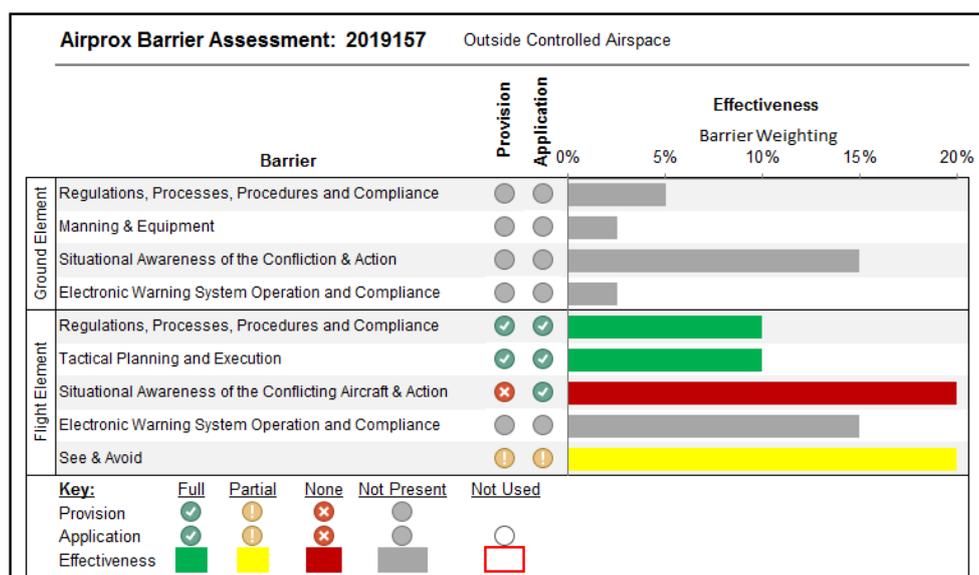
Safety Barrier Assessment⁴

In assessing the effectiveness of the safety barriers associated with this incident, the Board concluded that the key factors had been that:

Situational Awareness of the Conflicting Aircraft and Action were assessed as **ineffective** because neither pilot had any SA on the other aircraft.

See and Avoid were assessed as **partially effective** because although the PA23 did not see the ASK21, the ASK21 pilot saw the PA23 late and was able to carry out emergency avoiding action
