AIRPROX REPORT No 2019175

Date: 02 Jul 2019 Time: 1035Z Position: 5130N 00017E Location: 3nm SE Damyns Hall

PART A: SUMMARY OF INFORMATION REPORTED TO UKAB

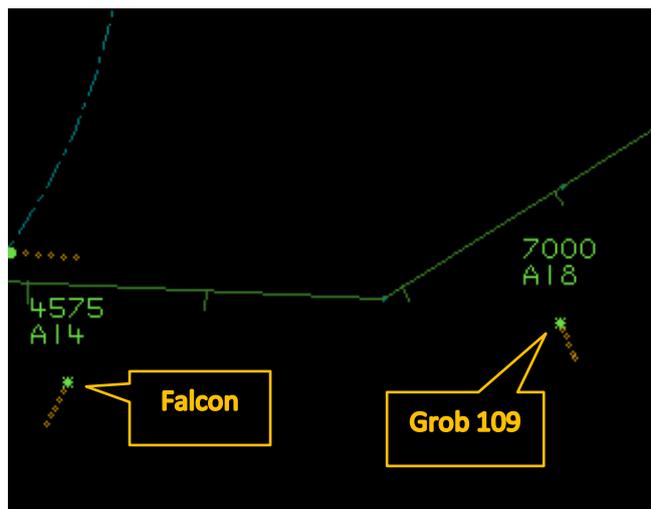
Figure 1 - 10:31:30

At 1030:50, the Falcon pilot called the Southend Radar controller and advised they were currently at Swanley at 1600ft, and requested a Basic Service. A Basic Service was agreed, and the pilot was instructed to squawk 4575. There was no further communication between the Falcon pilot and the controller until after the Airprox occurred.

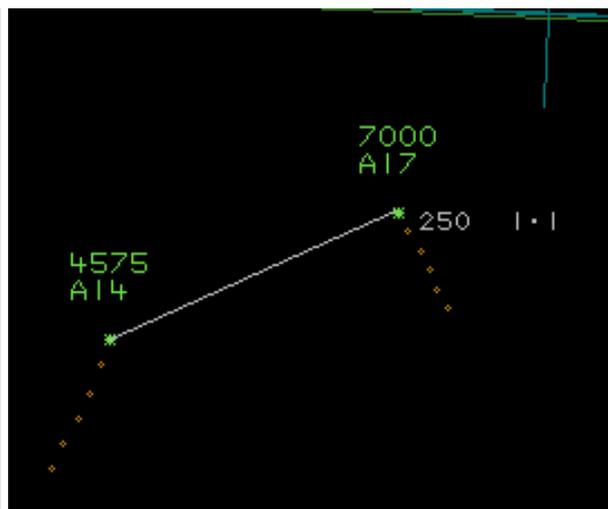
Figure 2 - 10:34:45
(Grob109 pilot commenced descent)

In the period leading up to the Airprox there had been an indicated 400ft of vertical separation between the Falcon and the Grob109, with the Mode C on the Grob109 being unverified information. The controller would not have been aware that the Grob109 pilot intended to descend into Damyns Hall Airfield.

At 10:35.15, and just prior to the Airprox occurring, the controller responded to an initial call from an unrelated aircraft. This aircraft was not displaying Mode C information and the R/T exchange was slightly protracted as a result. This may have contributed to the controller not noticing that the Grob109 pilot had commenced descent.

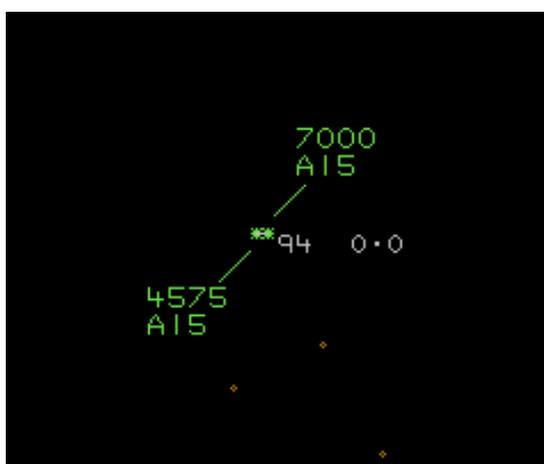
Figure 3- 1035:46 CPA

The Grob 109 pilot made an R/T call to the Southend controller immediately after the Airprox had occurred. They advised the controller that they had just encountered a near miss and asked if the controller was aware of any aircraft in the Damyns Hall area. The controller advised that the Falcon had been in that area and that they were providing the pilot with a Basic Service. The Airprox occurred in Class G airspace with the Falcon pilot in receipt of a Basic Service from Southend Radar. The Grob 109 was not receiving a service from Southend Radar and was displayed to the controller as unknown traffic.

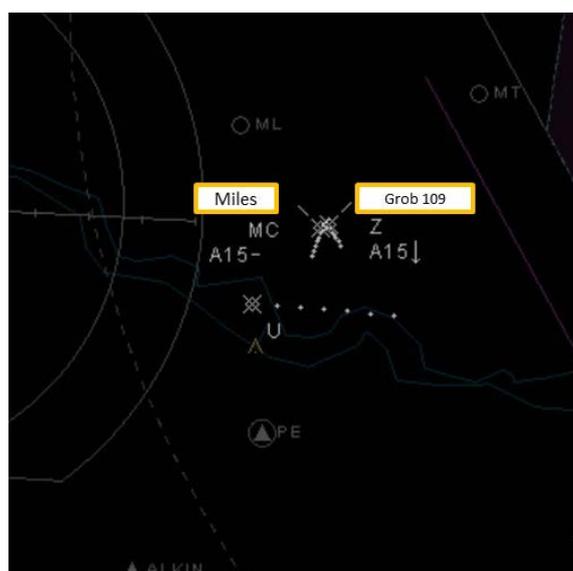
Figure 4: CPA 1035:46

At 1030:03, the Miles Falcon pilot called Southend for a Basic Service. He was given a squawk and placed under a Basic Service. At 1035:10, just before CPA, another pilot called the Southend controller requesting a Basic Service, this aircraft was 5nm south-east of North Weald and the controller passed a squawk and was then involved in telling him that the aircraft was not displaying Mode C. At 1037:52, the Grob109 called on the frequency to report that he had just had a near miss with a Miles aircraft. The controller confirmed that there was a Miles on frequency and the Grob109 pilot said it was 'a very close near-miss' and he would call later to get more details, he then left the frequency. Figure 4 shows CPA as displayed on the Southend radar.
