**AIRPROX REPORT No 2019178**

Date: 03 Jul 2019 Time: ~1045Z Position: 4954N 00617W Location: 5nm NE St Mary's

**PART A: SUMMARY OF INFORMATION REPORTED TO UKAB**

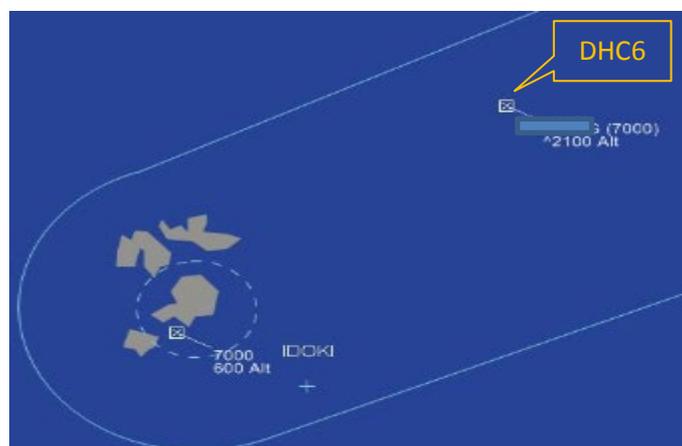
Figure 2 - 10:46.40

At 10:46.40 (Figure 2), the EC135 pilot was cleared for take-off, “[EC135 c/s], RW32, climbing initially to Altitude 1000ft, with a right turn out, cleared for take-off, surface wind 040/16 knots”. The pilot readback “32 climbing to 1000ft initially before right-hand turn out, copied the wind c/s”.

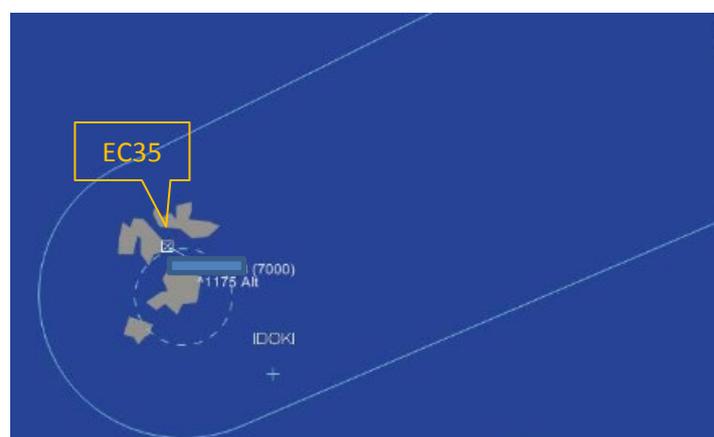
Figure 3 – 10:49.00 (DHC6 has faded from radar)

At 10:49.00 (Figure 3), the EC135 pilot reported “outbound in the climb 3000ft, QNH1026”. The controller passed traffic information, “opposite direction traffic is an Islander followed by a twin otter, at altitude 1500ft and 2000ft respectively”. The pilot responded that they had copied the traffic. The controller then addressed the BN2 and DHC6 pilots and asked, “[BN2 c/s] and [DHC6 c/s] did you copy the previously mentioned helicopter climbing?”. The DHC6 pilot responded with “roger” and the BN2 pilot responded with their callsign.

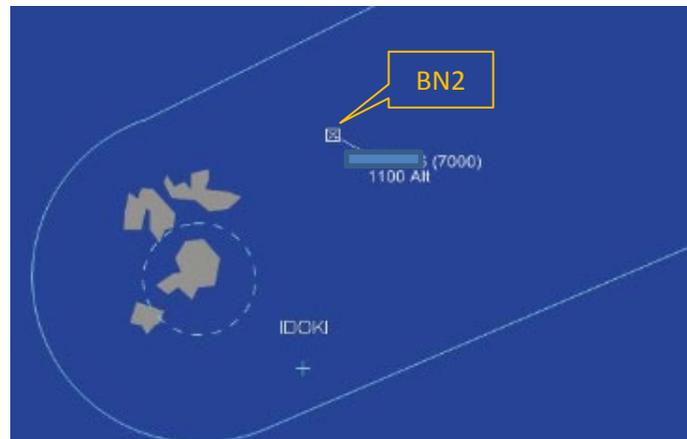
Figure 4 - 10:49.30 BN2 displayed, EC135 and DHC6 faded.  
DHC6 known to be ahead of the BN2

At 10:49.30 (Figure 4), the DHC6 and BN2 pilots were instructed to route initially toward Round Island and advised that there was traffic going-around from RW32. Both pilots acknowledged the instruction to route toward Round Island. Note: this would reduce the risk of the DHC6 and BN2 coming into conflict with the potential go-around aircraft from RW32 (that would subsequently be re-positioning for landing RW09) and would also route the DHC6 and BN2 further north of the EC135.

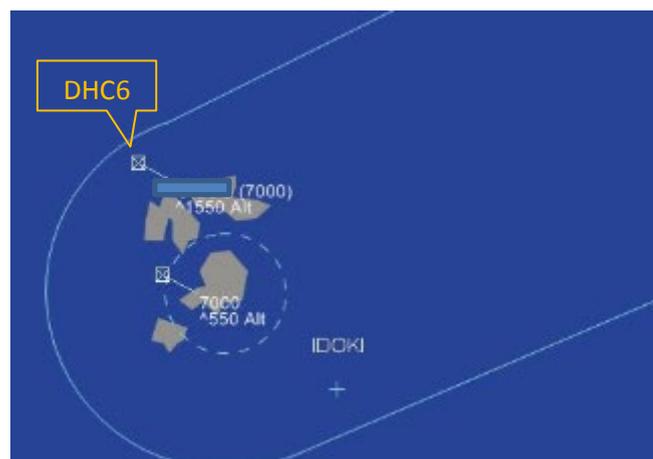
Figure 5 - 10:52.40

At 10:52.40 (Figure 5), the BN2 pilot reported at Round Island and still visual with the DHC6. The controller acknowledged the call from the BN2 pilot and then asked the DHC6 pilot to report their position. The DHC6 replied that they were also at Round Island and ready for base. The DHC6 pilot was instructed to report final No2.

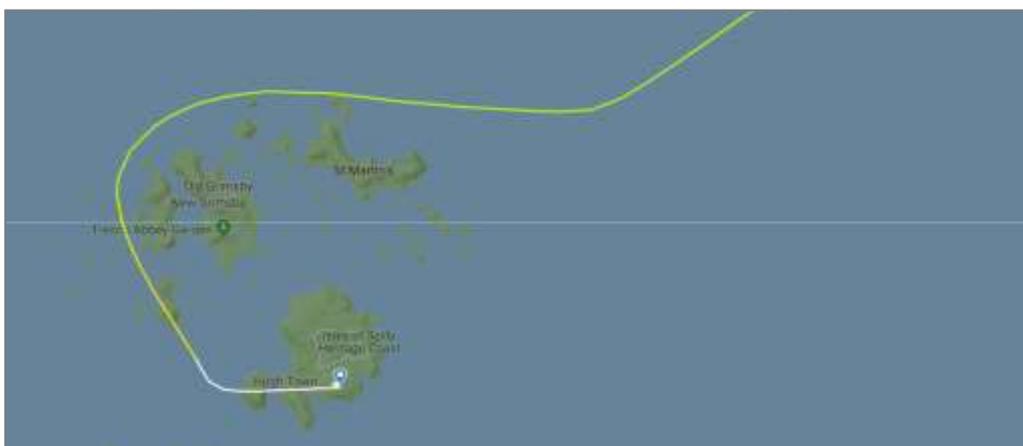
Figure 6: DHC6 Flight Track from Flightradar24

Whilst Flightradar24 data is unverified it shows the track of the DHC6 when they commenced the turn following the delaying action instruction after the Go-Around of the training flight on RW32, which is well outside of the ATZ. No data was available on the EC135 Helicopter.
