AIRPROX REPORT No 2019179

Date: 05 Jul 2019 Time: 1153Z Position: 5048N 00015W Location: W Seaford

PART A: SUMMARY OF INFORMATION REPORTED TO UKAB

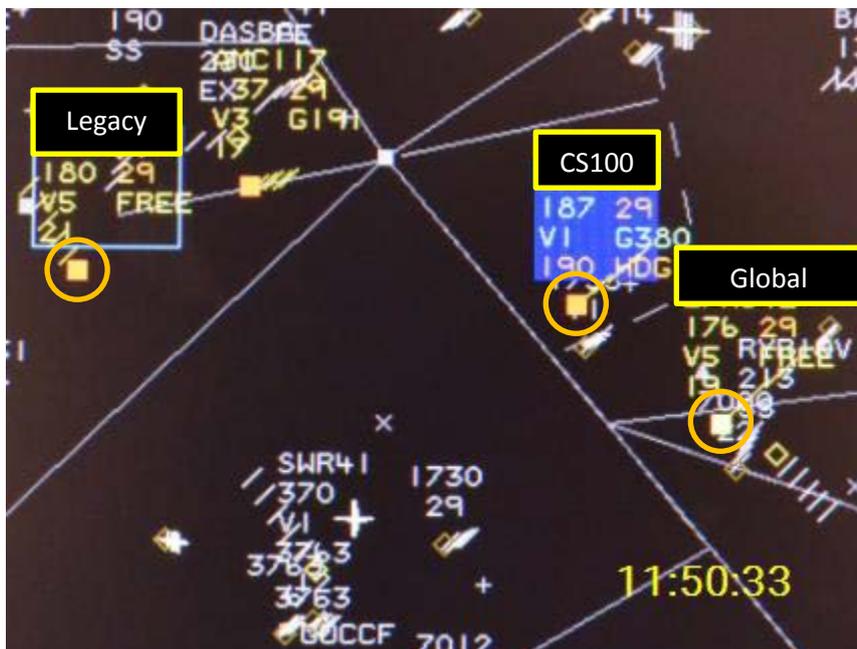
Figure 1.

The pilot of the CS100 reported on the S18 frequency at 1149:34 (all times UTC) and the S18 CT&P later instructed the pilot, at 1150:33 to climb to FL290 and to expedite the climb out of FL220. See Figure 1 for relative positions of the aircraft.

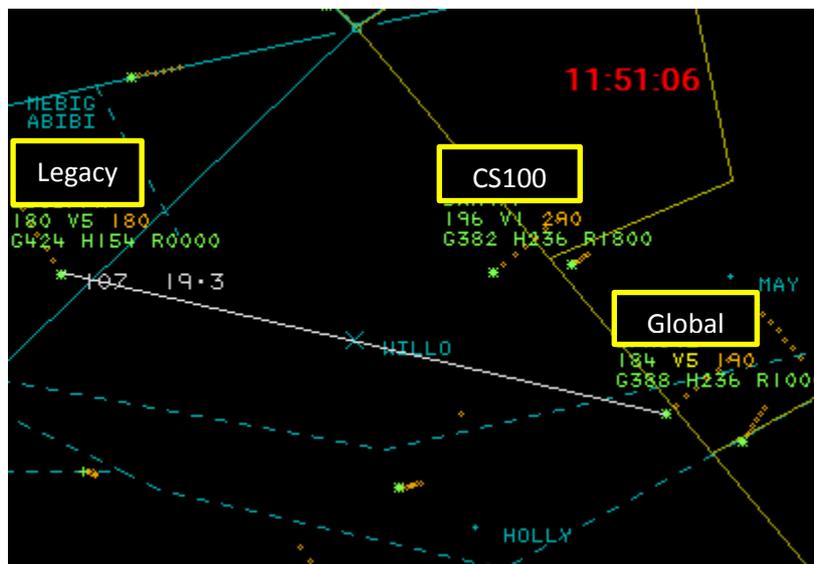
Figure 2.

At 1151:01, the S18 CT&P instructed the pilot of the CS100 to turn left onto 180°. The TC CAP controller telephoned S18 at 1151:06 (Figure 2), reference the Legacy stating “do you want him at nineteen (FL190), released for climb against that [CS100 C/S]” and the S18 CT&P responded “the [CS100 C/S] is going to miss him now, but nineteen is going to be better for me.” FL190 was coordinated for the Legacy.

The CS100 was positioned 4.8nm north of MAY (Figure 6), with no coordination effected by the TC BIG controller with the S18 controller. This positioning was to ensure that the aircraft remained clear of Heathrow and Gatwick arrivals from the south. The Global Express was not level by the S17/S18 boundary, (see Figure 2), again with no coordination effected with the S18 controller.

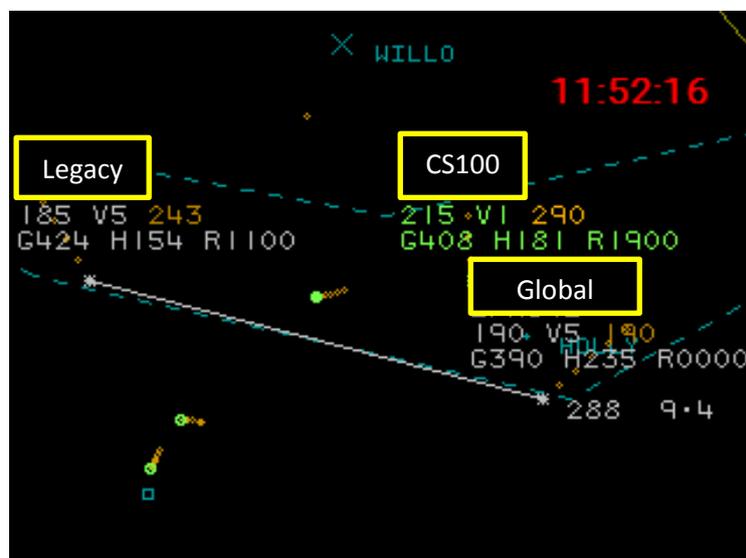
Figure 3.

During this R/T exchange low-level Short Term Conflict Alert (STCA) activated between the Global Express and the Legacy on the LAC radar display at 1152:10², prior to high-level STCA activating three seconds later. Immediately following the pilot readback, at 1152:16 (Figure 3) the S18 CT&P instructed the pilot of the Legacy “*Avoiding Action, turn right heading two-three-zero degrees*” which was correctly readback.

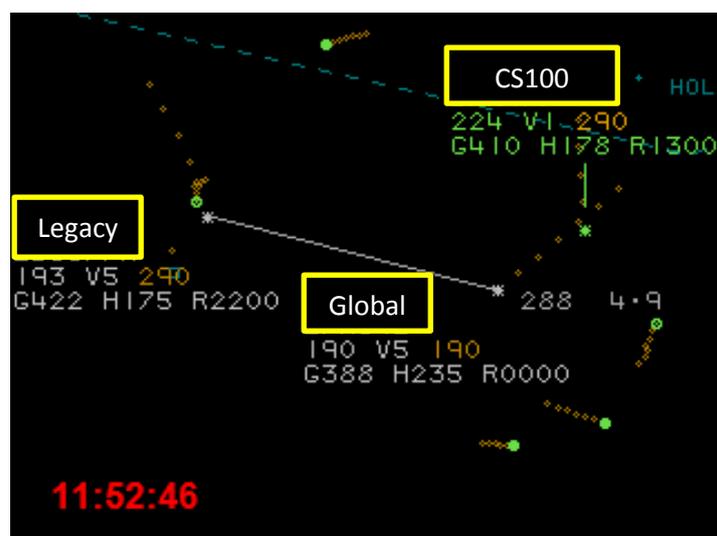
Figure 4.

Separation was eroded at 1152:46 (Figure 4).

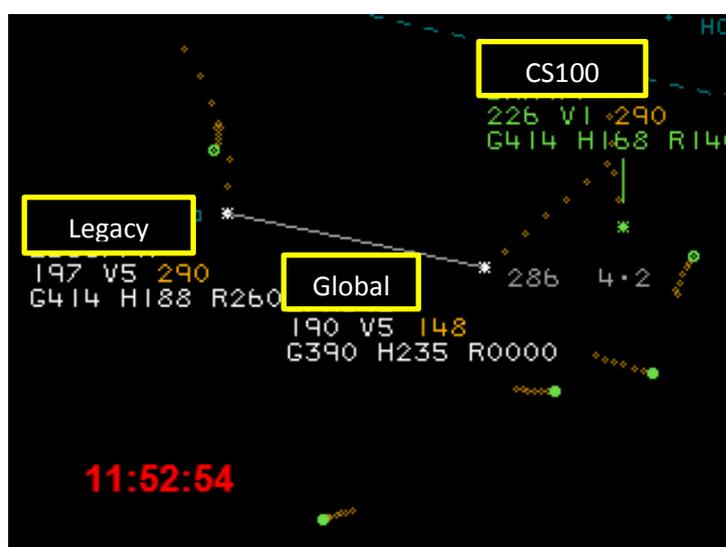
Figure 5.

Minimum separation occurred at 1152:54 (Figure 5), and was recorded on the LTCC Multi-Track Radar as 4.2nm and 700 feet.

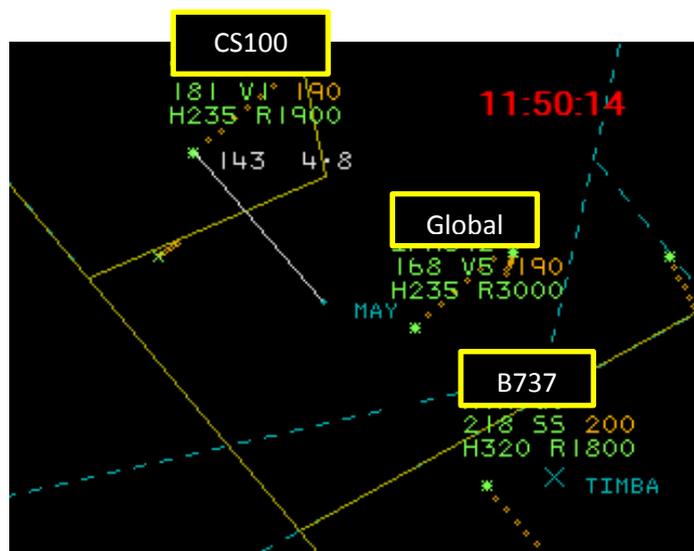
Figure 6.

Upon receiving the CS100 on frequency, the S18 CT&P could not initially issue further climb due to conflicting inbound traffic within S17 a B737 in the descent to FL200 (see Figure 6) and could not issue a left turn as a result of the Global Express.

The LAC Sector 17 Planner (S17 P) had highlighted the CS100 to the TC CAP controller in a telephone call at 1148:27 asking “*have South told you about that one*” and later in the discussion the TC CAP controller stated “*well I won't drop that inbound [B737 C/S]*” (shown in Figure 6). The TC BIG controller later notified the TC CAP controller of the CS100 by telephone.

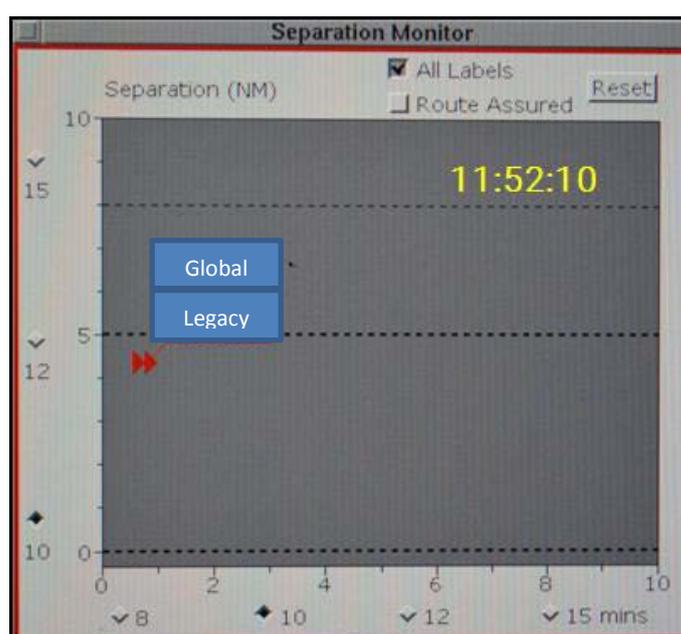
Figure 7.

The pilot of the Legacy reported on the S18 frequency at 1152:00 and was issued climb to FL290 and this clearance was input into iFACTS. A red interaction was subsequently displayed at 1152:10 indicating that iFACTS predicted 5nm separation would be eroded, see Figure 7 for S18 CT&P Separation Monitor (SM).
