## AIRPROX REPORT No 2019206

Date: 24 Jul 2019 Time: 1118Z Position: 5315N 00058W Location: Retford/Gamston Aerodrome

### PART A: SUMMARY OF INFORMATION REPORTED TO UKAB

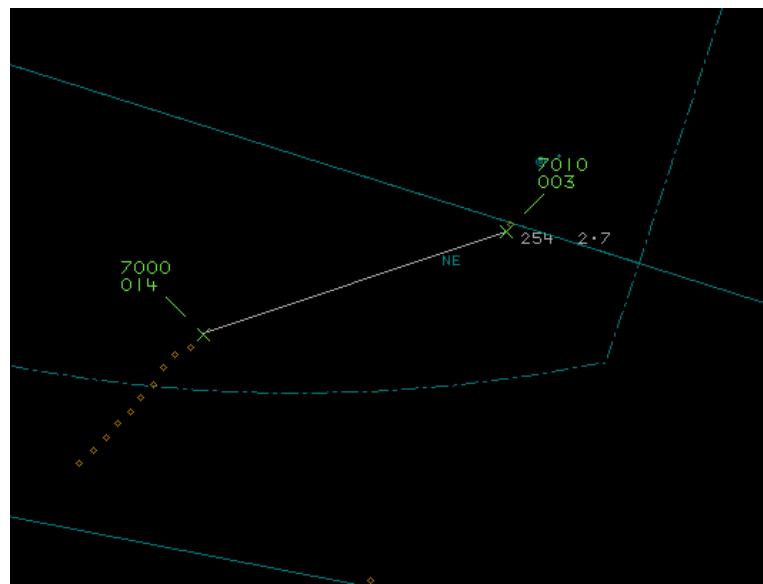
Figure 1 – 11:17:34

Both aircraft were detected by the NATS radars and the following screenshots show the relative positions of the aircraft as the incident unfolded. In Figure 1 below, the PA28 (7000) is about to enter the ATZ and the C152 (7010) is climbing out from its previous approach.

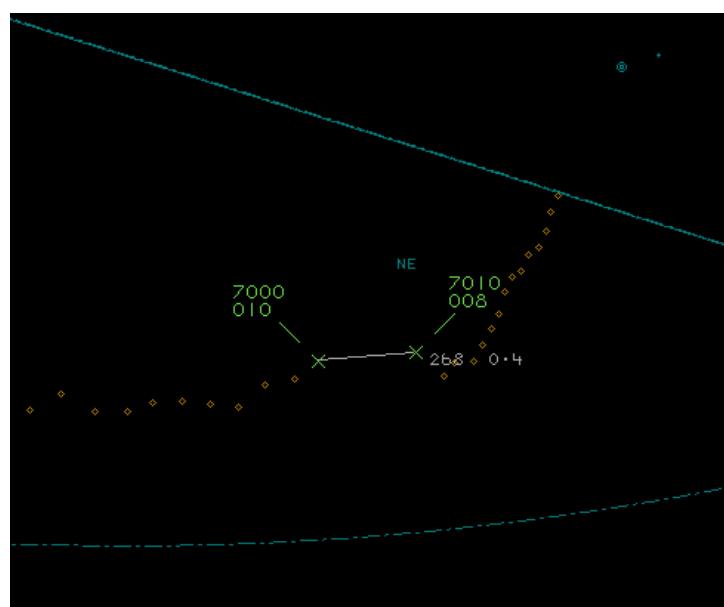
Figure 2 – 11:18:26

Figure 2 shows that the C152 has turned crosswind and is continuing to climb to circuit height while the PA28 is continuing inbound and descending to circuit height to join downwind.

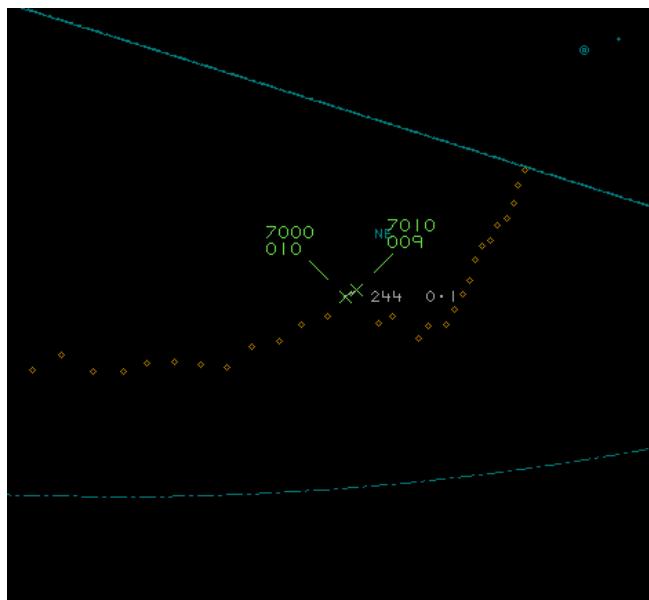
Figure 3 – 11:18:34

Figure 3 shows the final radar sweep prior to CPA. The separation between the 2 aircraft at this time is measured on the radar as 0.1nm.

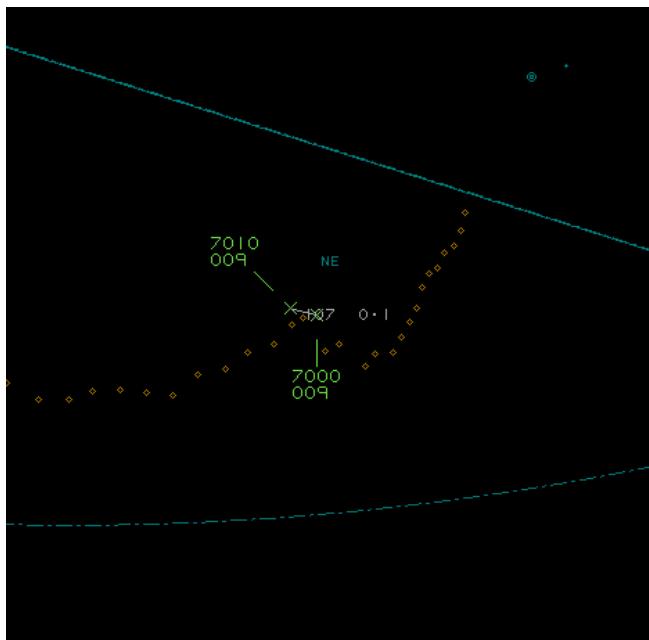
Figure 4 – 11:18:38

Figure 4 shows the first radar sweep after CPA. The separation between the 2 aircraft at this time is also measured on the radar as 0.1nm and, because the tracks have crossed between radar sweeps, the CPA is assessed as <0.1nm.
