AIRPROX REPORT No 2019209

Date: 26 Jul 2019 Time: 1612Z Position: 5332N 00240W Location: 1nm E MIRSI

PART A: SUMMARY OF INFORMATION REPORTED TO UKAB

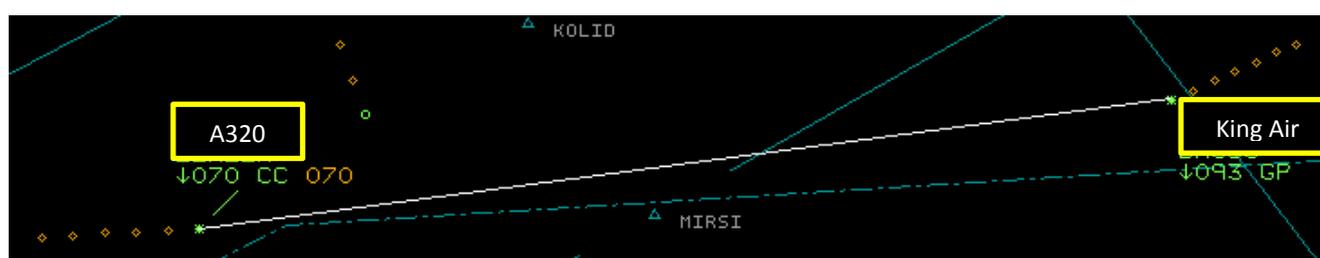
- 1609:53. The King Air pilot was instructed to descend to FL90
- 1610:41 (Figure 1). The King Air pilot was instructed to descend to FL80 (passing FL93 at the end of the instruction). This was read back correctly

Figure 1. 1610:43; King Air was cleared FL80.

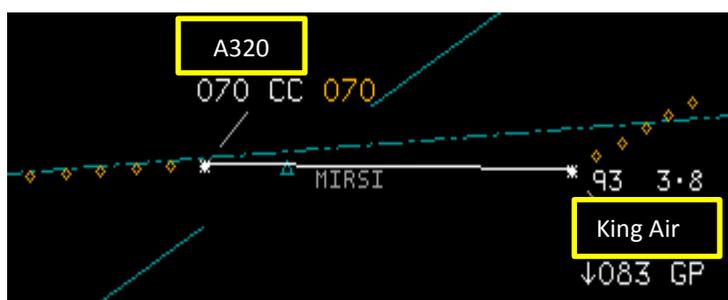
- 1611:34 (Figure 2). STCA activated with a low-severity alert
- 1611:47 (Figure 3). Radar replay indicates that the King Air descends below FL80.
- 1611:55 (Figure 4). Separation was lost as the King Air's Mode C indicated 300ft below the cleared level of FL80

Figure 2. 1611:34; STCA activated.

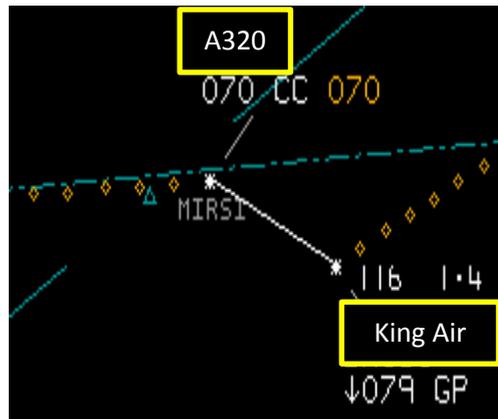
Figure 3. 1611:47; King Air indicated FL79.

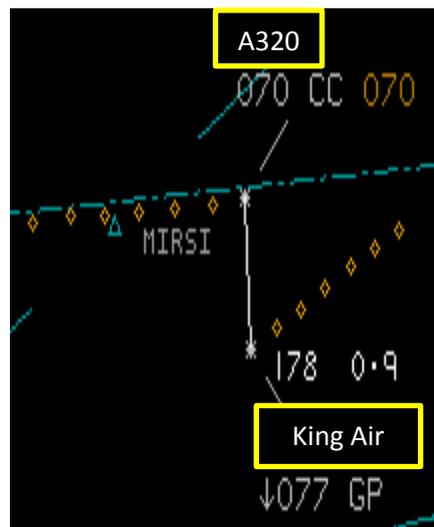
Figure 4. 1611:55 Separation lost as King Air's Mode C is outside the 200ft tolerance, indicating FL77.

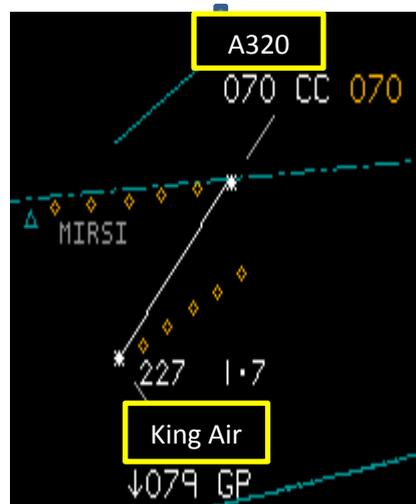
- 1612:03. Separation was regained as the King Air's Mode C indicated within 100ft of the cleared level
- 1612:11. STCA activation ceased
- 1612:18. The King Air pilot was instructed to descend to FL70

Figure 5. 1612:03 Separation regained as Mode C indicated within required tolerance (previous update also showed FL77).
