**AIRPROX REPORT No 2019242**

Date: 18 Jul 2019 Time: 1439Z Position: 5113N 00110W Location: ivo Popham

**PART A: SUMMARY OF INFORMATION REPORTED TO UKAB**

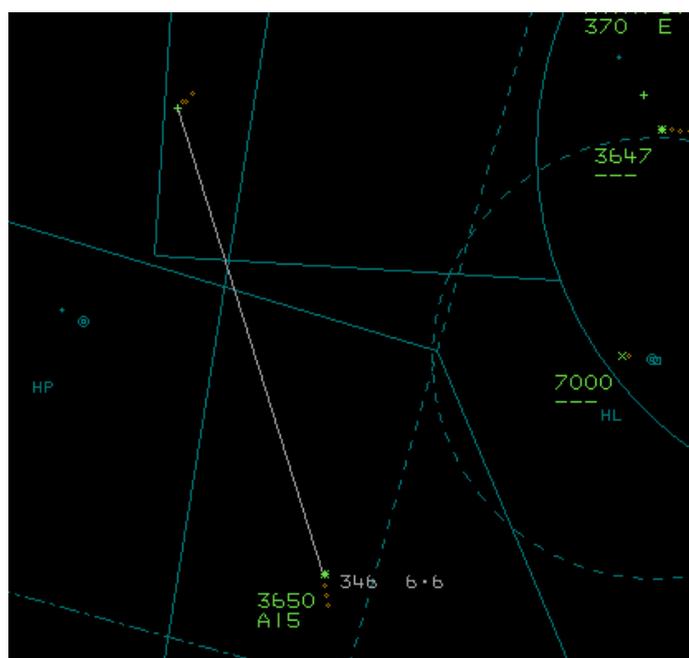
Figure 1 was timed at 1436:12 and corresponds with Odiham Approach passing Traffic Information on the traffic believed to be the incident glider and another Chinook departing Odiham. Separation at this point was 6.6nm.

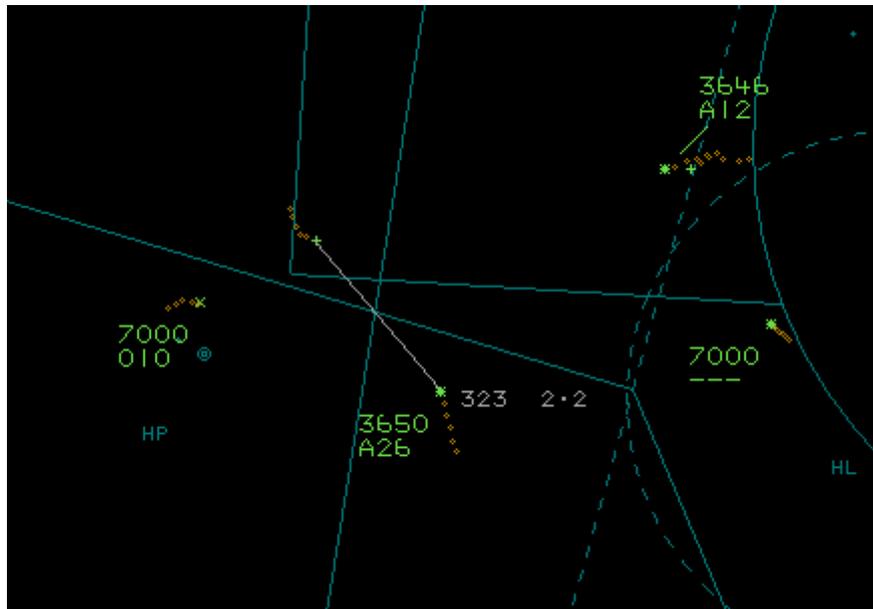
Figure 2

Shortly afterward, the Odiham Approach Controller noticed traffic which they believed was climbing out of Popham and passed this information to the Chinook who reported not being visual with this traffic. By this point, separation between the Chinook and primary contact had decreased to 2.2nm (Figure 2).

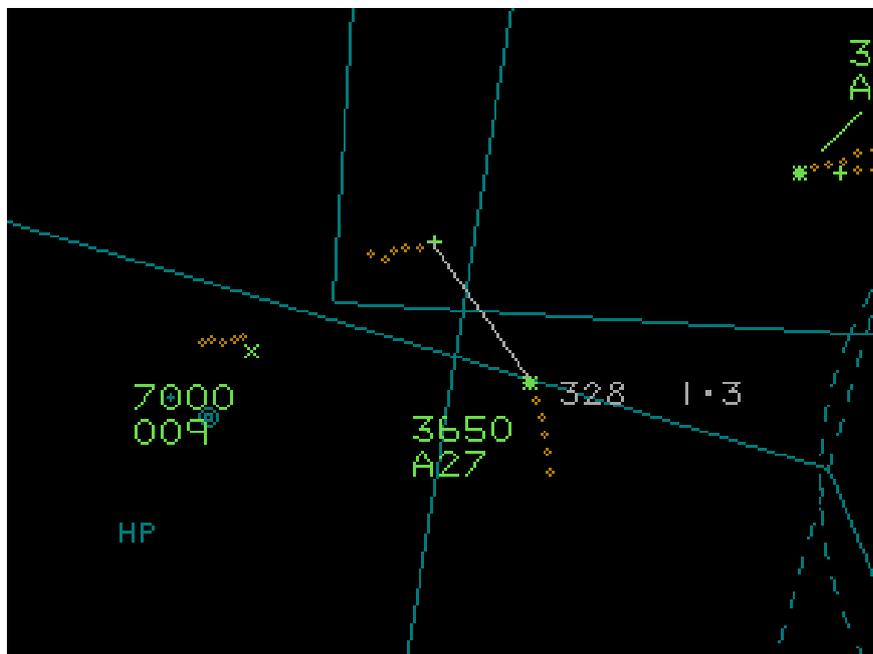
Figure 3

The Odiham Approach Controller passed updated Traffic Information to the Chinook at a range of 1nm (Figure 3). The Chinook pilot reported not being visual.

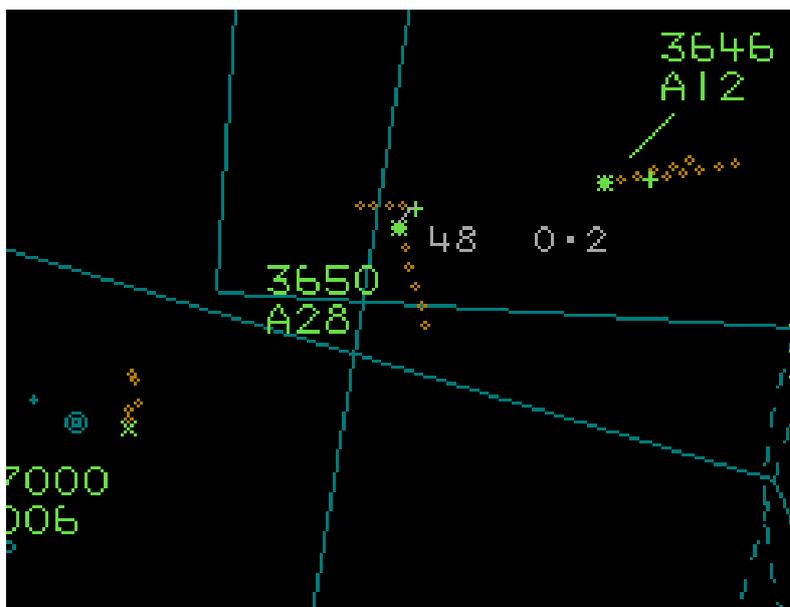
Figure 4 – CPA

CPA occurred 40sec after this final Traffic Information and was measured at 0.2nm (Figure 4).
