AIRPROX REPORT No 2019279

Date: 19 Sep 2019 Time: 1133Z Position: 5153N 00209W Location: Gloucestershire Airport

PART A: SUMMARY OF INFORMATION REPORTED TO UKAB

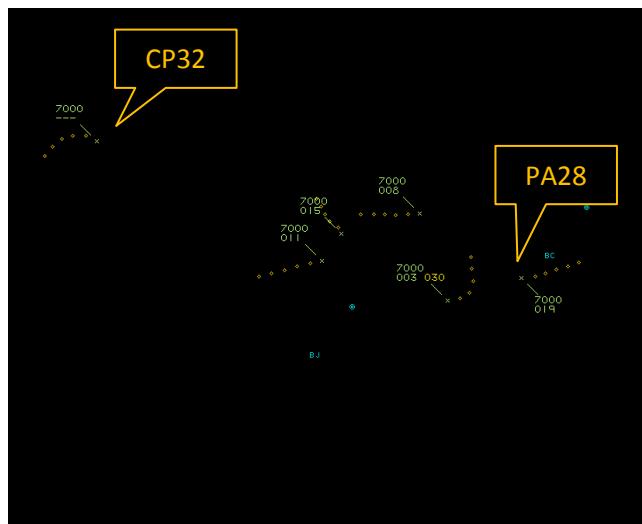
Figure 1 - 1127:20

At 1127:20, the PA28 pilot reported at 2nm, (he was actually 3nm east). The Approach controller instructed the pilot to *"take up delaying action to the south"*, advising that there would be a 2-minute delay for their join because the Tower was very busy. This was acknowledged by the pilot, and the radar contact believed to be the PA28 was observed commencing left-hand orbits. Three other aircraft were ahead in the circuit – one on final approach, one late downwind, one commencing the downwind leg, and one other aircraft joining the overhead from the north (Figures 1 & 2).

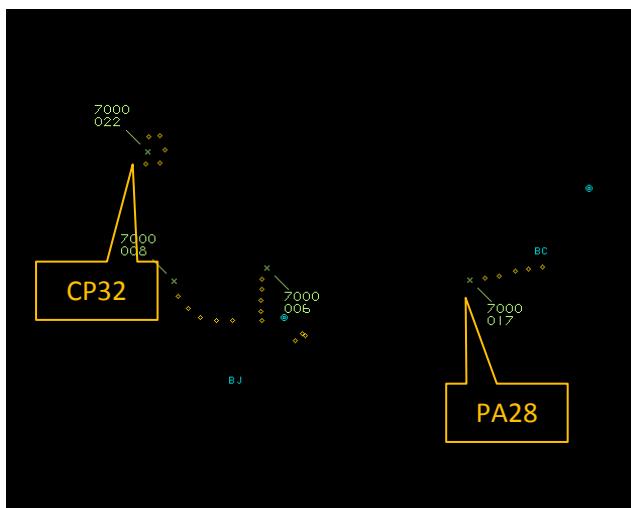
Figure 3 – 1130:52

At 1130:23, the CP32 was instructed by App to route towards the overhead, and to switch to the Tower frequency. At 1130:52 (Figure 3), the CP32 pilot reported inbound to the overhead. The Tower controller acknowledged this, instructing them to report the overhead before descending, and advising that they had further traffic for the overhead approaching from the south, (the PA28, which was actually approaching from the east). The Tower controller then passed reciprocal Traffic Information to the PA28 pilot on the CP32 advising that it was inbound from the north.

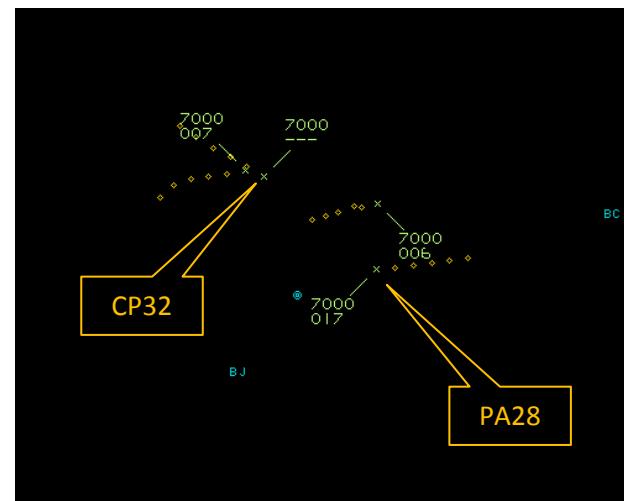
Figure 4 – 1131:58

At 1131:58 (Figure 4), the PA28 pilot reported in the overhead. The Tower controller instructed them to descend on the dead side and to report doing so, which was acknowledged by the pilot.

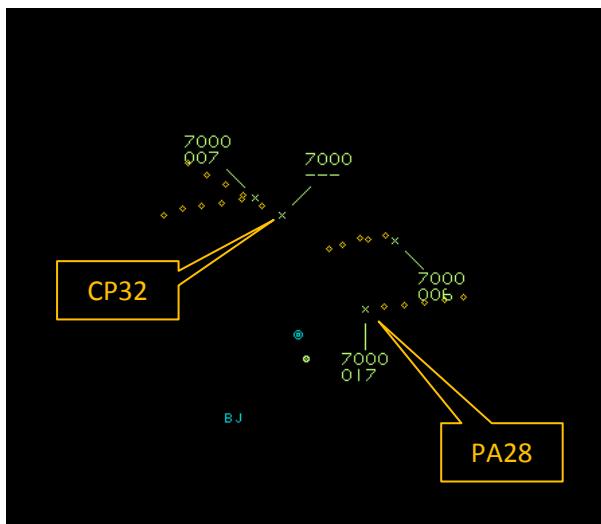
Figure 5 – 1132:10

At 1132:10 (Figure 5), the CP32 pilot reported in the overhead and advised that they were “visual with the traffic”. The Tower controller instructed the CP32 pilot to “follow him, report downwind, in fact, report descending on the dead side”, which was acknowledged. The CP32 was 1.3nm NW of the PA28 at this time.

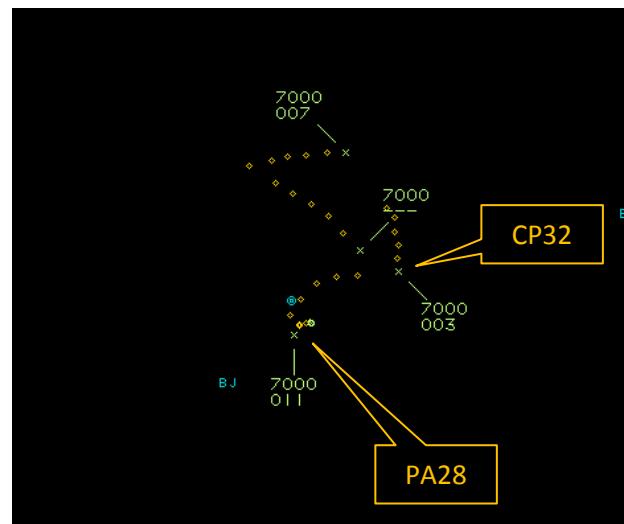
Figure 6 – 1132:48

At 1132:48 (Figure 6), the CP32 pilot advised “*descending dead side, the other aircraft's in a left hand turn on the dead side*”. The Tower controller acknowledged this and, at 1133:15, called the PA28 and requested a position report. The PA28 pilot reported that they were about to join downwind. The Tower controller advised “*I don't have you in sight but eh someone reported you're doing a left-hand pattern. It is a right-hand pattern for RW27, so just safely climb again towards the overhead and report ready to descend*”, which was acknowledged by the pilot. The aircraft were still 1.3nm apart at this stage.

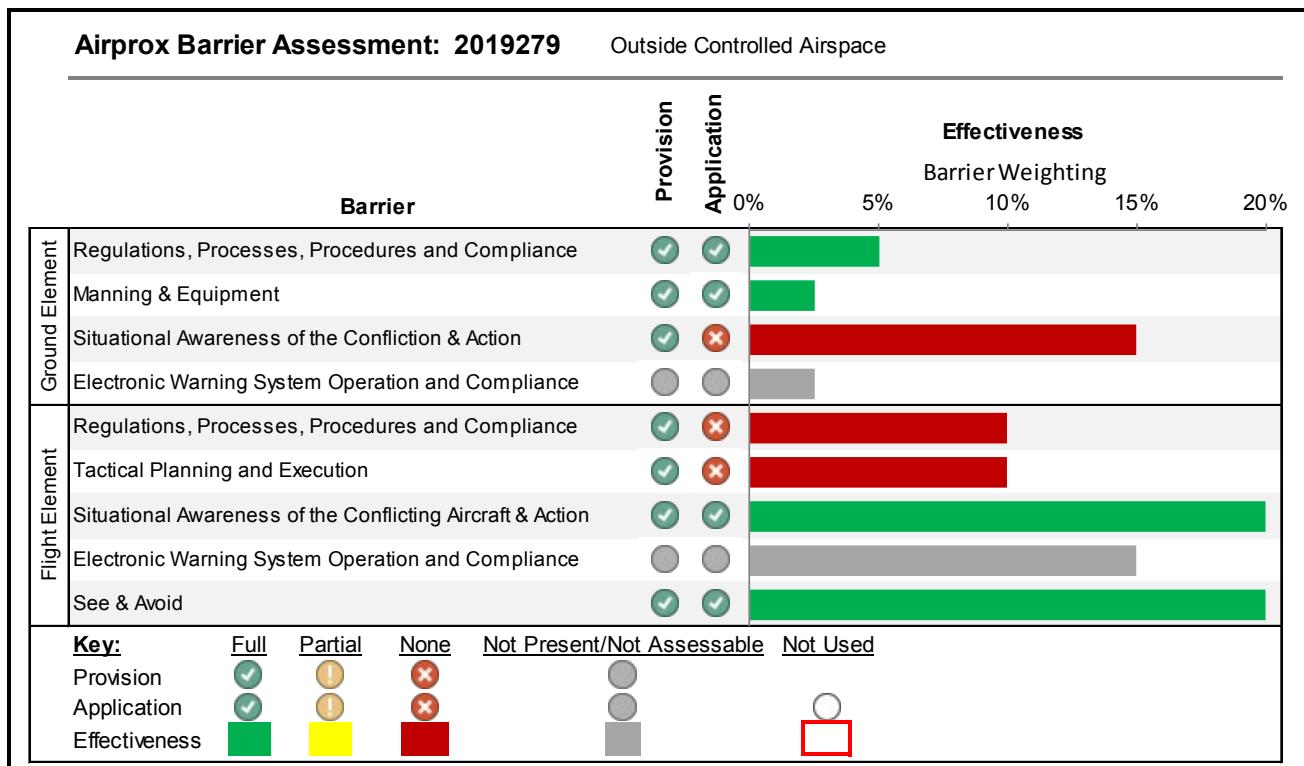
Situational Awareness of the Confliction and Action were assessed as **ineffective** because the controller did not identify the conflict because he could not see the PA28 turn the wrong way in the overhead.

Regulations, Processes, Procedures and Compliance were assessed as **ineffective** because the PA28 pilot did not follow the correct circuit direction when he joined.

Tactical Planning and Execution was assessed as **ineffective** because although the PA28 pilot was given the correct circuit information, he turned the wrong way.
