AIRPROX REPORT No 2019297

Date: 17 Oct 2019 Time: 1442Z Position: 5328N 00146W Location: Derwent Valley

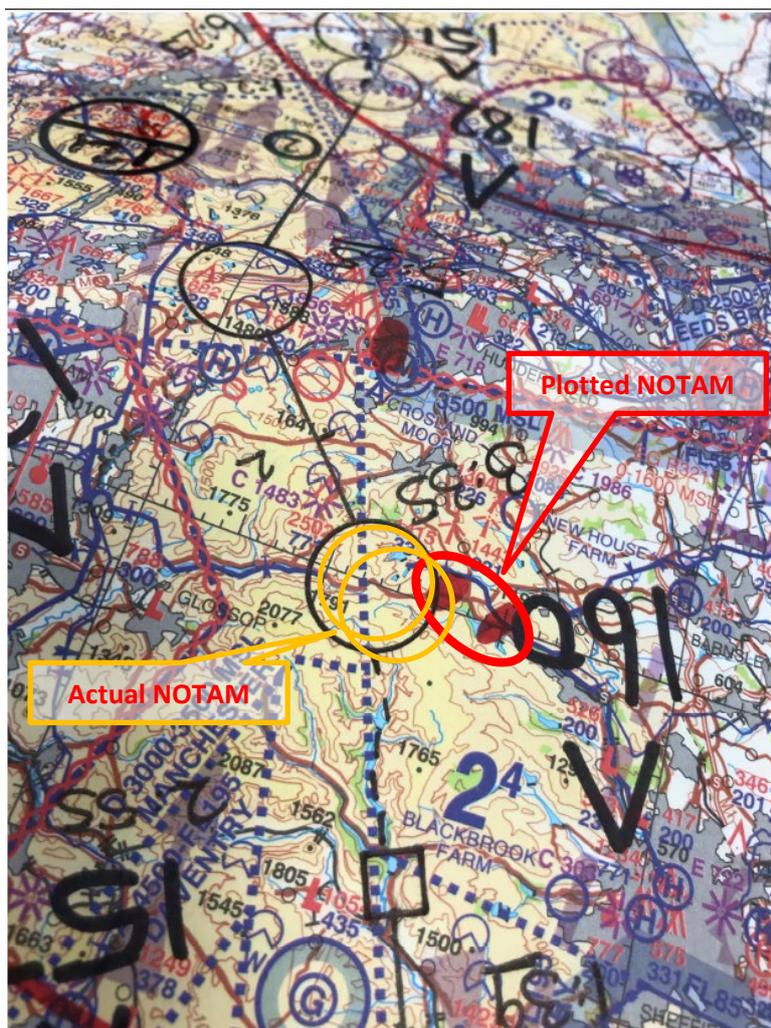
Figure 1 Prefect route planning showing NOTAM plotting on map

Route Planning. For the most part, Prefect navigation route planning is conducted on the Mission Planning System (MPS). This allows the crews to upload the route (as a series of waypoints) to the aircraft which provides steering information to them. If planning is undertaken on the day of the sortie, crews can overlay current NOTAM data on the MPS screen – NOTAM data cannot be loaded to the aircraft navigation system for display in-cockpit. If the route is flown at a later time, the NOTAM data must be refreshed. However, issues with the quality of the printed 'map' from the MPS mean that crews are directed to draw their route on legacy ½ mil maps for use in-cockpit. NOTAMs must then also be hand drawn onto the map, with most crews manually transposing the data from the MPS screen to the hand-drawn map –this air gap presents a clear opportunity for error and on the balance of probability, the NOTAM was incorrectly transposed from the screen to the legacy map on this occasion.

This Airprox was caused as a direct consequence of the Prefect crew mis-plotting the associated NOTAM and therefore flying closer to the MD500's location than planned. The thorough and comprehensive investigation made six recommendations to reduce the likelihood of a similar event happening in the future. To address the issue of the mis-plotting of NOTAMs, a review of the use of Mission Planning Software is underway to reduce the potential for transfer errors between the digital plan and hand-drawn charts. It has also been recommended that max operating height within a CANP NOTAM should be displayed as 'max operating height' and that a review of ground training lesson plans are undertaken to ensure that crew's understanding of NOTAMs, and CANPs in particular, is adequate. Further, it has been recommended that NOTAMs which detail CANP avoids clearly highlight CANP status and the additional avoid criteria requirement.

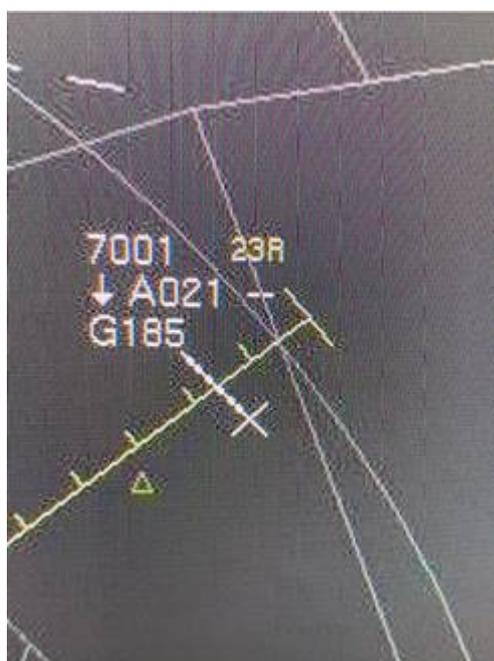
Figure 2- 1441:10

A NATS investigation found that at 1441z the MD500 pilot reported that he had just been passed 'very close' by a light aircraft that had directly overflown them whilst they were getting airborne for one of their underslung lifting tasks. He was unable to identify the traffic but reported it as a small, low-wing single-engine aircraft. He thought the same aircraft had overflown them about 90mins previously. A review of the radar showed that the helicopter was not visible on the radar, due to the low-level nature of the task in the foothills of the Pennines and therefore the Airprox was not visible to the controller. The helicopter was also often out of RT contact due to terrain shielding. At the time reported by the pilot, a 7001 squawk could be seen tracking southeast, indicating 2000ft altitude and remaining about 4nm east of the Manchester control zone (Figure 2). There was no requirement for the controller to pass Traffic Information because the MD500 was under a Basic Service and it was impossible for the controller to know whether the helicopter was airborne or not, or what its position was. The 7001 was unknown traffic to the controller, was not in contact with Manchester and remained outside CAS at all times, fading from radar 1min later.

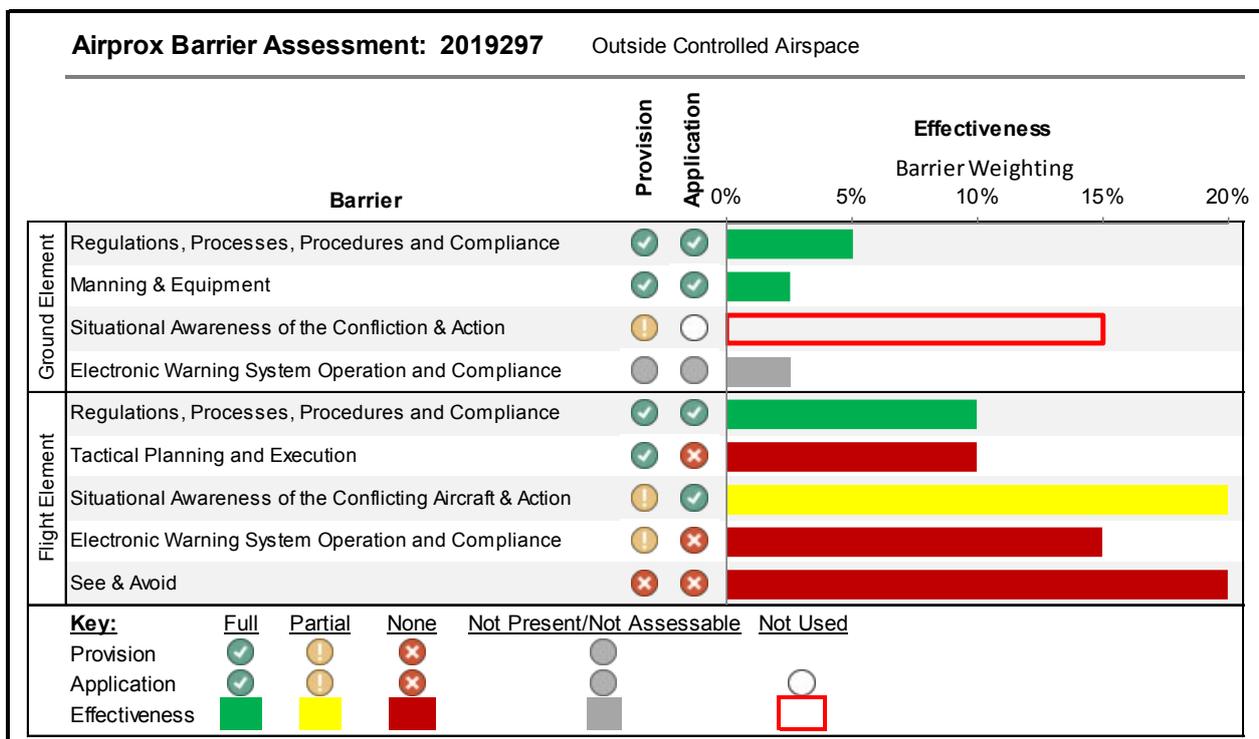
Tactical Planning and Execution was assessed as **ineffective** because the Prefect pilot mis-plotted the NOTAM.

Situational Awareness of the Conflicting Aircraft and Action were assessed as **partially effective** because the Prefect pilots were aware from the NOTAM that the MD500 was operating in the area.

Electronic Warning System Operation and Compliance were assessed as **ineffective** because the TAS in the Prefect did not alert as expected.

See and Avoid were assessed as **ineffective** because neither pilot saw the other aircraft in time to take avoiding action.
