AIRPROX REPORT No 2019313

Date: 13 Nov 2019 Time: 1159Z Position: 5159N 00222W Location: 1nm west of Berrow

PART A: SUMMARY OF INFORMATION REPORTED TO UKAB

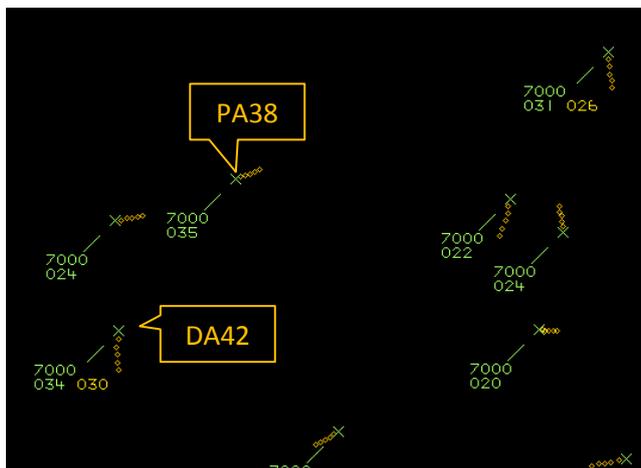
Figure 1 – 1157:00

An Airprox with a PA38 was reported by the pilot of a DA42, whilst both were operating in an area to the northwest of Gloucestershire Airport. Both pilots reported that they were receiving a Basic Service from Gloster Approach. Only the DA42 could be positively identified on the radar replay. Figures 1-4 show the tracks of both aircraft up to and subsequent to CPA, which occurred at 1158:40.
