AIRPROX REPORT No 2019330

Date: 05 Dec 2019 Time: 1012Z Position: 5046N 00150W Location: Bournemouth

PART A: SUMMARY OF INFORMATION REPORTED TO UKAB

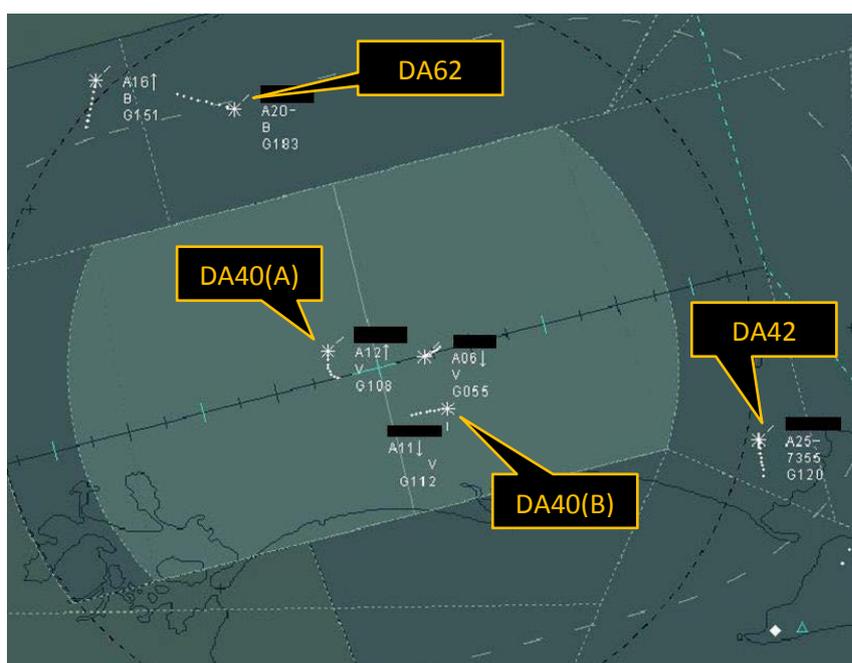
Figure 1 – 1010:00

In addition to the two Airprox DA40s, the Bournemouth Tower controller had another DA40 in the circuit, a DA62 inbound from the north and a DA42 inbound from the south-east for an ILS approach. At 1010:00 DA40(B), reported downwind left-hand (Figure 1).

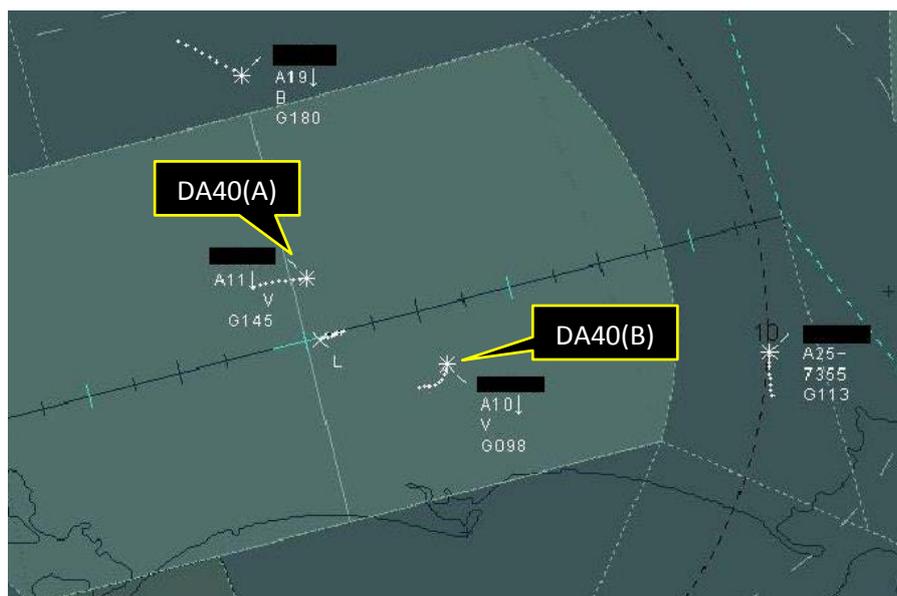
Figure 2 – 1011:54

The controller was dealing with a number of vehicular movements on the airfield and one aircraft ground movement when, at 1010:20, the radar controller pre-noted the DA62 from the north and the DA42 on a 13-mile final. At 1011:00, the DA62 pilot called the Tower controller and was instructed to report right-base and advised that the right-hand circuit was active. The controller then passed Traffic Information on the DA62 to the DA40(A) pilot who had turned downwind right-hand. The pilot acknowledged this, although their transmission was distorted. The controller asked the pilot if they could try their second radio, which was acknowledged. At 1011:25, the DA40(B) pilot reported ready for left-base and was instructed by the controller to report final, which was acknowledged. At 1011:54, the DA40(A) pilot reported downwind right-hand for a touch-and-go. The controller advised them that they were No2, and that No1 was a DA40 turning onto left-base about 2 miles to the south-east. The controller asked the DA40(A) pilot to report if they became visual (with DA40(B)), which was acknowledged (Figure 2).

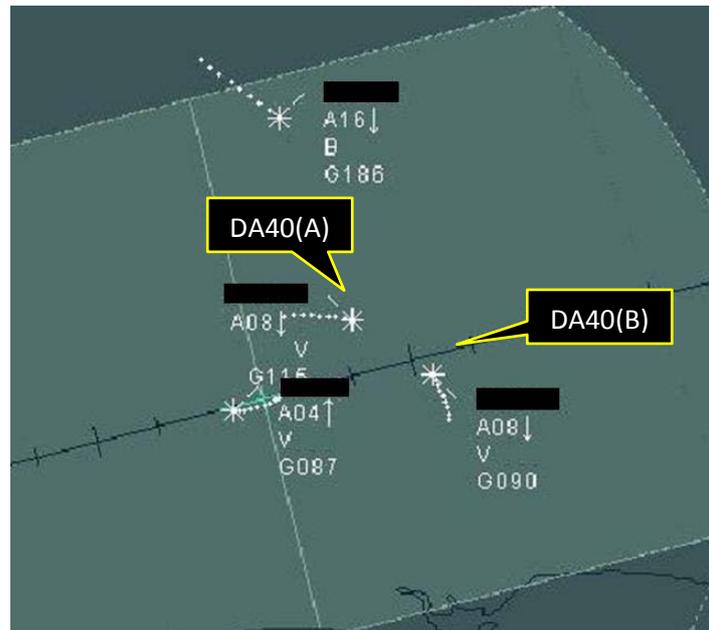
Figure 3 – 1012:33

The controller was then occupied with two groups of vehicles crossing the runway. At 1012:33, the controller advised the DA62 pilot that they were “No3 in traffic, No2 is in your 1 o’clock at about 3 miles downwind”. They then continued the transmission without a break, calling the DA40(A) pilot and instructing them “not too tight downwind - you’re turning inbound confirm?”. The DA40(A) pilot replied “Wilco” (Figure 3).

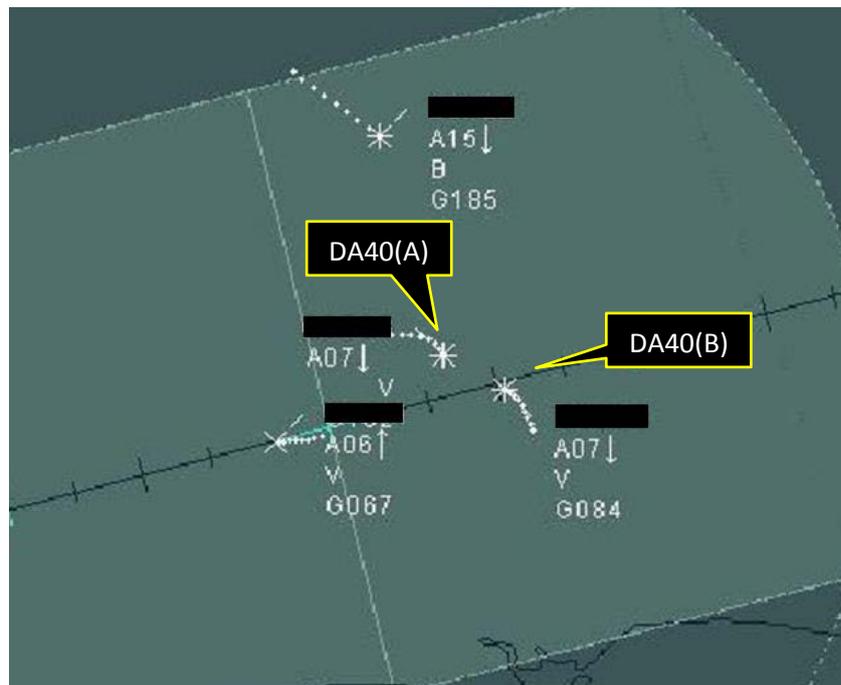
Figure 4 – 1012:47

At 1012:47, the controller instructed the DA40(A) pilot “(incomplete abbreviated callsign) turn right, (abbreviated callsign) turn right now, you’re in front of another aircraft turning onto final. You’re No2 to that aircraft. Are you visual?”. The DA40(A) pilot advised “traffic not sighted”. (Figure 4).

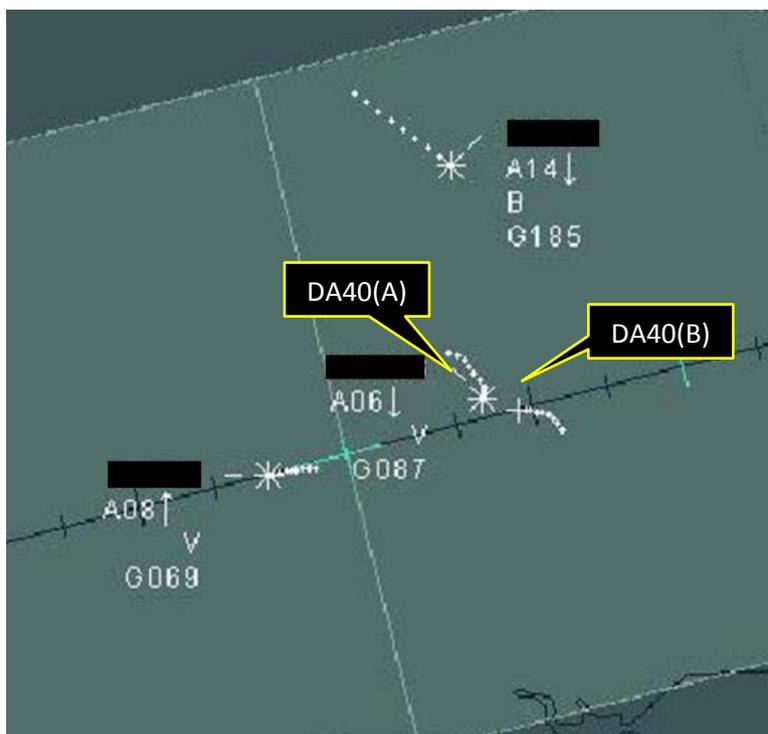
Figure 5 – 1012:58 CPA

Then, at 1012:58, the controller instructed the DA40(B) pilot “(abbreviated callsign) er turn left immediately” which was acknowledged. It is estimated that this was the point of CPA, with the aircraft separated by less than 0.5NM and 100ft (Figure 5).
