AIRPROX REPORT No 2019015

Date: 25 Jan 2019 Time: 1602Z Position: 5152N 00209W Location: Gloucestershire ATZ

PART A: SUMMARY OF INFORMATION REPORTED TO UKAB

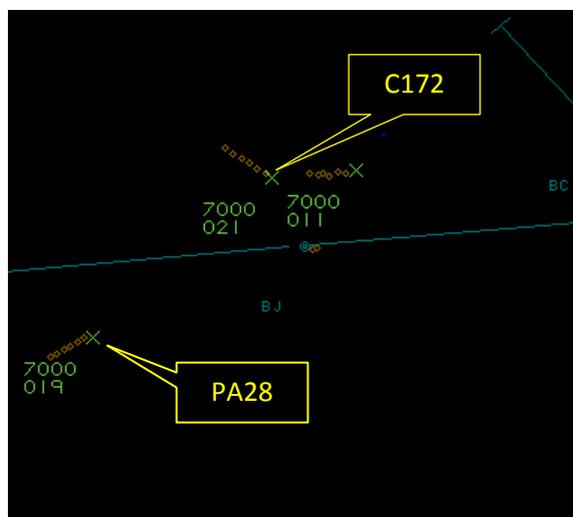
Figure 1 - 1600:31

The C172 pilot reported 3nm to run at 1559:10 and was instructed to report descending deadside. At 1600:31 (Figure 1), the PA28 pilot reported 3nm to run and was advised to report downwind left-hand RW27. At 1601:18 (Figure 2), the C172 pilot reported descending deadside and was instructed to report downwind.

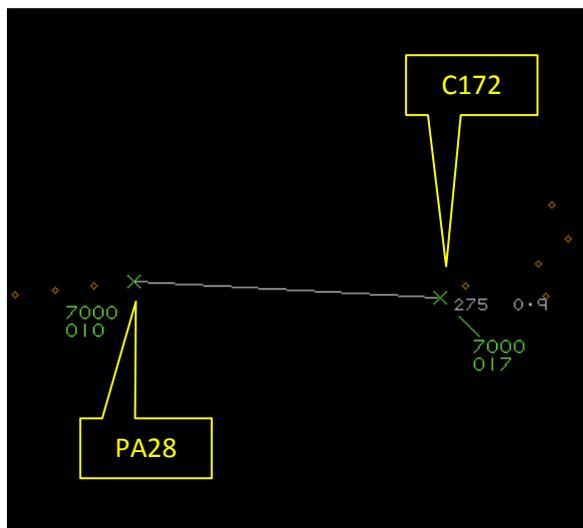
Figure 3 - 1602:10

At 1602:10 (Figure 3), the PA28 pilot reported downwind left-hand RW27, to land. The pilot was instructed to report before turning base. CPA occurred at 1602:27 (Figure 4), with the aircraft separated by 0.1nm laterally and 300ft vertically.

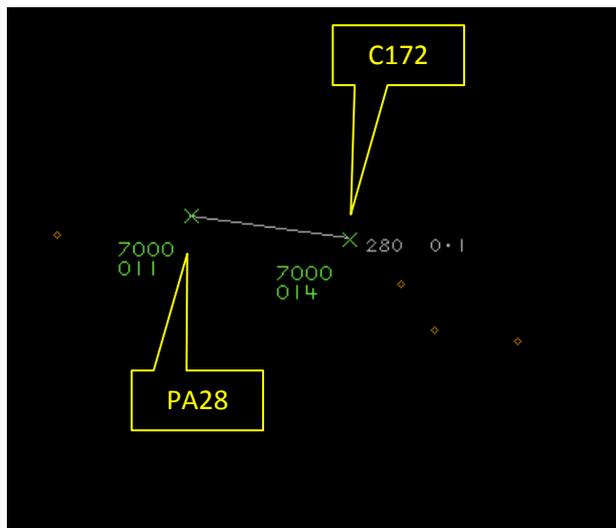
Figure 4 - 1602:27

When assessing the risk, the Board agreed that it had been fortuitous that the two aircraft had had 300ft separation because neither pilot had assimilated that there would be a conflict. However, because avoiding action was not necessary, they agreed that although safety had been degraded, there was no risk of collision; risk Category C.

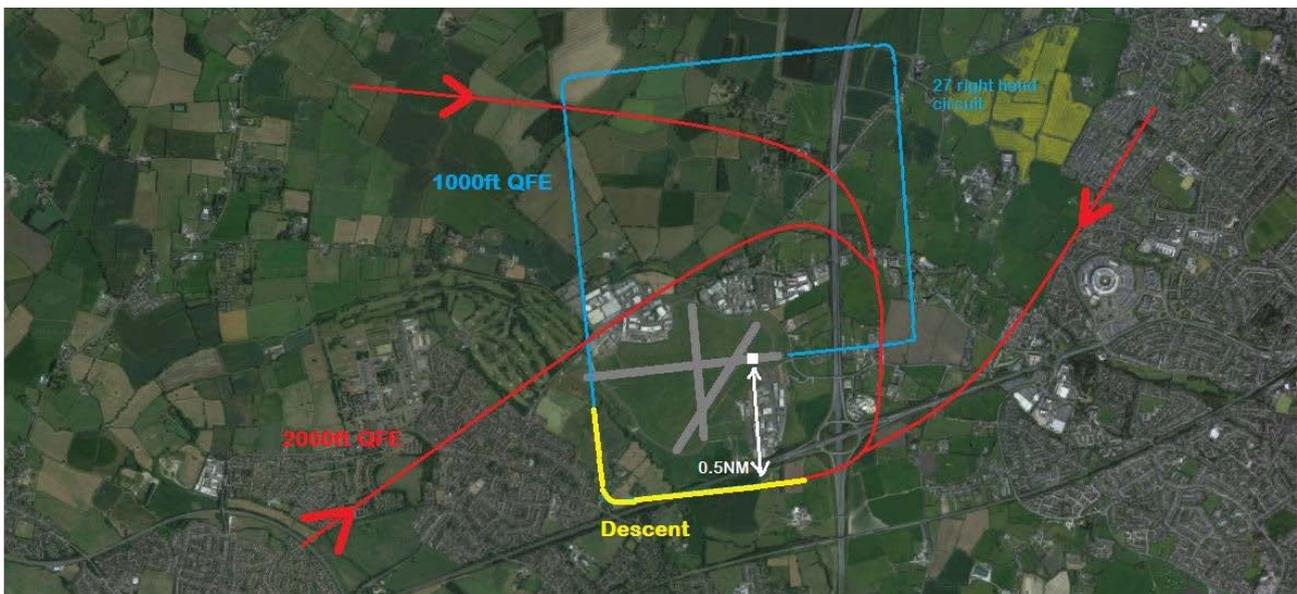
The picture below shows three typical overhead joining profiles for a right-hand circuit on Runway 27. The blue circuit phase is simply indicative, its shape and size will depend on other traffic:

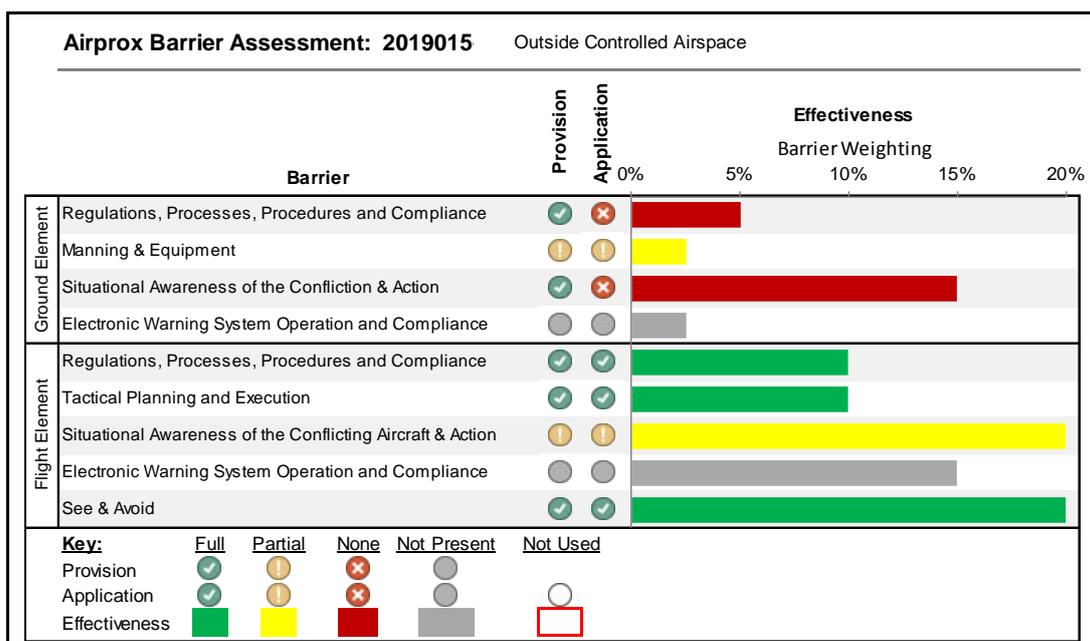
In assessing the effectiveness of the safety barriers associated with this incident, the Board concluded that the key factors had been that:

Regulations, Processes, Procedures and Compliance were assessed as **ineffective** because ATC should have integrated the 2 aircraft and provided Traffic Information.

Manning and Equipment were assessed as **partially effective** because the ATM in the tower was unserviceable.

Situational Awareness and Action were assessed as **ineffective** because the ADC did not foresee the confliction and did not give Traffic Information to the pilots.

Situational Awareness and Action was assessed as **partially effective** because although there was generic Traffic Information available from the RT due to both pilots being on the same frequency, neither pilot fully assimilated that the other would be a factor.
