AIRPROX REPORT No 2019036

Date: 25 Feb 2019 Time: 1413Z Position: 5044N 00208W Location: 11nm WSW Bournemouth

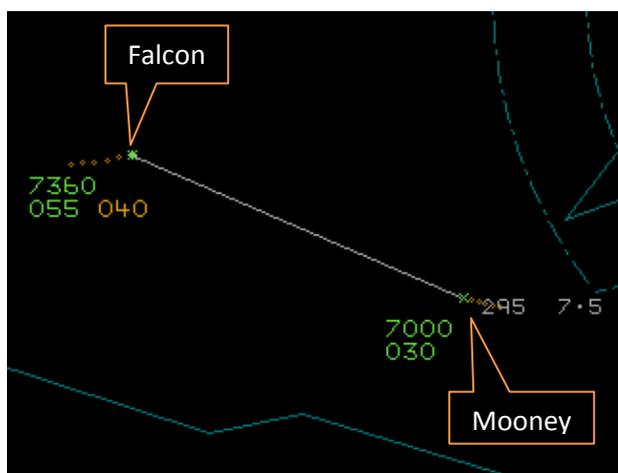
Figure 1 - 1411:00

At 1411:00 (Figure 1), the controller passed Traffic Information to the Falcon pilot on the Mooney, advising them that there was traffic that may possibly cross their track, in their one o'clock, range of 5 miles, at 3600ft, northbound and fairly slow moving. The pilot responded that they had the traffic on TCAS and were looking.

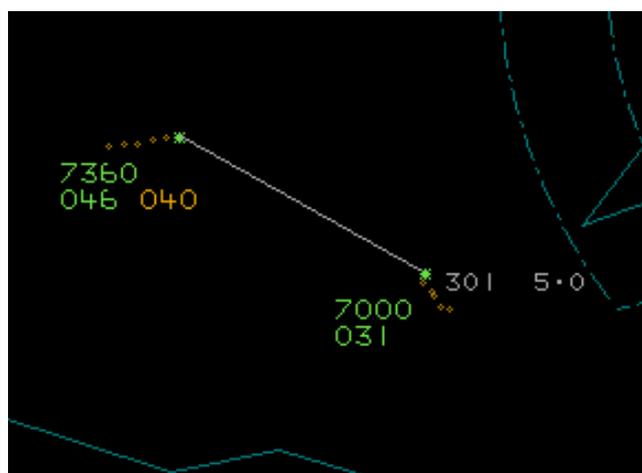
Figure 2 - 1411:30

At 1411:30 (Figure 2), the controller made a blind R/T broadcast addressed to the callsign of the Mooney, warning the pilot that there was jet traffic in their 10 o'clock, 3 miles, 4900ft, routing straight into Bournemouth RW08 from the west, going to descend through their level and cross ahead. The controller then repeated that there was jet traffic to cross ahead left to right. There was no response.

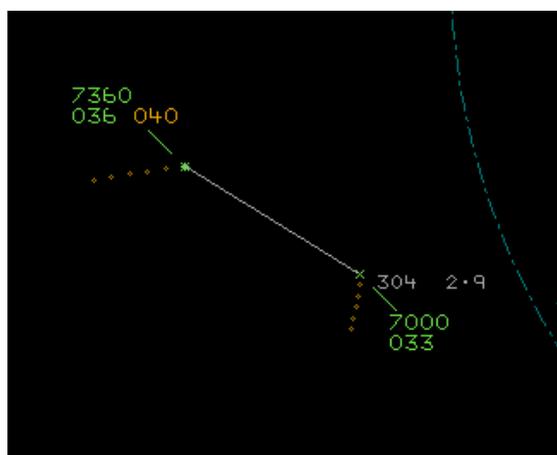
Figure 3 - 1412:00

At 1412:00 (Figure 3), the controller updated the Traffic Information to the Falcon pilot, advising him that the traffic was now 1 o'clock, 2 miles, 3900ft northbound. The pilot responded with "Roger". The controller then advised the pilot that if they wished to descend further they could descend to altitude 2500ft, at their discretion, and that the traffic was at 4000ft. The Falcon pilot responded that he would descend to altitude 2500ft.

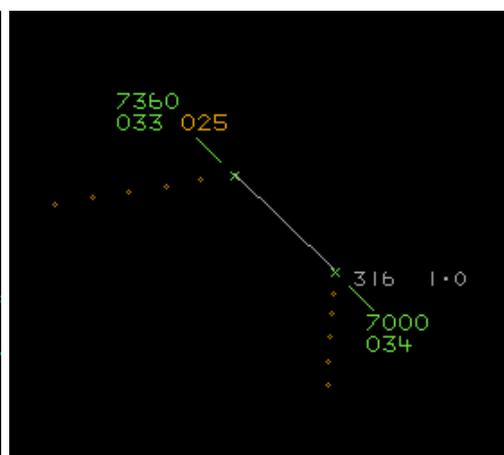
Figure 4 - 1412:30

At 1412:30 (Figure 4), the Falcon pilot advised the controller that they had received a TCAS RA. The controller responded by updating the Traffic Information to 1 o'clock, half a mile, 4000ft. The pilot responded that they were visual and following the TCAS RA.

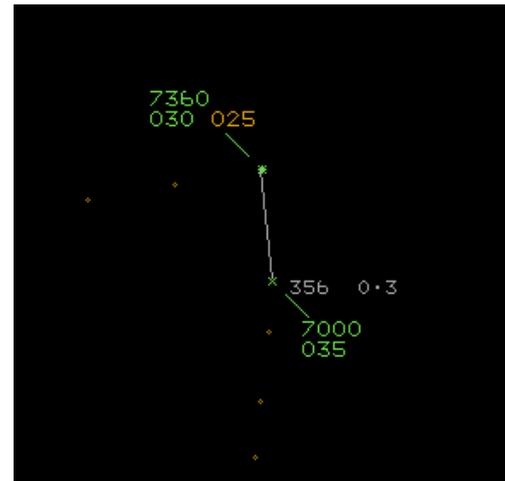
Figure 5 - 1412:39

CPA occurred at 1412:39 (Figure 5), with the aircraft separated by 0.3nm laterally and 500ft vertically.
