AIRPROX REPORT No 2019049

Date: 28 Mar 2019 Time: 1001Z Position: 5127N 00338W Location: Ogmore by Sea

PART A: SUMMARY OF INFORMATION REPORTED TO UKAB

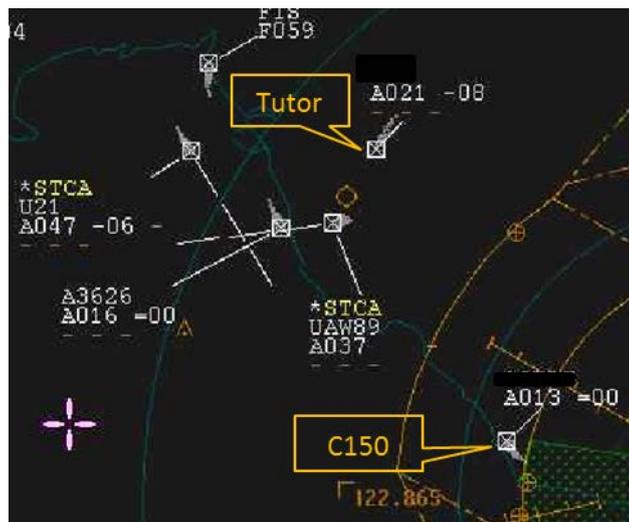
Figure 1 0957:20

At 0957:20 (Figure 1), the Tutor pilot called the Cardiff controller advising that their detail was complete. They were cleared for a standard Nash Point recovery. The pilot readback standard Nash Point recovery not above altitude 1500ft.

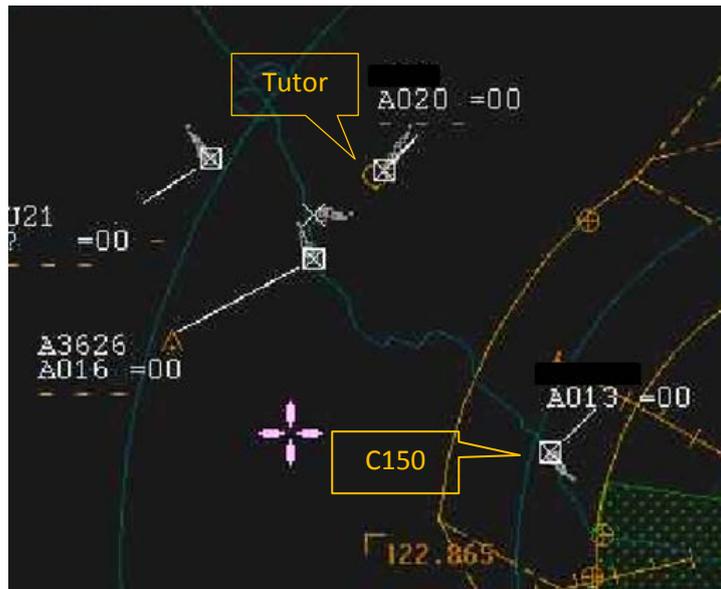
Figure 2 - 0958:10

At 0958:10 (Figure 2), the controller asked the pilot of a third aircraft (transponder code 3626) if they were recovering and established that this aircraft was approaching Porthcawl recovering to St Athan. The controller issued a standard Nash Point arrival clearance not above altitude 1500ft and passed Traffic Information on the C150 as *“traffic outbound from Nash routing along the coast”*. The pilot responded that they would keep a good lookout for traffic and be not above height 1500ft.

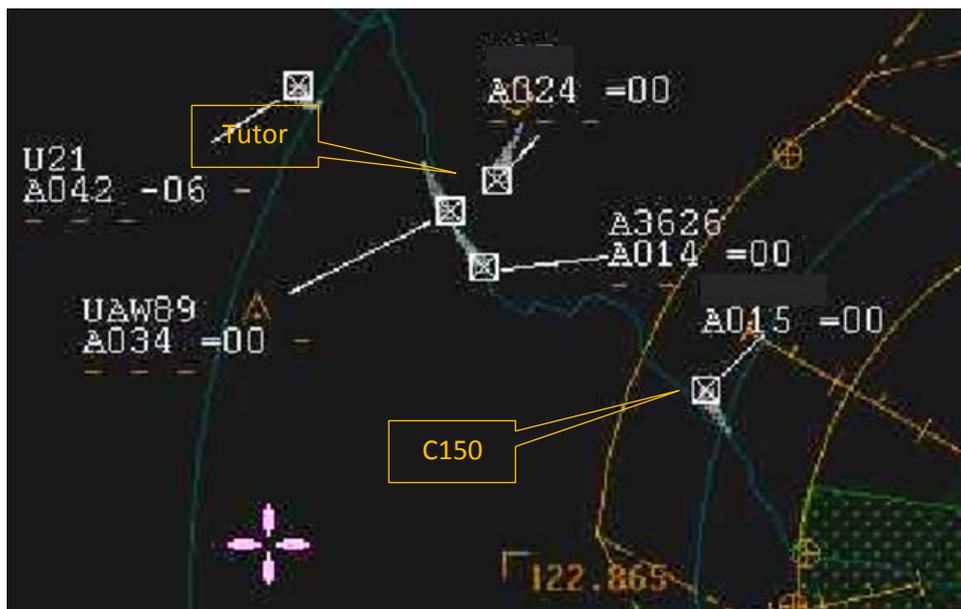
Figure 3 - 0959:00

At 0959:00 (Figure 3), the controller advised the C150 pilot to keep a good lookout as they routed along the coast as there was a couple of aircraft recovering back to St Athan, at 1500 and 2300ft. The pilot responded that they were looking.

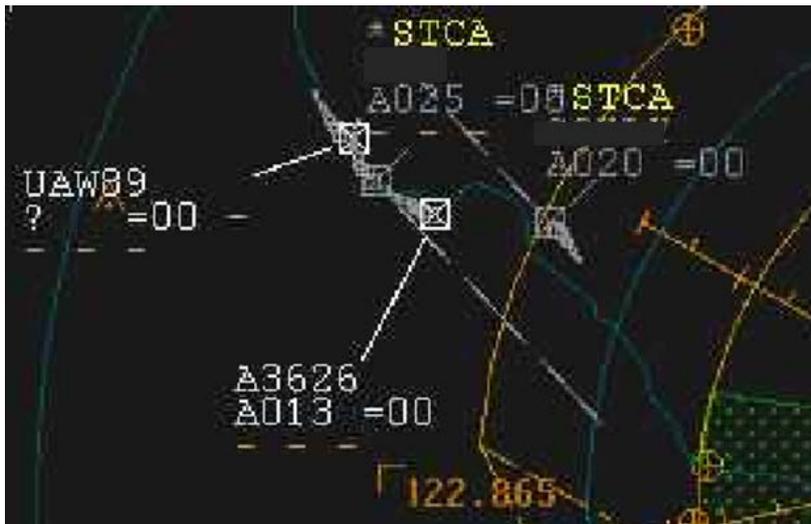
Figure 4 1000:10

At 1000:10 (Figure 4), the controller passed Traffic Information to the Tutor pilot advising them that a Tobago had departed St Athan outbound via Nash Point and advised that the third aircraft (SSR 3626) was ahead of them by about half a mile. The Tutor pilot responded that they had copied the traffic and had the third aircraft in sight. The STCA alerted between the C150 and the Tutor.

At 1000:30 the Tutor pilot advised that they were faster than the one ahead and requested a non-standard join not above altitude 2000ft. This was approved by the controller.

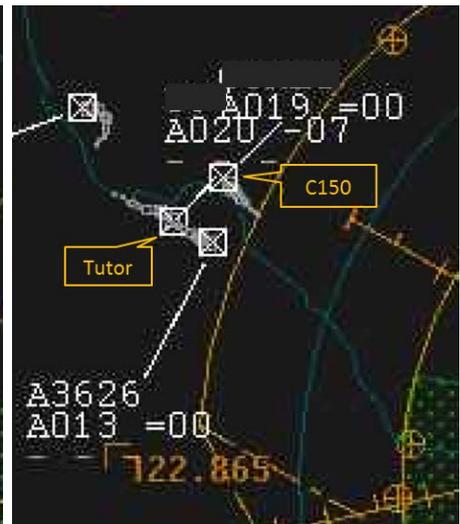
Figure 5 - 1001:10

At 1001:10 the aircraft passed each other on the left-hand side with 100ft vertical separation. ATSI were unable to measure the lateral distance between the two aircraft but Cardiff ATC reported the separation as 1.3nm (Figure 5).

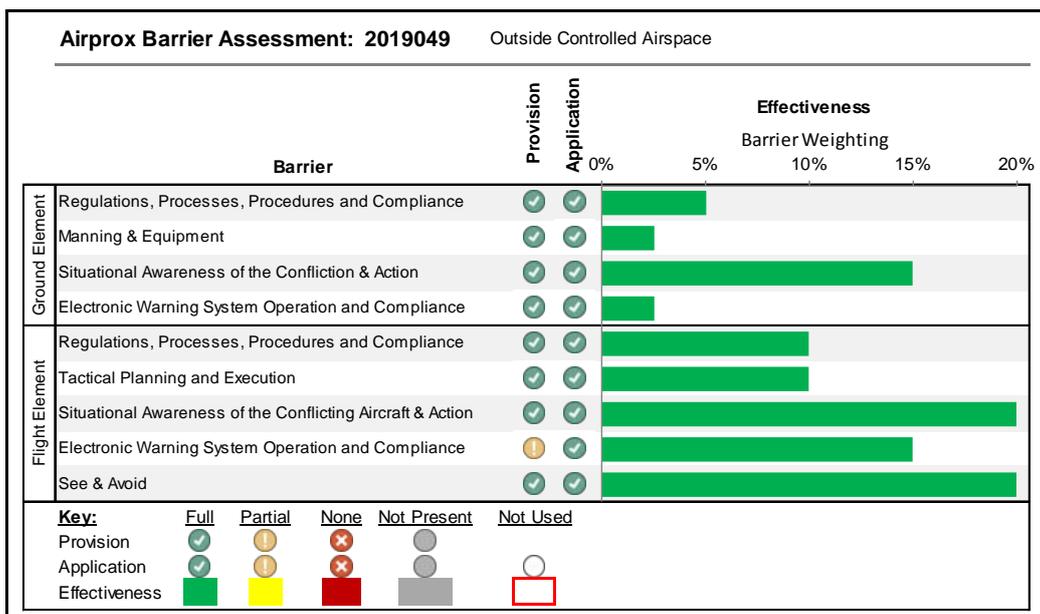
Safety Barrier Assessment²

In assessing the effectiveness of the safety barriers associated with this incident, the Board concluded that they had all been effective.
