AIRPROX REPORT No 2019053

Date: 03 Apr 2019 Time: 1532Z Position: 5310N 00019W Location: 7nm NW Coningsby

PART A: SUMMARY OF INFORMATION REPORTED TO UKAB

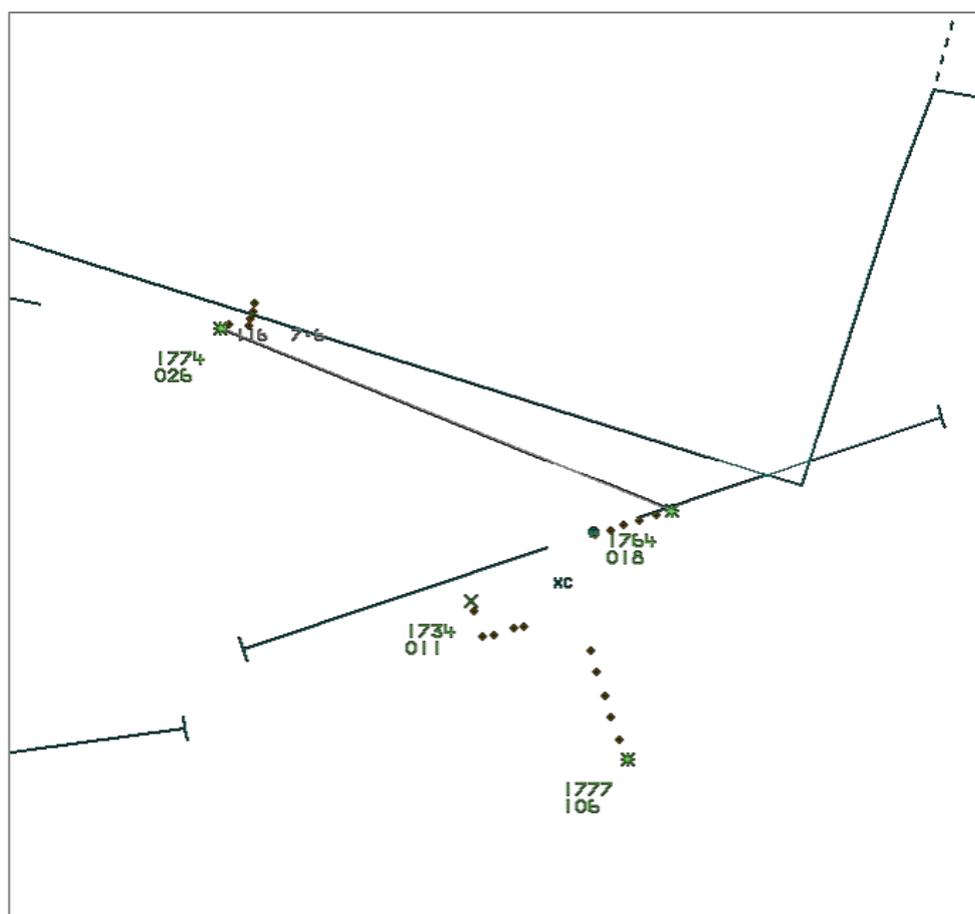
Figure 1 (Typhoon 1764, Tutor 1774)

The Typhoon had departed the Coningsby visual circuit with the intent of completing radar approaches for training and was given climb out instructions which included an initial heading of 290° and a climb to 2000ft. The Typhoon was one of a pair of aircraft in 5nm trail for individual radar approaches. The Tutor was completing a medium-level navigation exercise routing anti-clockwise round the Coningsby MATZ at 2000ft prior to return to RAF Wittering. In order to maintain VMC, the Tutor was unable to climb or descend due to thunderstorms in the area. Due to this vertical restriction, the Tutor pilot agreed to maintain an orbit about 8nm northwest of Coningsby to allow the Typhoons to complete their instrument approaches. The airspace picture was further complicated by opposing runway directions at Coningsby and Cranwell which required liaison between the units and the activation of a sterile area ('Area A') in accordance with a Letter of Agreement between the two units. On departure, the Typhoon pilot requested a Deconfliction Service. Separation at this point was 7.5nm (Figure 1).

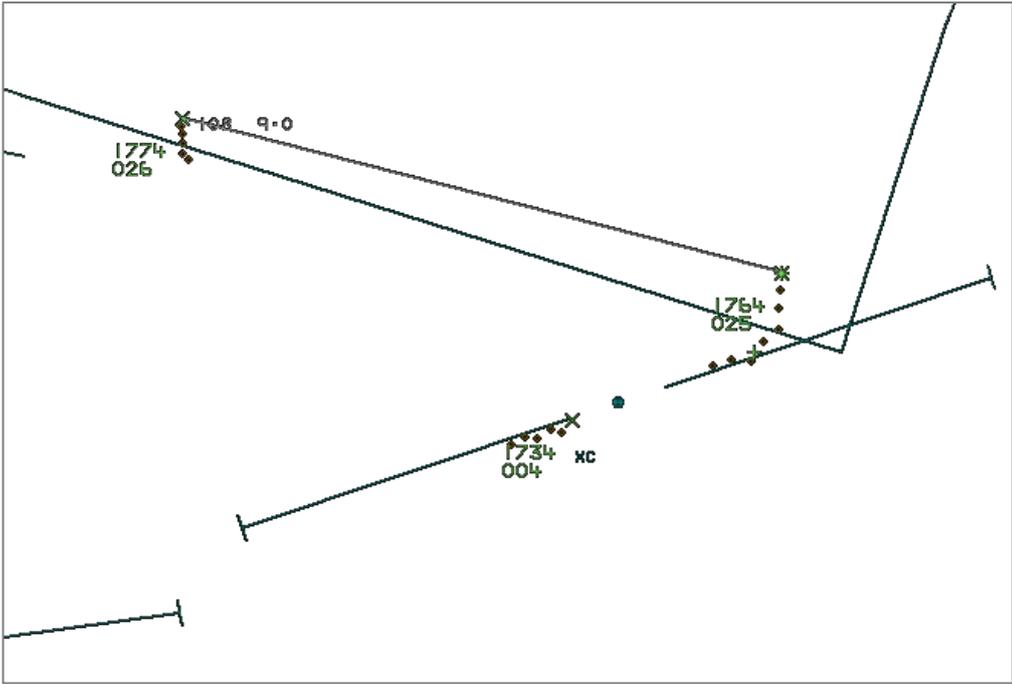
Figure 2

Due to multiple aircraft operating to the west of Coningsby and the opposing runway direction at Cranwell, the Approach Controller asked if the incident Typhoon was able to accept a Traffic Service. This was agreed by the pilot. Due to the climb out profile of the Typhoon, separation had increased to 9nm at the point this service change was agreed (Figure 2).

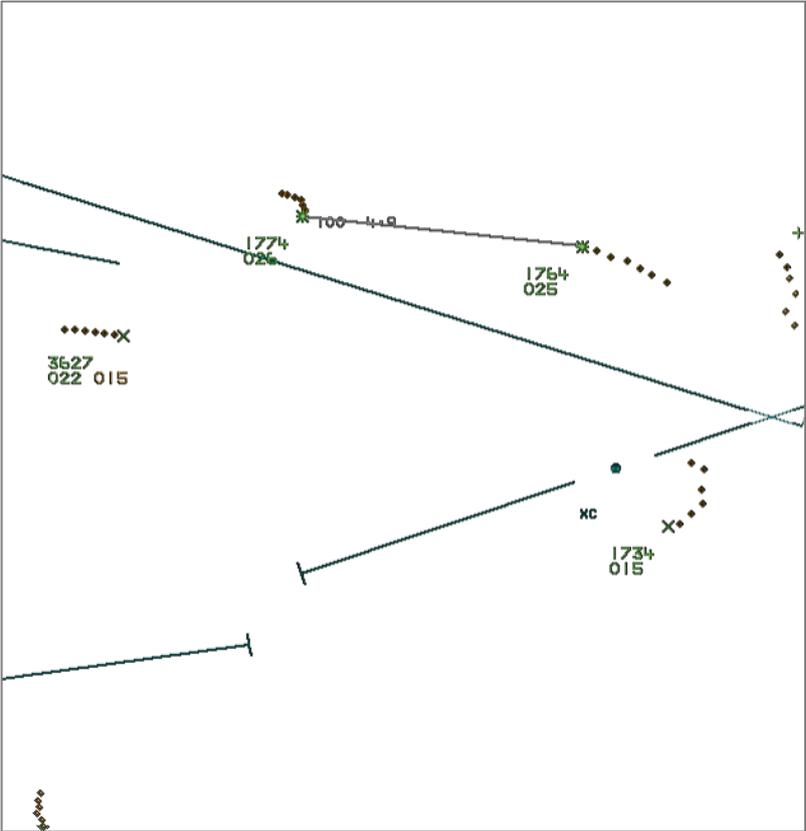
Figure 3

The next two minutes of R/T exchanges were taken up with the Approach Controller passing the procedure minima and the non-incident Typhoon requesting Traffic Information (TI) on an aircraft he had detected on his air-to-air radar. Shortly after this exchange, separation between the aircraft decreased to 5nm. The Coningsby LARS Controller passed TI to the Tutor pilot at 5nm and amplified the information with type (Typhoon) and the fact that it was in the Coningsby Instrument Pattern. Although not visual with the Typhoon, the Tutor pilot received a TAS warning consistent with the TI passed (Figure 3).

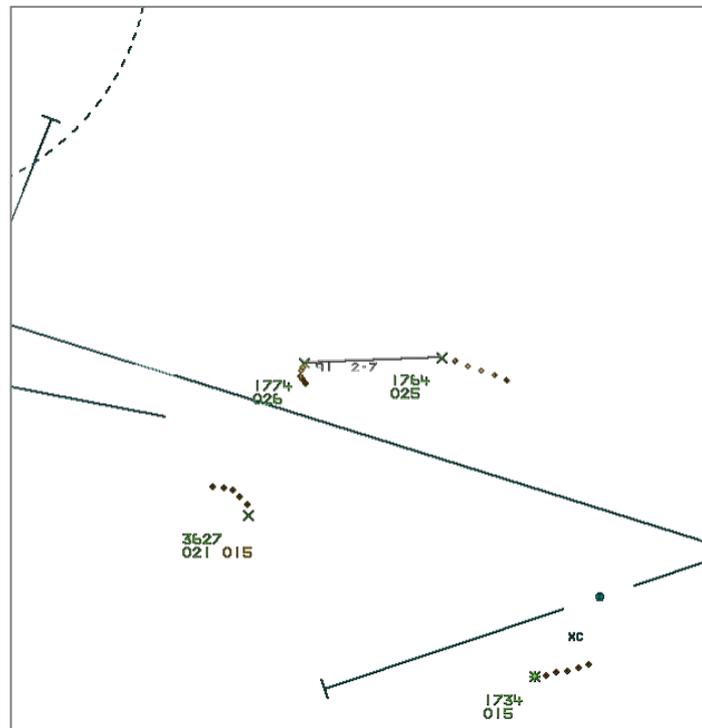
Figure 4

Separation between the aircraft continued to decrease and the incident Typhoon was given a positioning turn, left on to heading 210°. The Typhoon had not been provided with any TI by this point; the Tutor had received updated TI at 3nm but was still not visual with the Typhoon. Separation between the aircraft had decreased to 2.7nm laterally and 100ft vertical by the end of this R/T exchange (Figure 4).

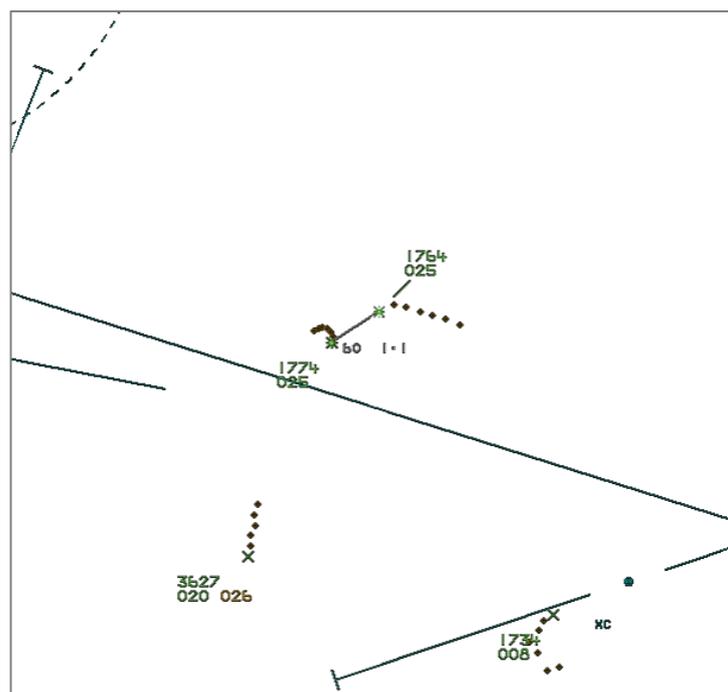
Figure 5

Six seconds after the positioning turn was issued to the Typhoon pilot, the Coningsby Approach controller passed him TI. This TI was accurate and noted that the inbound turn should keep the Typhoon clear. However, because the Tutor was conducting a right-hand orbit rather than being steady on a heading, this was not the case. The Coningsby LARS controller passed TI to the Tutor for a third time by which point, separation had decreased to 1.1nm (Figure 5).

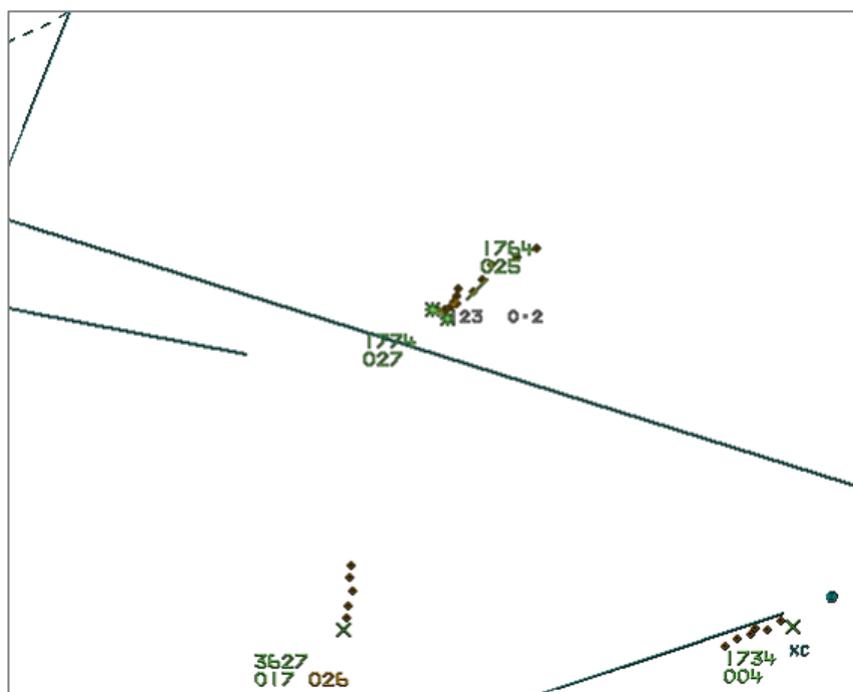
Figure 6 – CPA

Shortly after the TI was passed, the Approach Controller noted that the conflict was growing and turned the incident Typhoon onto a heading of 270°. The Closest Point of Approach (CPA) occurred 16sec after this turn onto west and was measured at 0.2nm and 200ft (Figure 6). Concurrent with this turn, the Coningsby Zone controller passed TI to the Tutor pilot for a 4th and final time at a range of ½mile. The Tutor pilot reported visual with the Typhoon at the same time as the recorded CPA.
