AIRPROX REPORT No 2019065

Date: 14 Apr 2019 Time: ~1455Z Position: 5348N 00241W

Location: M6, Junction 32

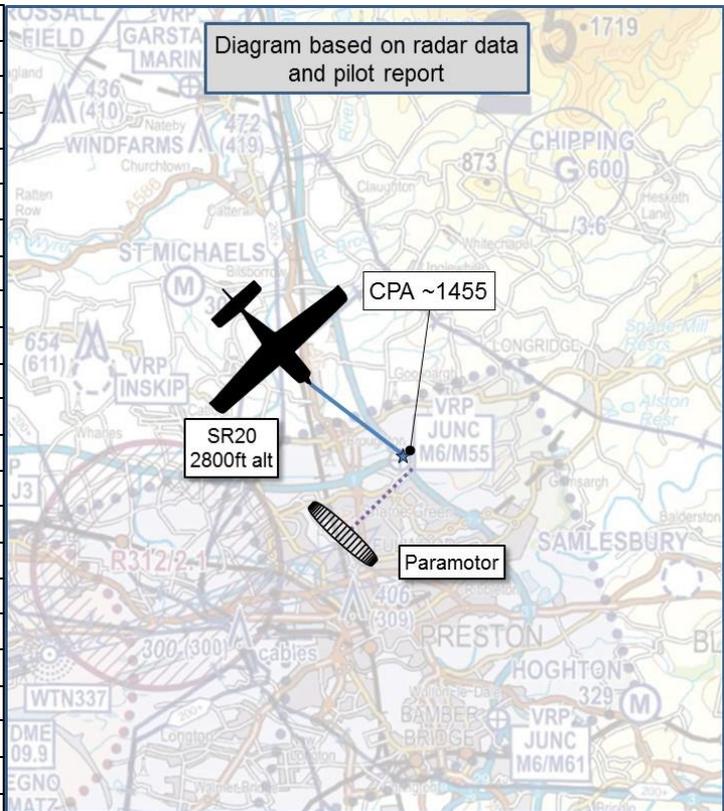
THE SR20 PILOT reports that he had glanced down momentarily to change radio frequency for the next ATS service, when he looked up and outside he saw what he believed to be a paraglider about 300m away at the same level tracking right to left. He immediately dived and turned right to avoid. He commented that normally he would have received a service from Blackpool but unfortunately Blackpool had closed unexpectedly so there was no agency to talk to in that area.

The Paramotor did not appear on the radar recording, therefore an accurate separation at CPA could not be verified.

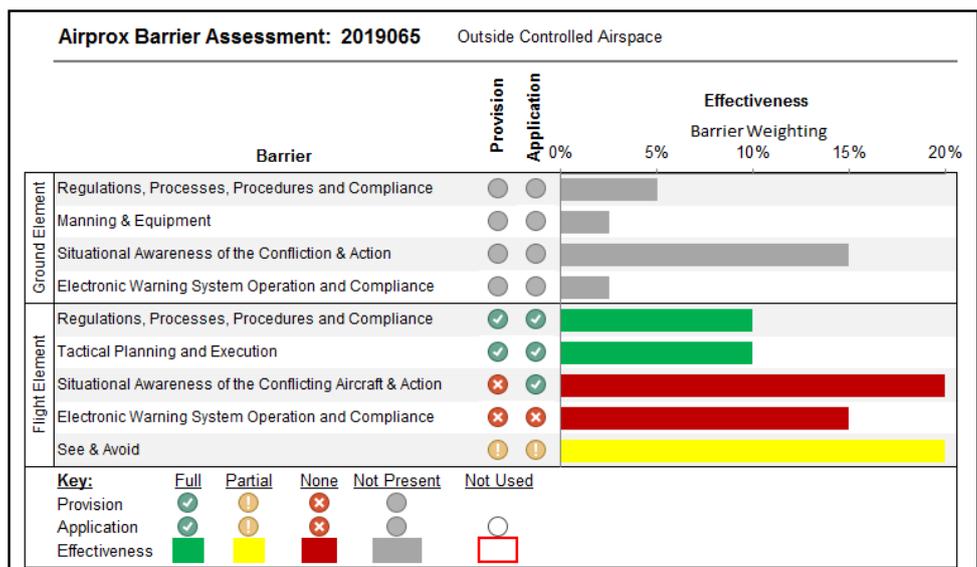
Situational Awareness of the Conflicting Aircraft and Action were assessed as **ineffective** because neither pilot had any situational awareness of the other aircraft.

Electronic Warning System Operation and Compliance were assessed as **ineffective** because the SA20's TAS could not detect the non-transponding paramotor.

See and Avoid were assessed as **partially effective** because the SR20 pilot saw the paramotor late, and then had to take emergency avoiding action. It was not known if the paramotor pilot saw the SR20.
