**AIRPROX REPORT No 2019070**

Date: 20 Apr 2019 Time: 1439Z Position: 5140N 00152W Location: ivo South Cerney airfield

**PART A: SUMMARY OF INFORMATION REPORTED TO UKAB**

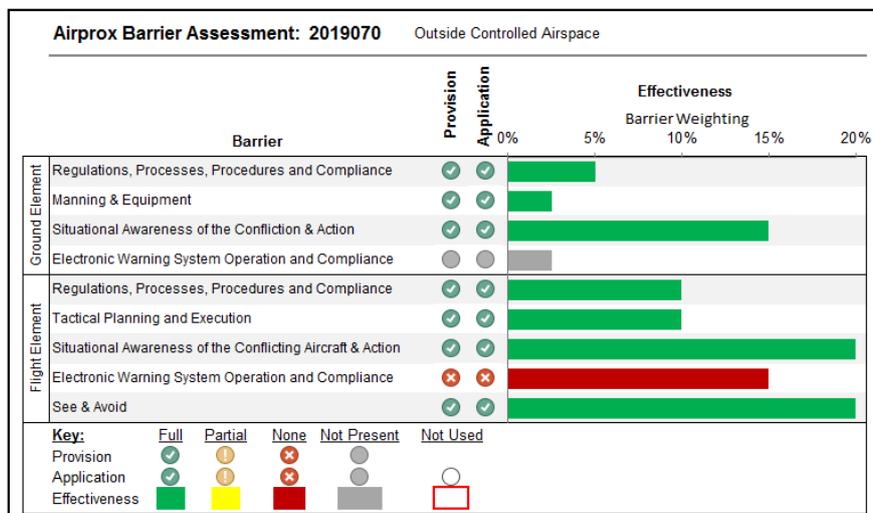
Safety Barrier Assessment<sup>3</sup>

In assessing the effectiveness of the safety barriers associated with this incident, the Board concluded that the key factors had been that:

**Electronic Warning System Operation and Compliance** were assessed as **ineffective** because although the C17 was equipped with an electronic warning system, the glider was not transponding.

**See and Avoid** were assessed as **effective** because the C17 crew obtained visual contact with the glider at 1nm.
