AIRPROX REPORT No 2019072

Date: 17 Apr 2019 Time: 1444Z Position: 5208N 00002E Location: Cambridge

PART A: SUMMARY OF INFORMATION REPORTED TO UKAB

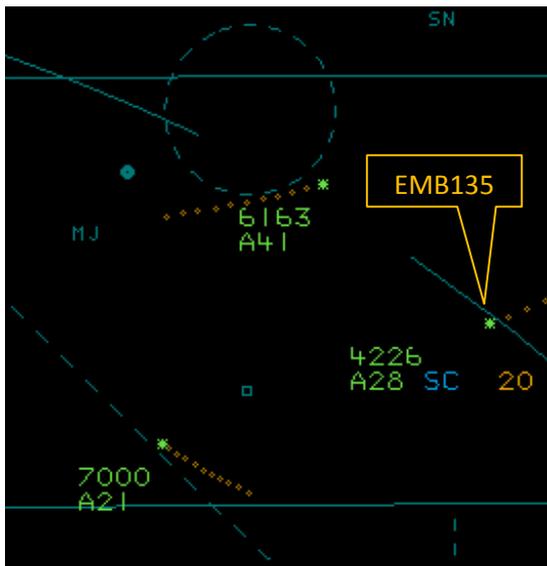
Figure 1-1442:00 Area Radar

At 1442:00 (Figure 1), the controller passed Traffic Information to the EMB135 pilot advising them that they had traffic in their right 2 o'clock, range of 4 miles, passing down their right-hand side, a caravan, maintaining 12,000 feet. The pilot responded with 'Roger'. This was followed by further traffic described as 12 o'clock, range 4 miles, indicating 2000 feet, westbound. The controller advised the pilot that they would be turning them before that traffic. The pilot responded with 'Roger'. The controller then asked the EMB135 pilot if they could accept one turn onto final approach. The pilot responded 'Affirm'.

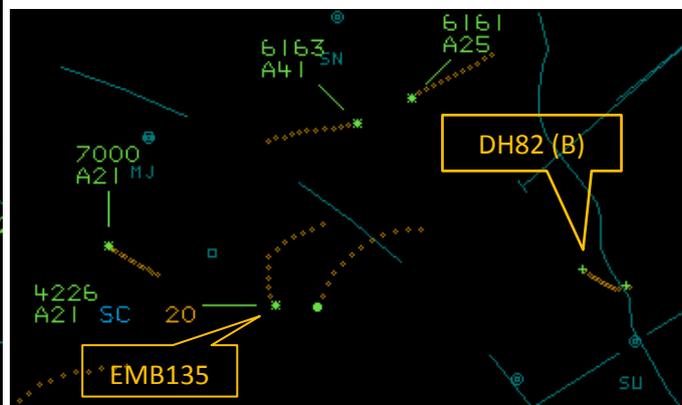
Figure 2-1442:50 Area Radar

At 1442:50 (Figure 2), the controller turned their attention back to the EMB135 pilot and instructed them to continue their left turn onto heading 060°.

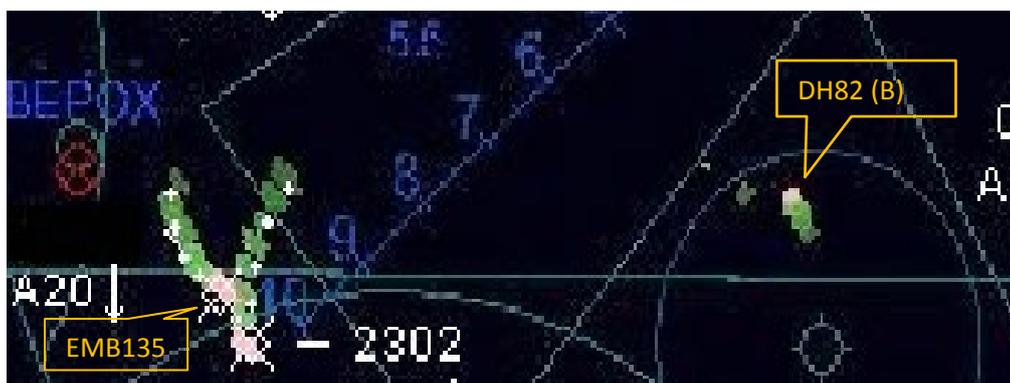
Figure 3-1442:57 Cambridge Radar

At 1442:57 (Figure 3), only one DH82 (DH82(B)) was displayed on the Cambridge Radar Display.

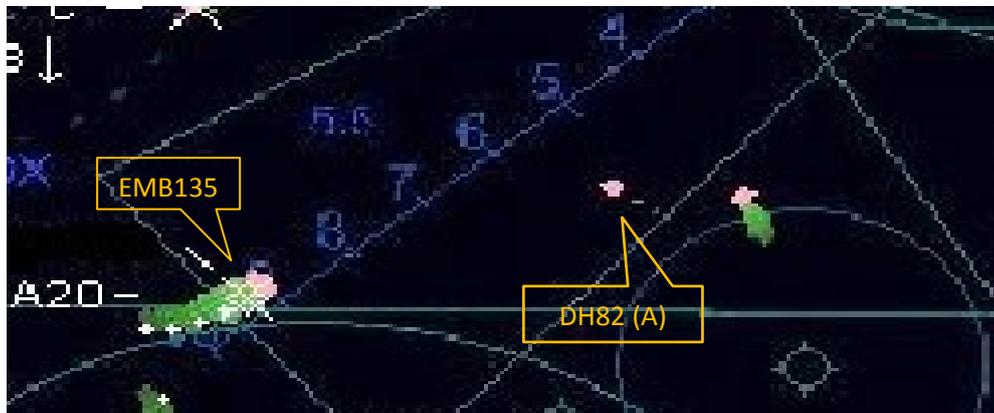
Figure 4-1443:29 Cambridge Radar

At 1443:29 (Figure 4), DH82(A) first appeared on the Cambridge Radar Display.

At 1443:29, the unknown DH82(A) radar contact first appeared on the Cambridge radar display with no history trail. The history trail was displayed at 1443:58, and the controller passed Traffic Information to the EMB135 pilot on the ‘pop-up’ DH82(A) traffic at 1444:20, asking the pilot if they wished to break off the approach. CPA occurred 30secs later.

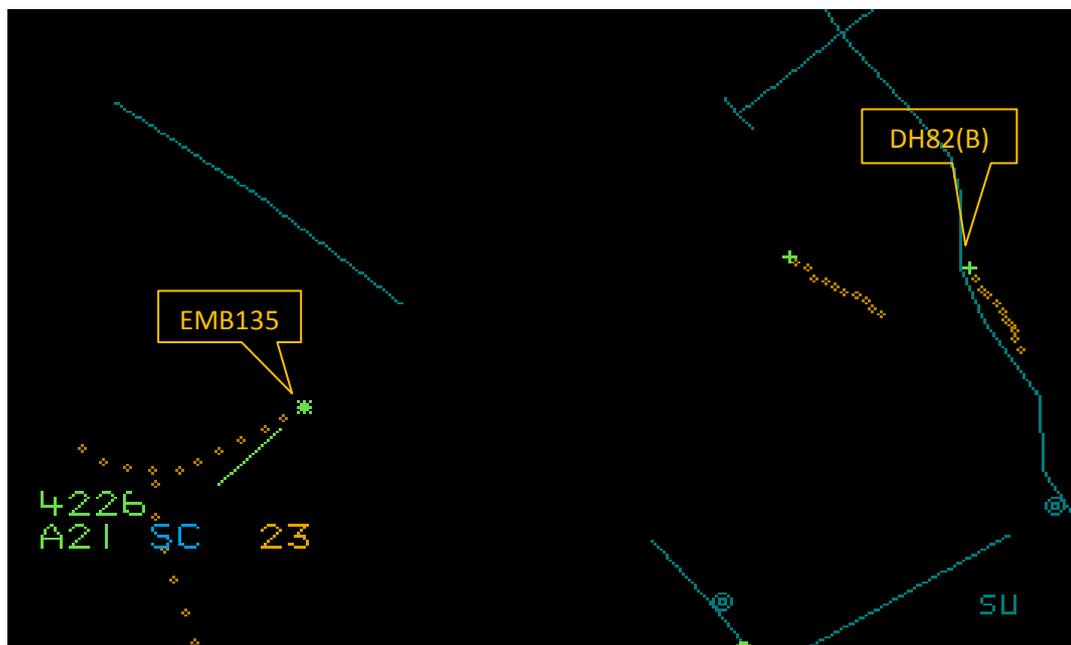
Figure 5-1443:40 Area Radar

At 1443:40 (Figure 5), the DH82(B) pilot made initial R/T contact with the Cambridge Radar controller and requested a Basic Service. The controller responded that it would be a Basic Service, QNH 1019, and asked the pilot to confirm what level they were climbing to. The pilot advised that they were level at 1200 feet on 1019 and that they would report at Maddingly. The controller passed Traffic Information on the EMB135 advising that it was 9 miles on final approach RW05, at 2000ft descending with the procedure, inbound to Cambridge. The pilot acknowledged with their callsign.

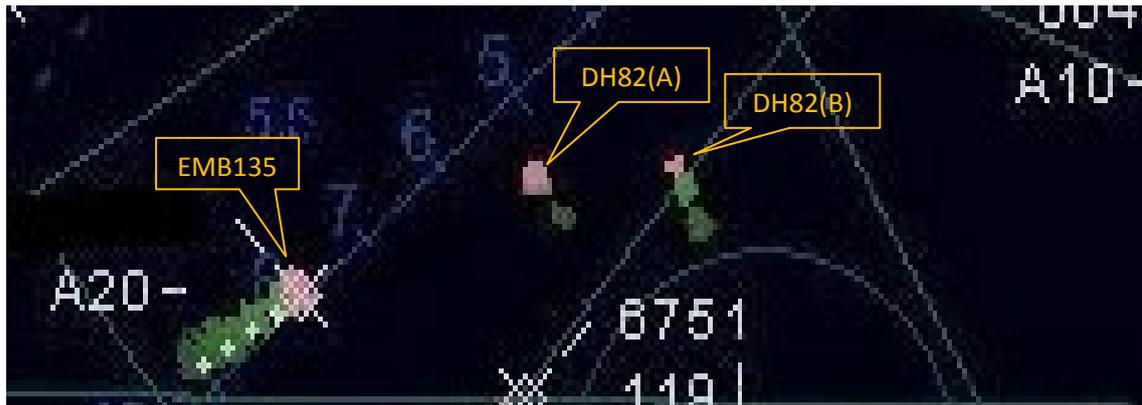
Figure 6-1443:58

At 1443:58 (Figure 6), the radar contact for DH82(A) was fully established on the Cambridge radar with a history trail.

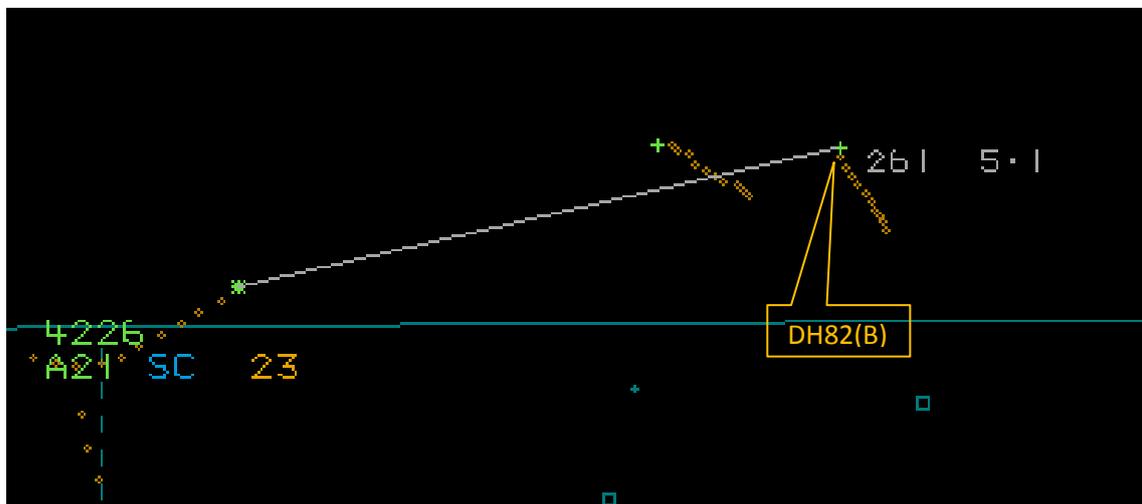
Figure 7-1444:00 Area Radar

At 1444:00 (Figure 7), the controller passed Traffic Information to the EMB135 pilot, described as “right, half-past one, range of 5 miles, believed to be a Tiger Moth at 1200ft”. The pilot responded with ‘Roger’.

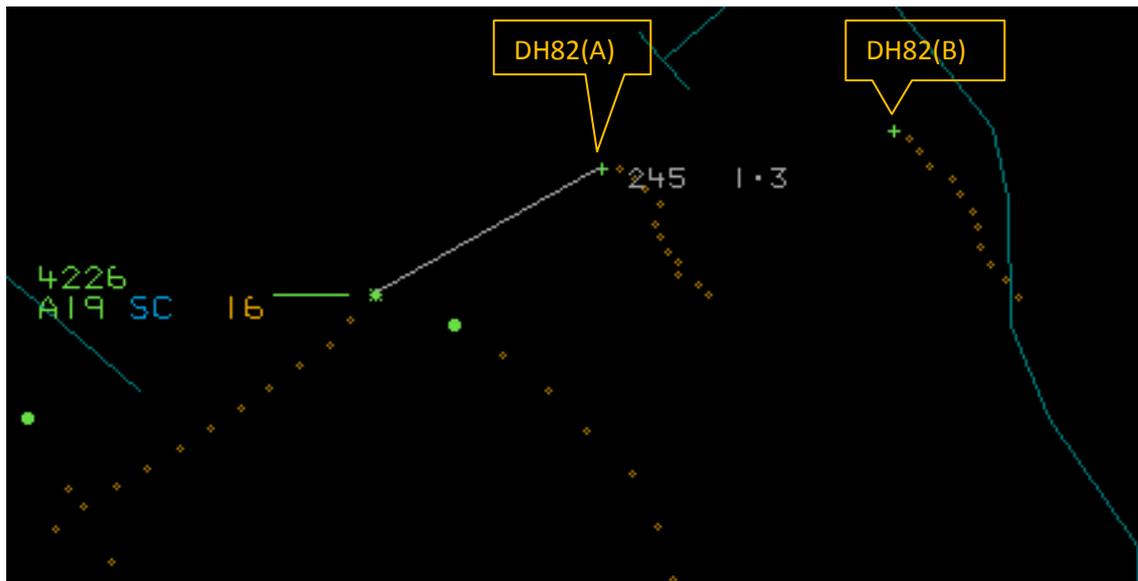
Figure 8-1444:30

At 1444:30 (Figure 8), the controller responded with “turn right now, avoiding action turn right heading 090°”. The pilot read back ‘turn right 090°’.

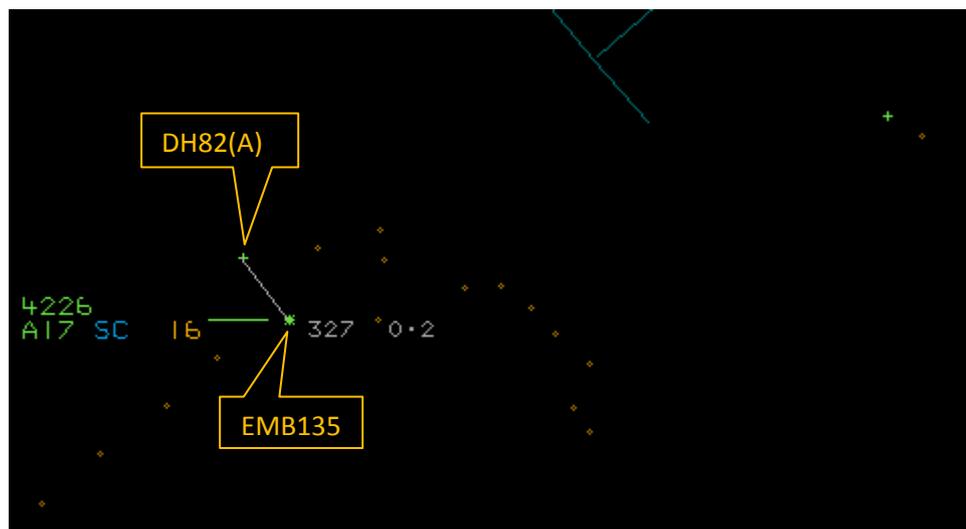
Figure 9-1444:50

CPA occurred at 1444:50 (Figure 9), with the aircraft separated by 0.2nm horizontally, the vertical separation could not be measured.

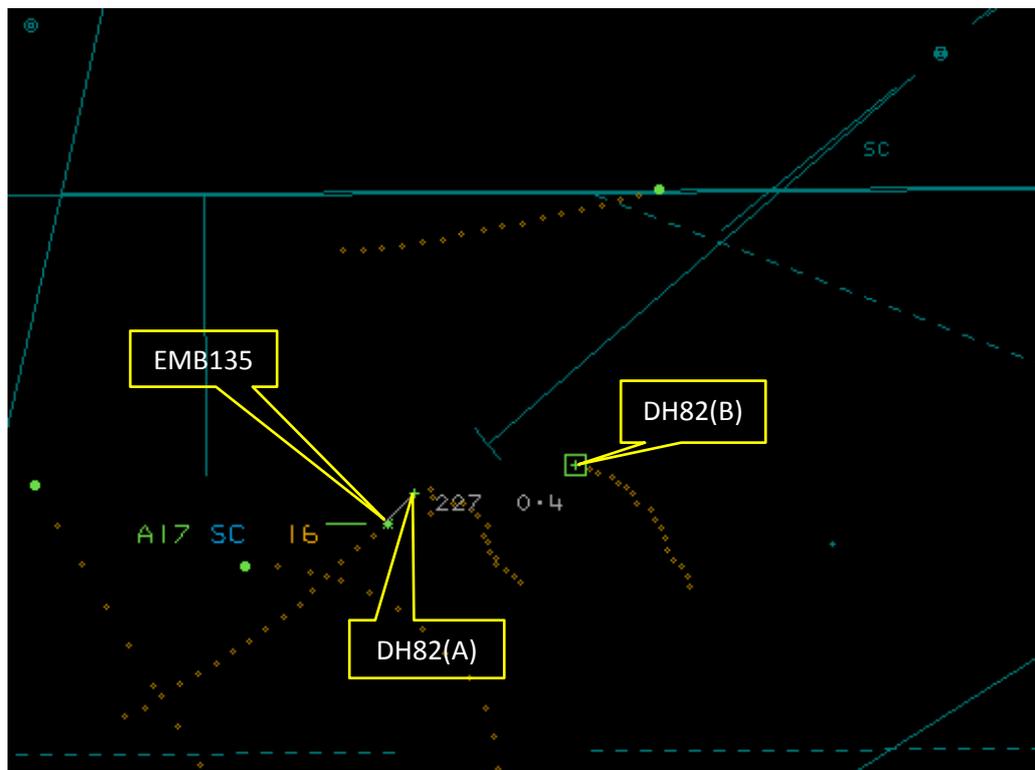
Figure 10: 1444:46

The Board then turned to the actions of the DH82(A) pilot and agreed that although entitled to fly where they were in Class G airspace, it was inadvisable to fly through the 'feathers' of the Cambridge RW05 Instrument Approach Procedure (as shown in Figure 10) without contacting Cambridge ATC as advised in Figure 11 (**CF6, 7, 8 & 9**). As a result, the Cambridge controller did not have situational awareness of his intentions until later than desirable and could not therefore pass timely TI to the EMB135 or the DH82(A) pilot regarding arriving or departing aircraft. Establishing communications with the appropriate ATCU in the vicinity of the feathers is especially important for non-transponding aircraft so that an accurate understanding of the traffic situation can be achieved. Notwithstanding, the Board noted that the DH82(A) pilot had seen the EMB135 and had descended to increase separation.

The Board were heartened to hear that Cambridge and Duxford now have an agreed procedure that will increase the liaison calls between the 2 agencies if Duxford aircraft operate close to the Cambridge approach/climb-out lanes and decide not to talk to Cambridge ATC. Notwithstanding, the Board reiterated that pilots should contact the controlling authority if their route will take them close to an Instrument Approach, and especially if they intend to pass through feathers marked on the VFR chart.
