AIRPROX REPORT No 2019078

Date: 21 Apr 2019 Time: 1646Z Position: 5053N 00125W Location: 4nm SW SAM VOR

PART A: SUMMARY OF INFORMATION REPORTED TO UKAB

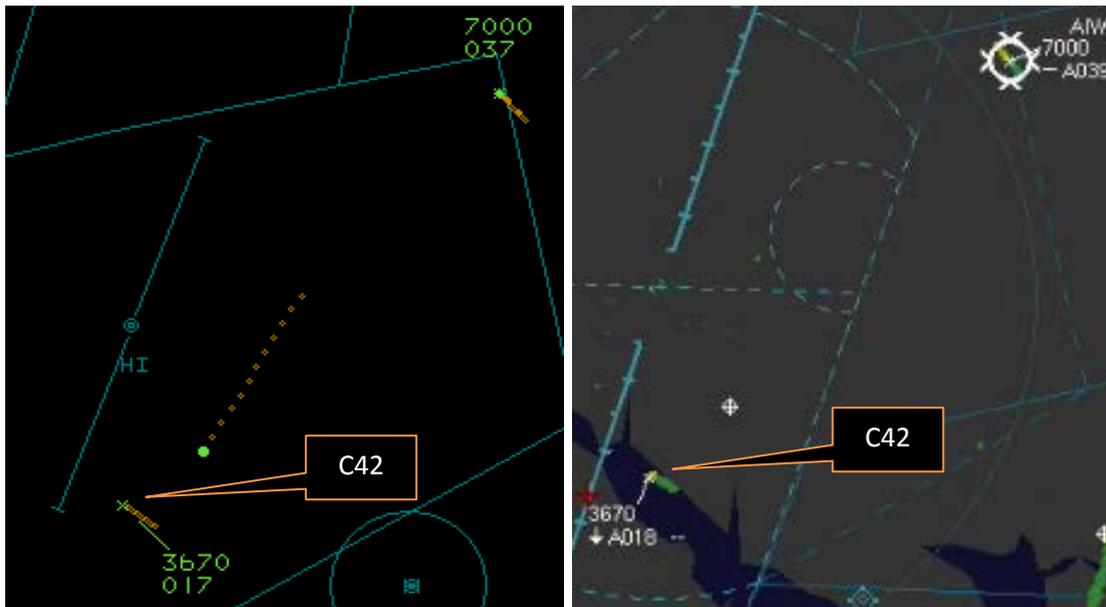
Figure 1-1644:50

At 1644:50, the Radar controller updated the Traffic Information to the C42 pilot advising that the Do228 was just departing now RW20. The pilot responded with 'roger' and 'thank you'. Figure 1 shows both the Area radar and Southampton radar replays at this time.

Area Radar Southampton Radar.

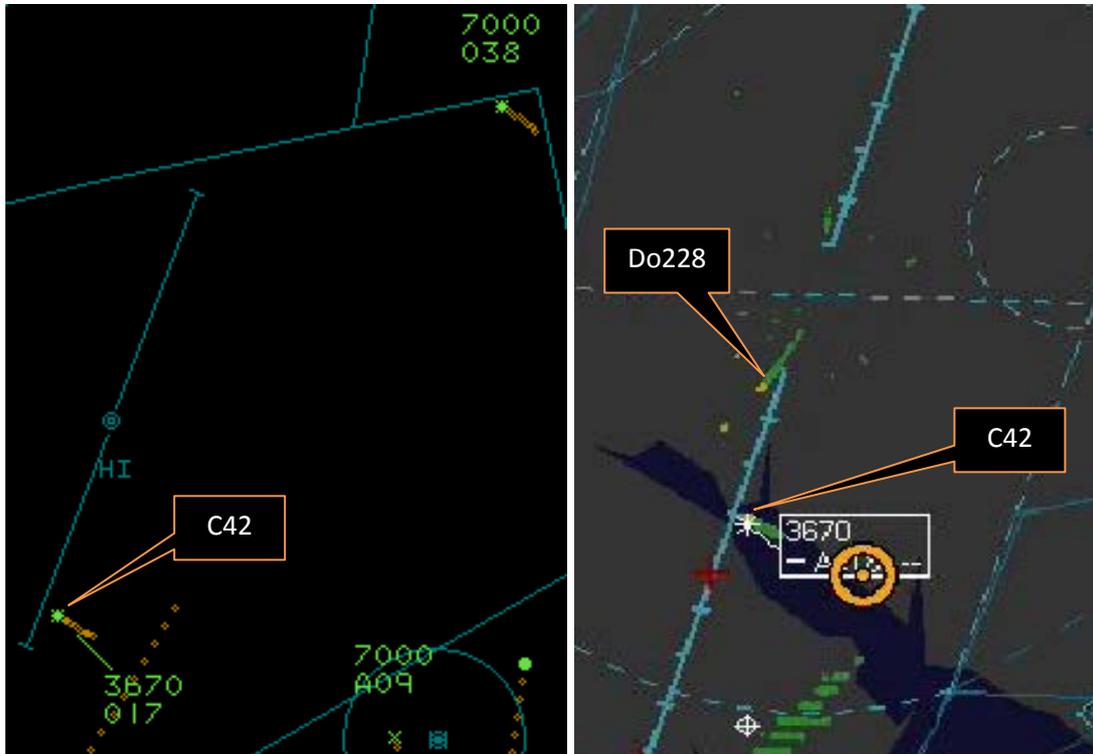
Figure 2-1645:40

At 1645:40, the Radar controller asked the C42 pilot if they were visual with the Do228 advising that it was now 2nm north of them, southbound. The pilot responded that they were not visual but looking. Figure 2 again shows both the Area radar and Southampton radar replays at this time, the Do228 is not yet visible on the Area radar but is displaying on the Southampton radar.

Area Radar Southampton Radar

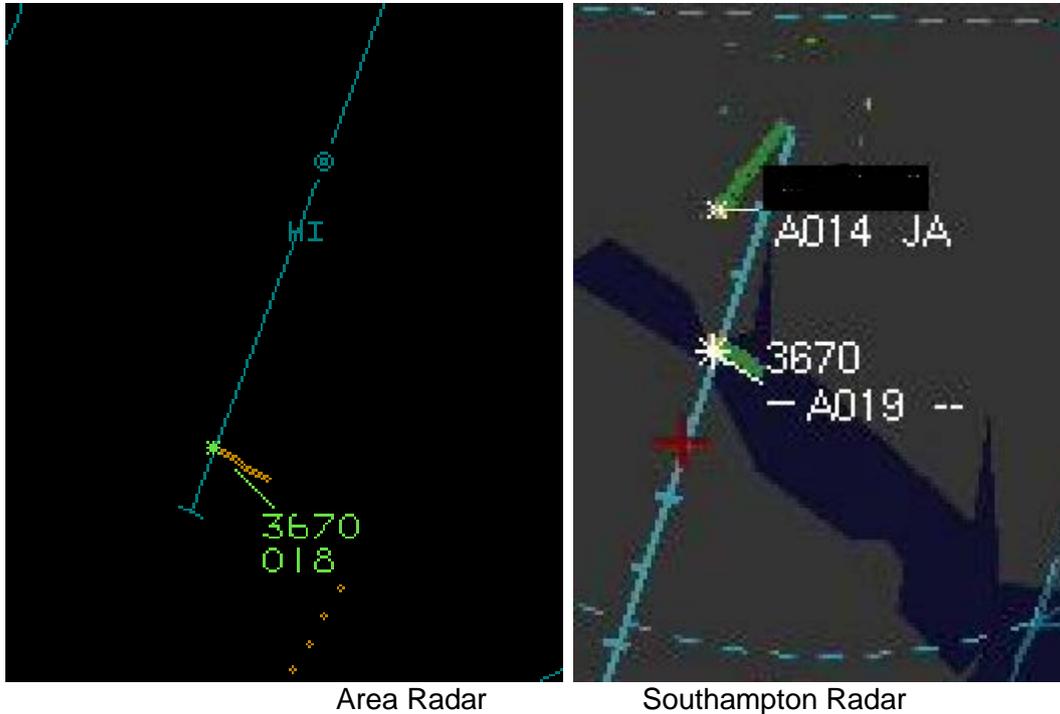
Figure 3-1646:00.

At 1646:00, the Aerodrome controller updated the Traffic Information to the Do228 pilot, advising them that the C42 was now 2nm due south of them and instructed the pilot to change to the Radar frequency. The pilot responded with “Solent Radar callsign”. At the same time, the C42 pilot reported visual with the Do228 and the Radar controller acknowledged. Figure 3 shows both the Area radar and Southampton radar replays at this time, the Do228 is still not yet visible on the Area radar but is displaying on the Southampton radar.

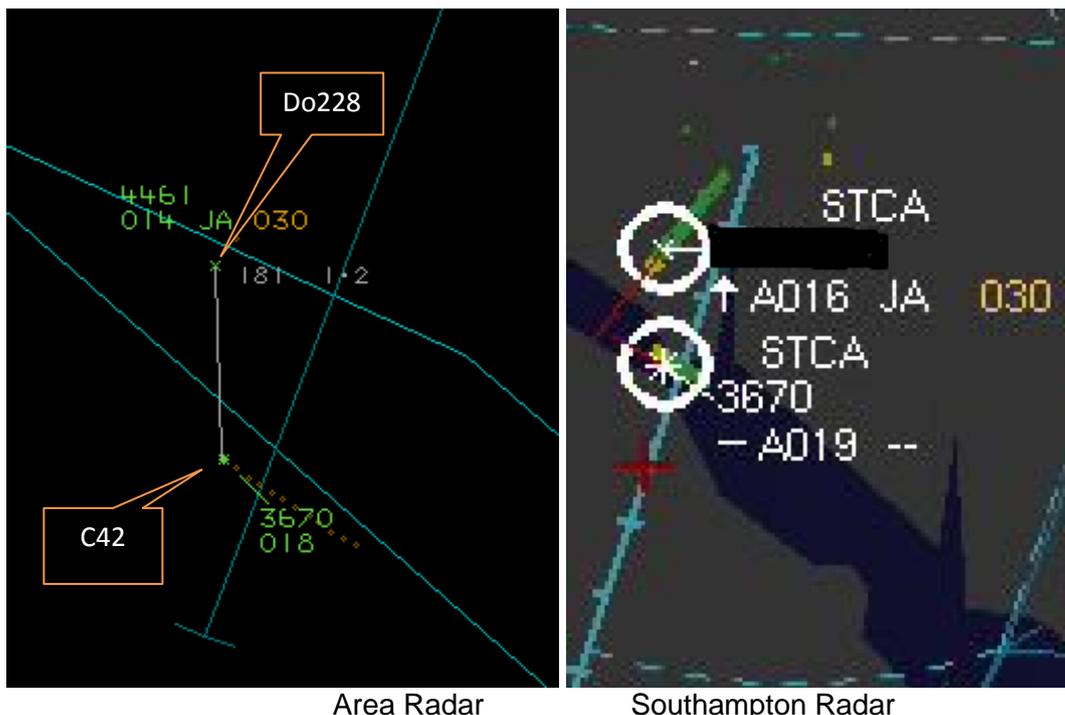
Figure 4-1646:10 .

At 1646:10 (Figure 4), the Do228 pilot made his initial call to the Radar controller advising that they were airborne and passing 1600ft on the noise abatement route. The controller asked the pilot if they were visual with the C42 just south of them at 1900ft. The pilot responded with negative.

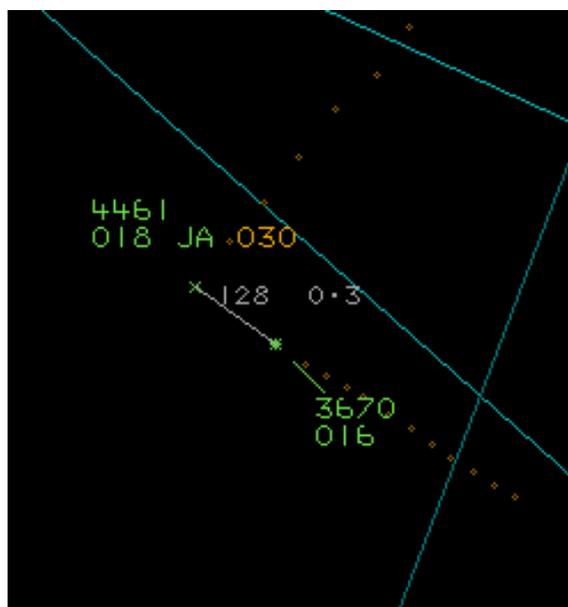
Figure 5-1646:30 CPA (Area Radar).

CPA occurred at 1646:30 (Figure 6), with the aircraft separated by 0.3nm laterally and 200ft vertically.

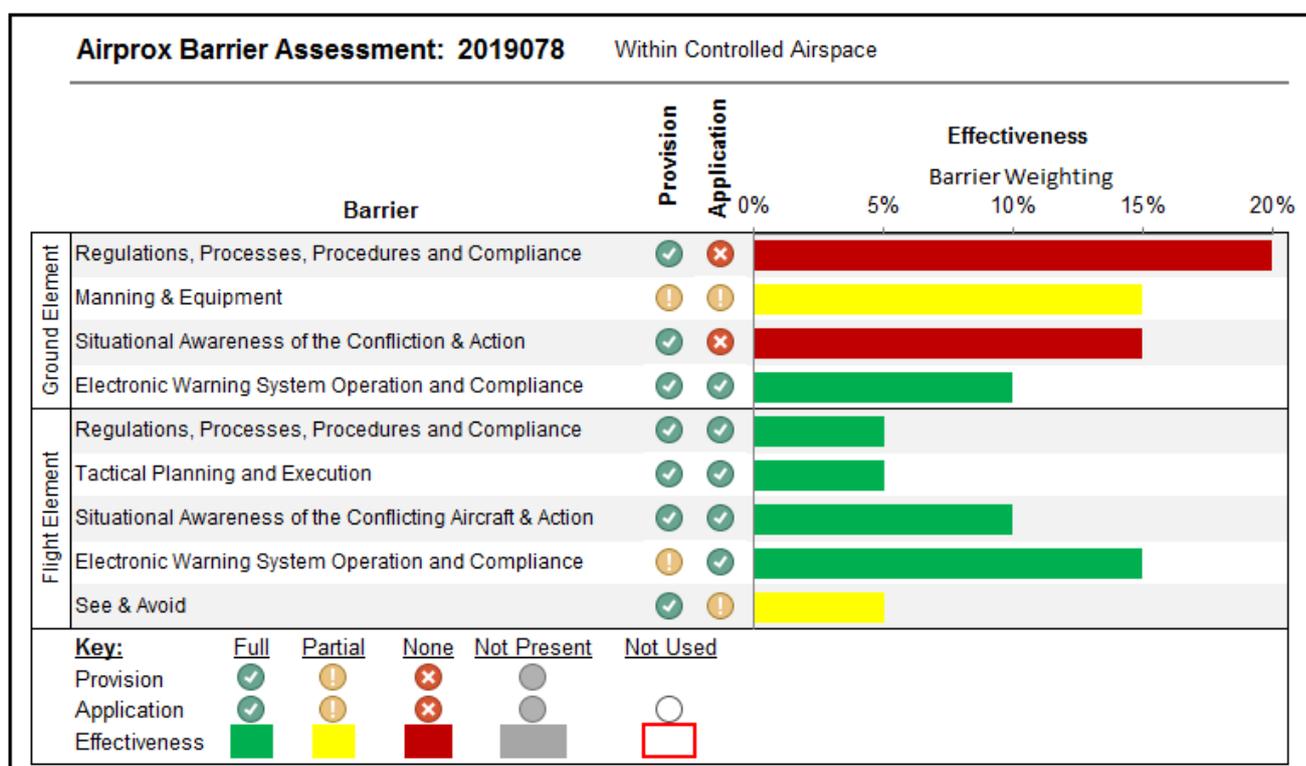
Regulations, Processes, Procedures and Compliance were assessed as **ineffective** because, although the controllers complied with the minimum service to be applied in Class D airspace by passing Traffic Information to both pilots, the C42's routeing should have been changed to remove

Manning and Equipment were assessed as **partially effective** because, due to staff shortages, the Radar controller had to perform both the Solent and Southampton positions combined.

Situational Awareness of the Confliction and Action were assessed as **ineffective** because, although realising the potential confliction, ATC only relied on passing Traffic Information with the assumption that the pilots would gain visual contact early enough to take appropriate action.

Electronic Warning System Operation and Compliance were assessed as **partially available** because only the Do228 was equipped with an electronic warning system.

See and Avoid was considered as **partially effective** because the Do228 pilot only saw the C42 late, and the C42 pilot did not take sufficiently effective action to adequately increase separation after obtaining visual contact.
